**Archaeological Monitoring**

**Annual pre-Season Sweep**

***Sceilg Mhichíl, Co. Kerry***

*Alan R. Hayden -  
April 2024*

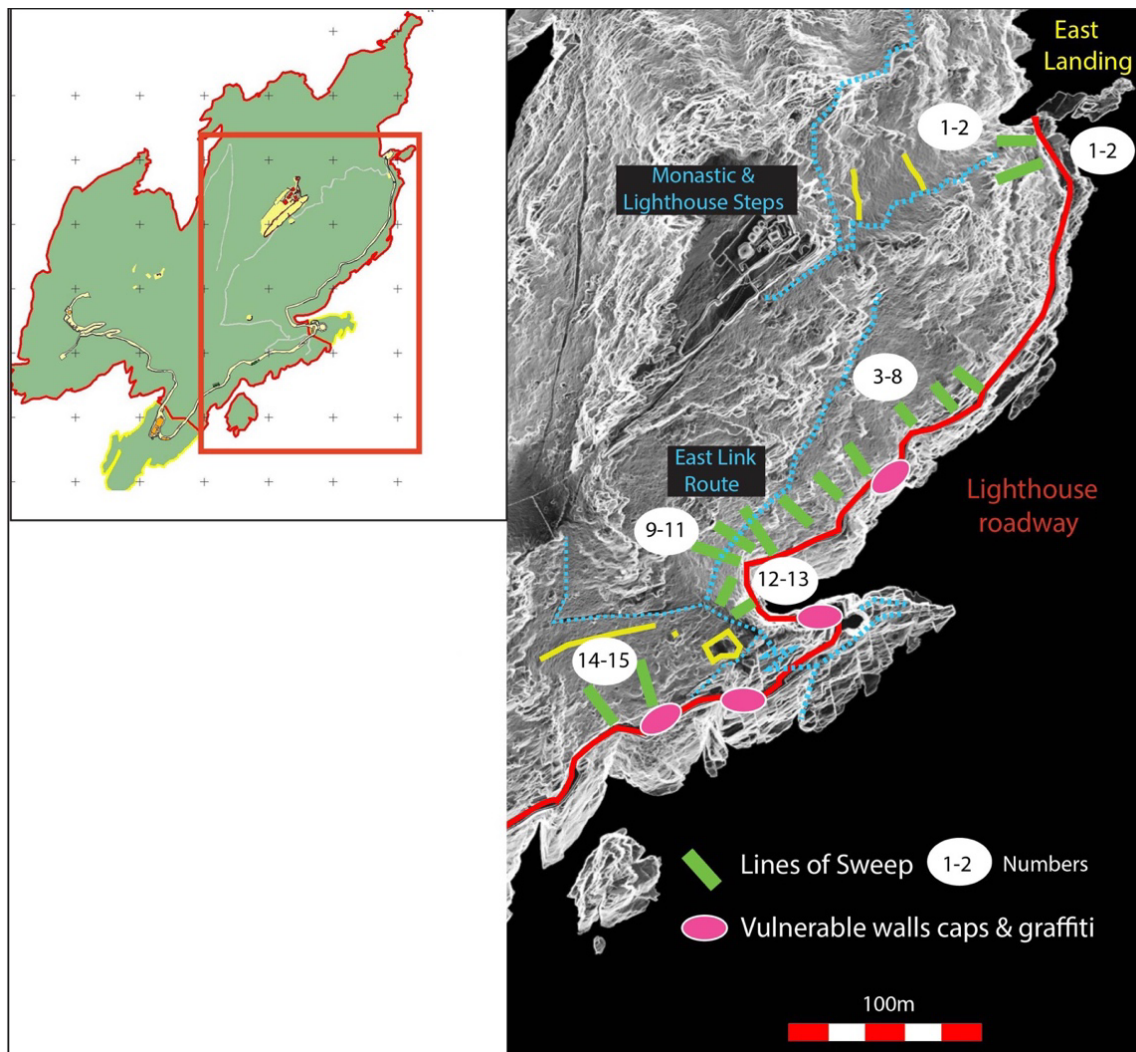
Fig. 2. The lines of the sweep undertaken and the known archaeological features in the vicinity.

Sweep lines 1 and 2 were undertaken in the vicinity of the East Steps to the monastery. The East Steps and the features associated with them are clearly visible and none were impacted in any way by the sweep.

Lines 3-7 lay in areas where there are no known archaeological features on the steep cliffs above the lighthouse roadway.

In the area above Cross Cove (sweep lines 8-11) the sweep crossed the line of the western part of the East Link pilgrimage route. Part of the west end of the East Link pilgrimage route was identified by the writer many years ago from a distance. A number of features on its eastern end (a beehive hut and several rock-cut crosses) were also explored and publicised by Michael Gibbons. Subsequently the LiDar survey of the island was also used to identify part of the route. However, despite its clearly early date and importance, the route has never been surveyed or inspected archaeologically by the NMS. So it remains unknown exactly what features might survive on it, where they might lie and in what condition they might be. As a result, any surviving features on the routeway are extremely vulnerable, and they also might not in any case be clearly visible as features today. Therefore in reality it cannot be determined whether or not this year's sweep (and of course previous year's sweeps) did or did not have an impact on the features of this early route.

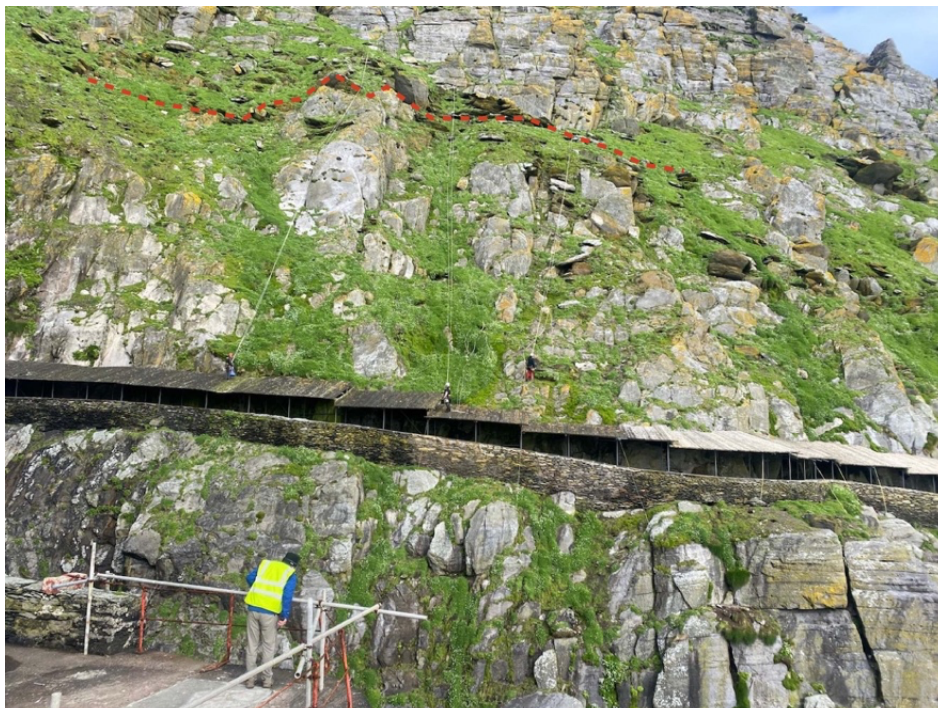
Sweep lines 8-11 clearly crossed the line of the East Link route, an early-medieval pilgrimage route that includes drystone-walled terraces, steps, a beehive hut and crosses (fig. 3). As this part of the route have never even been visited by an archaeologist, let alone surveyed in any way, we do not know what features may survive on it, where they lie and in what condition they might now be. Therefore we do not know whether or not, this and previous sweeps may have had any impact on any of the potential archaeological features on this route.

*Fig. 3. Sweep lines 9-11 crossing the line of the East Link route (dotted red line)with ecologist monitoring work through telescope in foreground. The contrasting roofs distinguish the newer sections from the original lighthouse-era canopy over the lighthouse roadway.*

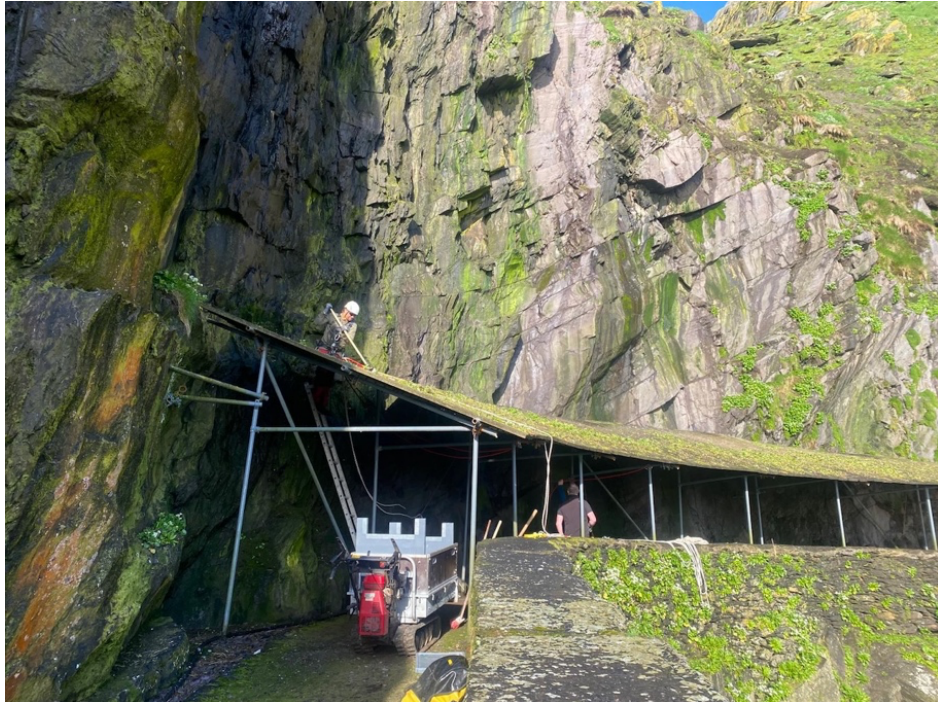
Lines 9-11 and 12-13 impacted on the canopy in Cross Cove. The sweep also included cleaning the canopy (fig. 4). The earliest section of canopy here is one of the features of the Lighthouse period of the occupation of the rock. The volumes we discovered in Kerry include details of the construction of the canopy, the date it was erected, how long it took to complete, the names of the three men who did the work and how much each of them was paid. We also have several references to the keepers cleaning and repairing the timber top of the canopy. No damage was done to the canopy by the sweep.

*Fig. 4. Cleaning the original lighthouse-era canopy at Cross Cove.*

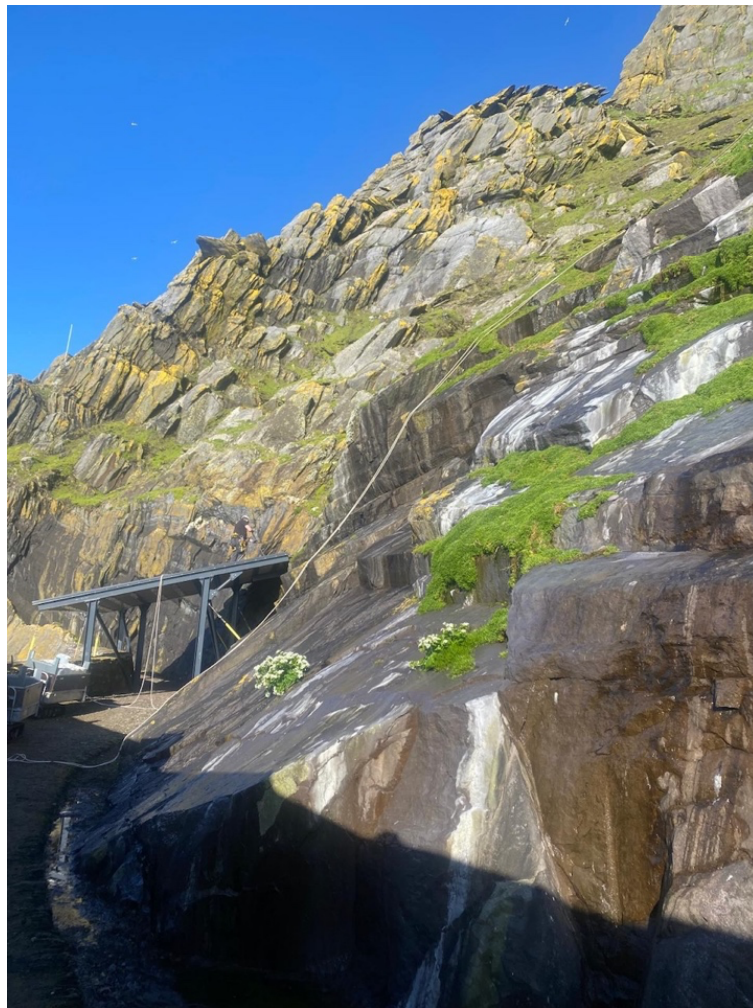
The large sloping rockface opposite the workmens' huts contains many inscribed names and initials of lighthouse keepers and personnel. It lay below sweep line no. 14 but no damage was done to it by the sweep (fig. 5.).

*Fig. 5. Sweep line 14 and the sloping rockface that contains much lighthouse-era graffiti.*
