**Reinstatement of the roadway features
removed to facilitate construction of the
three all-metal crash decks on the
Lower and Upper Lighthouse Roadways,
Sceilg Mhichíl, Co. Kerry.**

**Reinstatement of the roadway features removed to facilitate construction of the three all-metal crash decks on the Lower and Upper Lighthouse Roadways,
Sceilg Mhichíl, Co. Kerry.**

*Alan Hayden
Archaeological Projects Ltd,
September 2024*

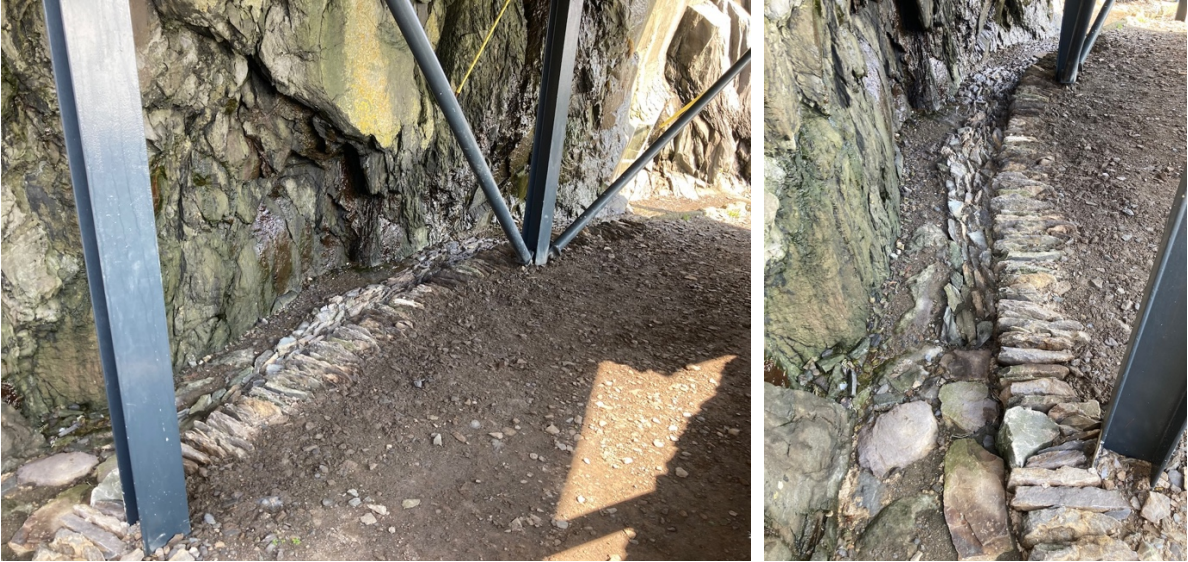
Except for the concrete wall of the so-called 'duckpond'¹ (of which only a short section was removed) the features on the internal side of the roadway had to be removed in full before the construction works. The lateral drain at the west end of this area was composed of stones laid flat due to the height of the underlying bedrock. Only a small section of the outer wall of the 'duckpond' had to be removed to facilitate one of the beams crossing under the roadway. This section was not reinstated as the concrete in the 4-inch thick wall will have to be tested to ensure that, that which is used to fill the gap matches the original.

Figs. 5 & 6. Crash Deck 1, general views of the reinstated features.

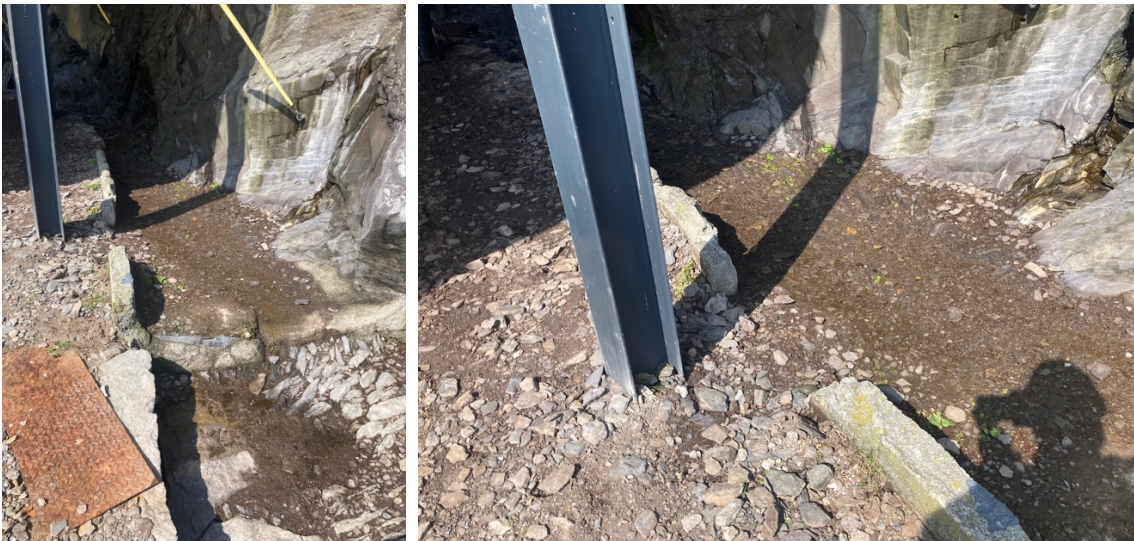
mason and crew did an excellent job and the new work matches well with the original. A short section of the concrete wall of the 'duckpond' beneath Crash Deck 1 remains to be repaired.

Figs. 7 & 8. Crash Deck 1, the remaining gap in the wall of the 'duckpond'.

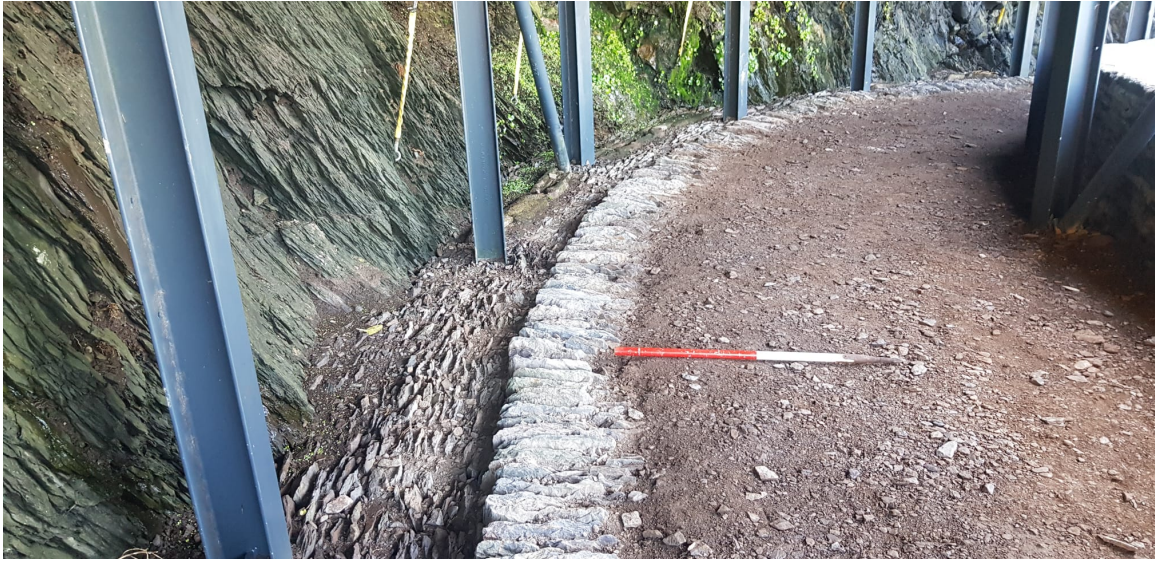
The features on the internal side of the roadway here had to be removed in full to facilitate construction. Several parts of the cable channel were in very poor condition and were not reinstated as they survived only as fragments. To ensure the long-term preservation of the sections reinstated, they were set down into the lateral drain, with their top at the same level as the surface of the lateral drain, to ensure they did not block water flow.

Fig. 9. Crash Deck 2, reinstated road edging, cable channel and lateral drain, looking downhill.

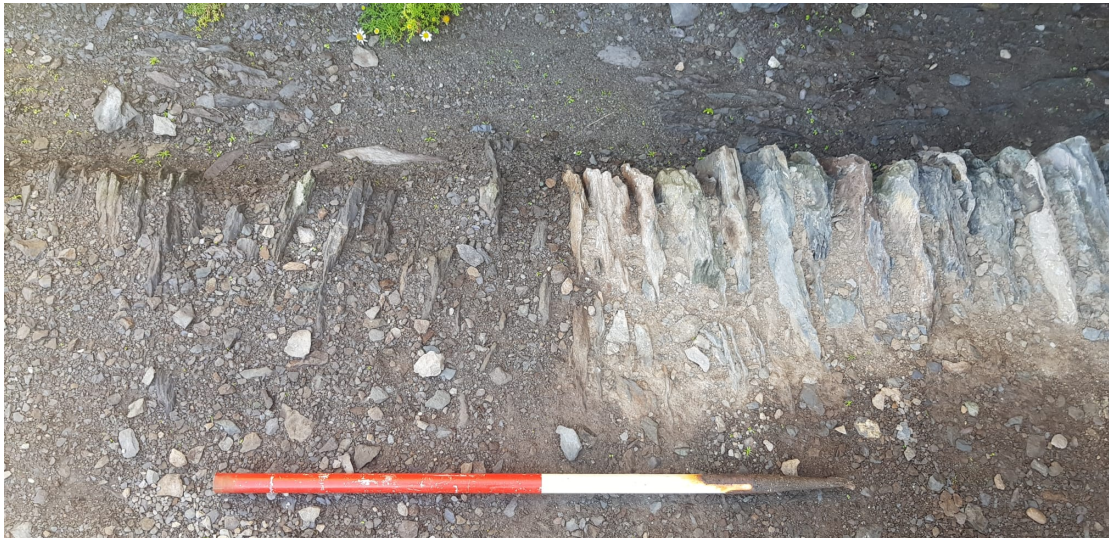
Fig. 10. Crash Deck 2, junction of original and reinstated road edging.

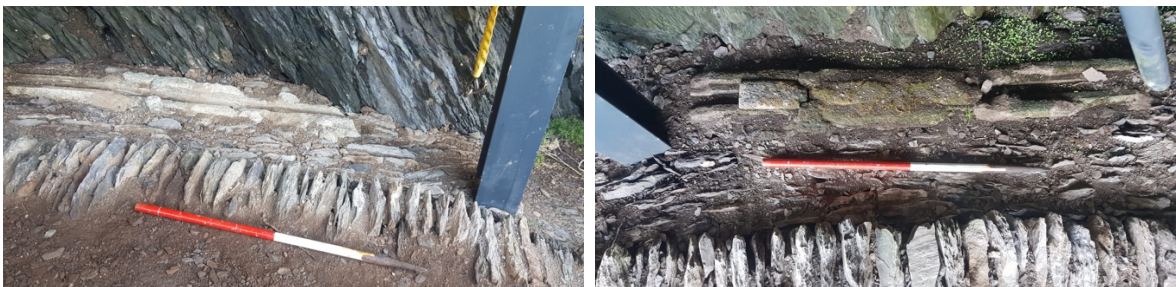
Figs. 11 & 12. Crash Deck 2, details of reinstated cable channel sections sunken into reinstated lateral drain.

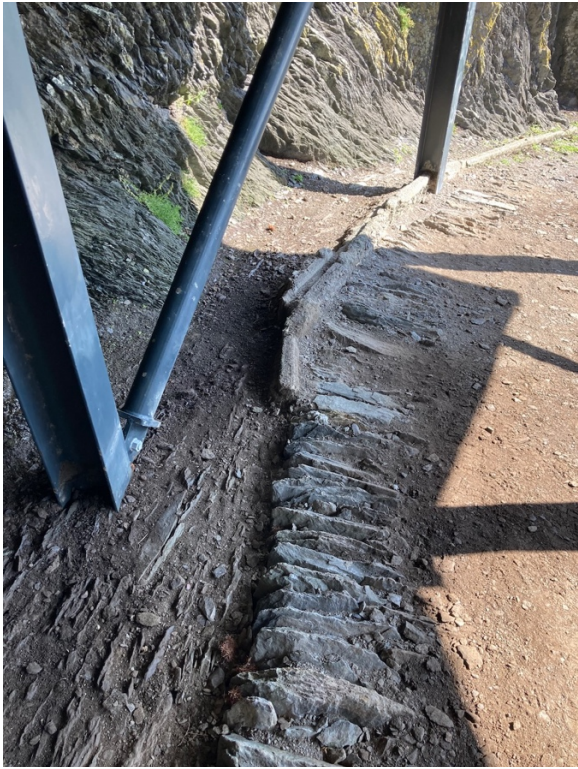
The features on the internal side of the roadway here were only removed where the ends of the lateral beams protruded across their line and hence the original line of the road edging and surface of the lateral drain was preserved in the undug sections. Over the lower half of the area of this crash deck the cable channel was set down into the lateral drain originally and was reinstated in its original position (fig. 13). Over the upper half of the area of the crash deck the cable channel originally lay in soil well above the level of the lateral drain. As original sections of the lateral drain here remained *in situ* and were not disturbed by construction, the cable channel could not be set down into the surface of the drain. It was relaid in its original position set in mortar on top of the surface of the lateral drain, as it would not impede water flow (fig. 14).

Fig. 13. Crash Deck 3, the reinstated features in its lower half.

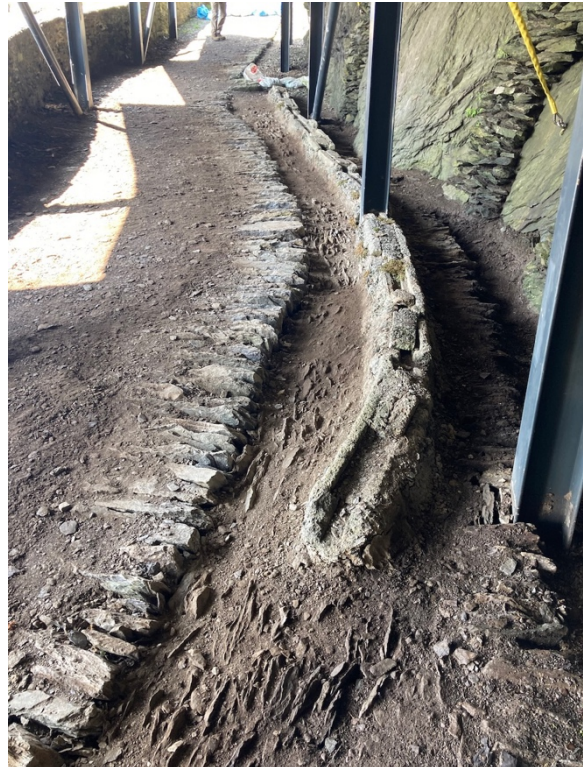
Fig. 14. Crash Deck 3, the reinstated features in its upper half.
