PRELIMINARY STRUCTURAL REPORT

Lower Lighthouse on Skellig Michael

The Office of Public Works

October 2024

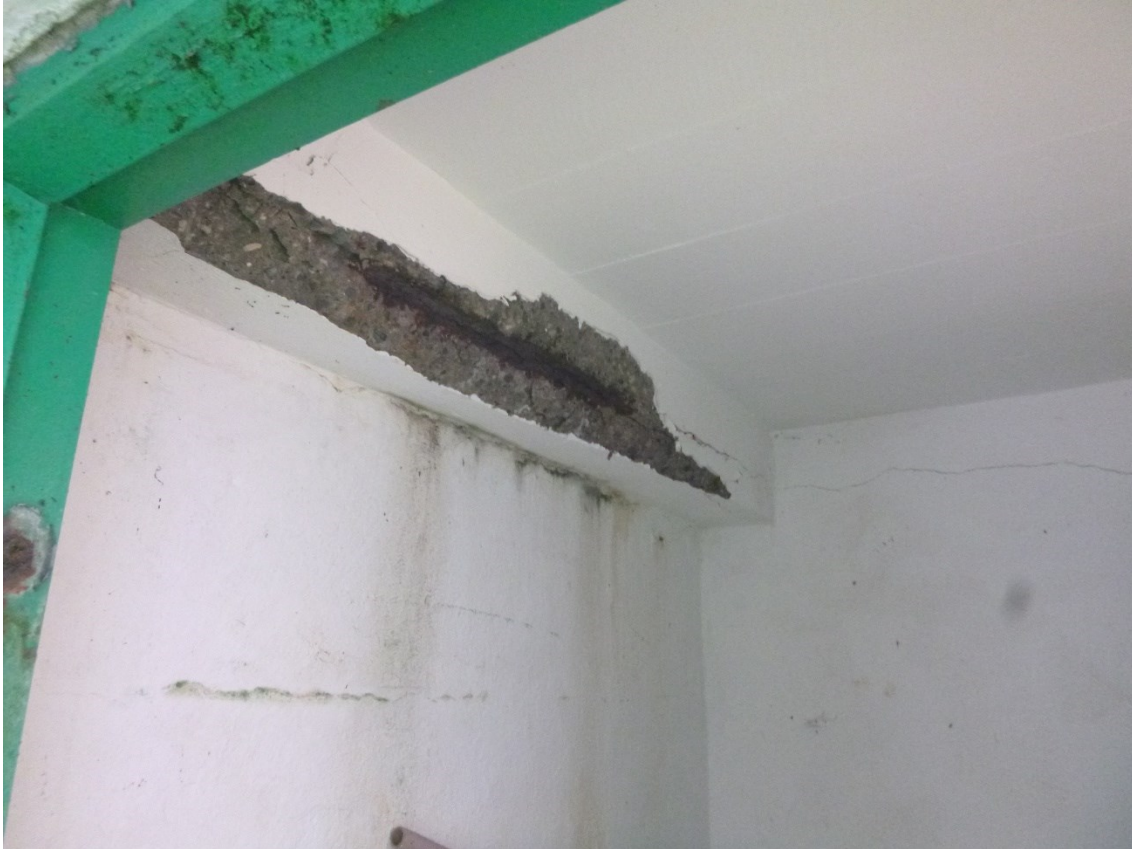
This single storey annex has a reinforced concrete slab flat roof. Unfortunately, the archive drawings did not give the details of the slab and therefore the capacity could not be checked. However, the spans are modest and there are no signs of corrosion or spanning on the underside of the slab so it is likely to be adequate to take a roof load. In the absence of any further archive information, a section of the underside of the roof slab should be opened up to establish the size and spacing of the reinforcing steel. The thickness of the slab also needs to be established. There is some longitudinal cracking, spalling and rebar corrosion of one of the downstand beams.

Photo 5: Cracking and exposed rebar in downstand beam of room off entrance

This single storey annex has a reinforced concrete flat roof slab. While structural information was not available from the archive drawings, the slab is in a reasonable condition and is likely to have adequate capacity to take a roof load. A section of the underside of the roof slab should be opened up to establish the size and spacing of the reinforcing steel. The thickness of the slab also needs to be established. The cracked concrete downstand beam needs to be repaired.

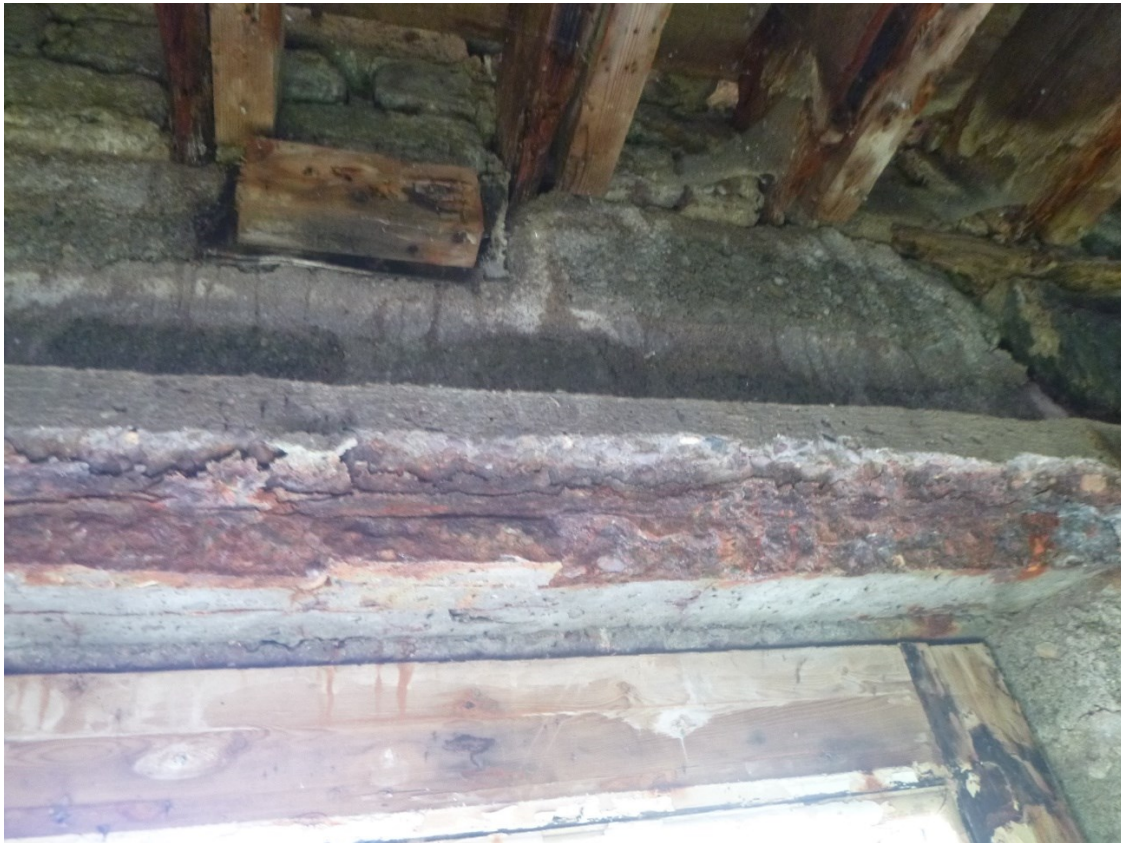
Photo 6: Cracking and corrosion of rebar in ground floor window lintel

There are a number of reinforced concrete lintels that have cracking which is likely be as a result of corrosion and expansion of the reinforcing steel in the lintel. These will need to be opened up to establish the extent of corrosion so a assessment can be made as to whether the lintel can be repaired or has to be replaced.

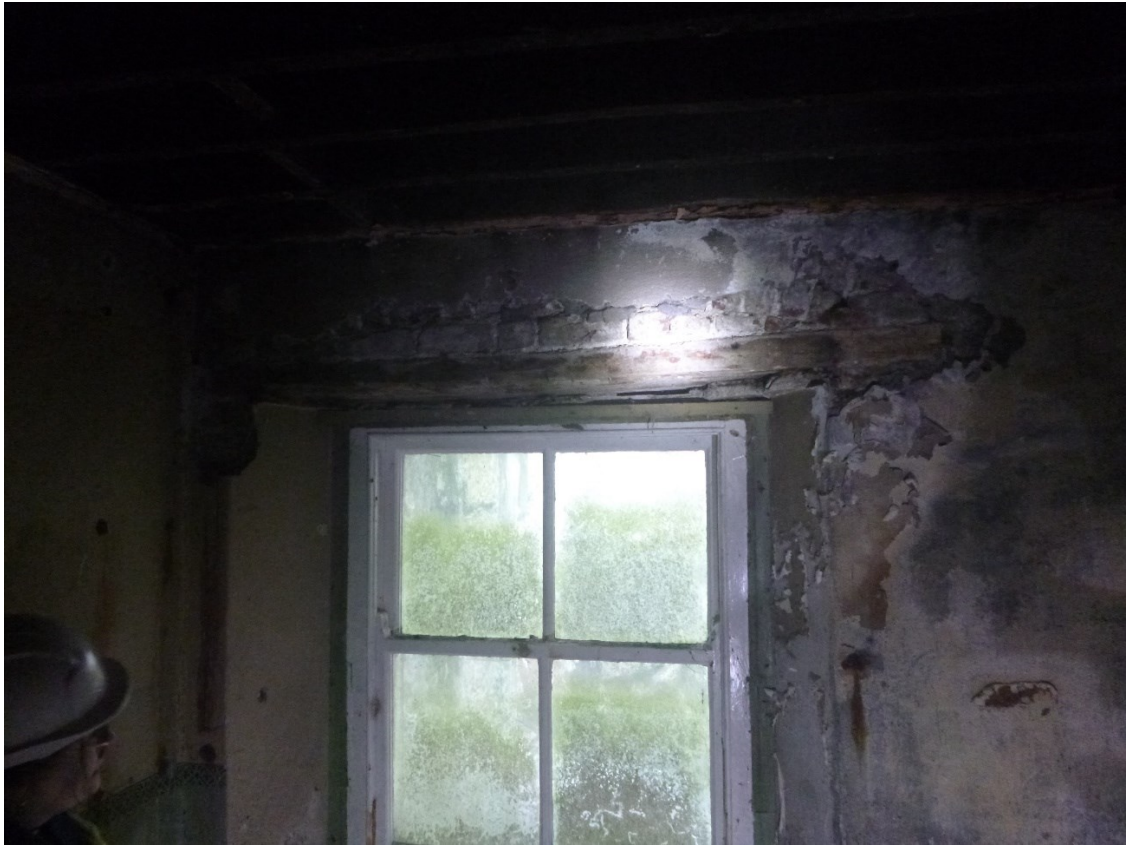
Photo 7: Sagging timber lintel over ground floor window

There are some timber and brick lintels that need to be exposed so that they can be assessed.
The adequacy of the asphalt covering to the flat roofs needs to be checked.

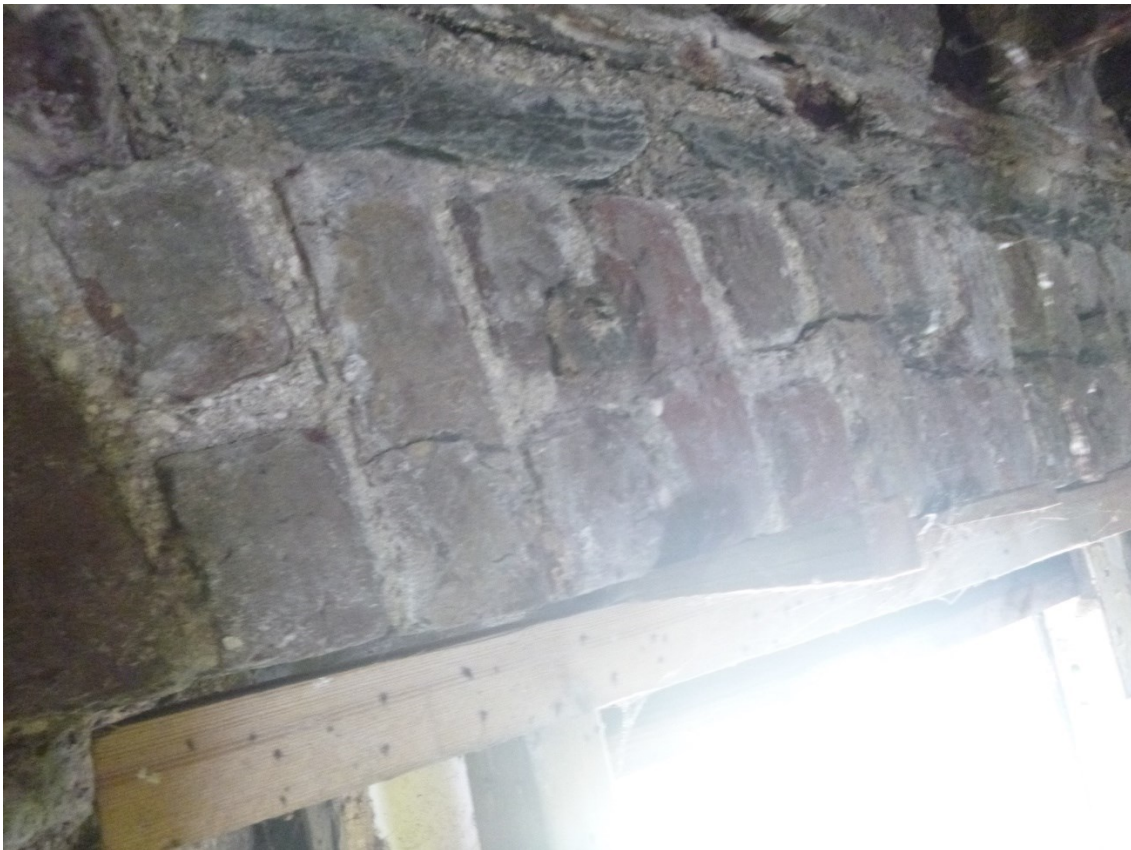
Photo 8: Cracking of bricks in ground floor window lintel

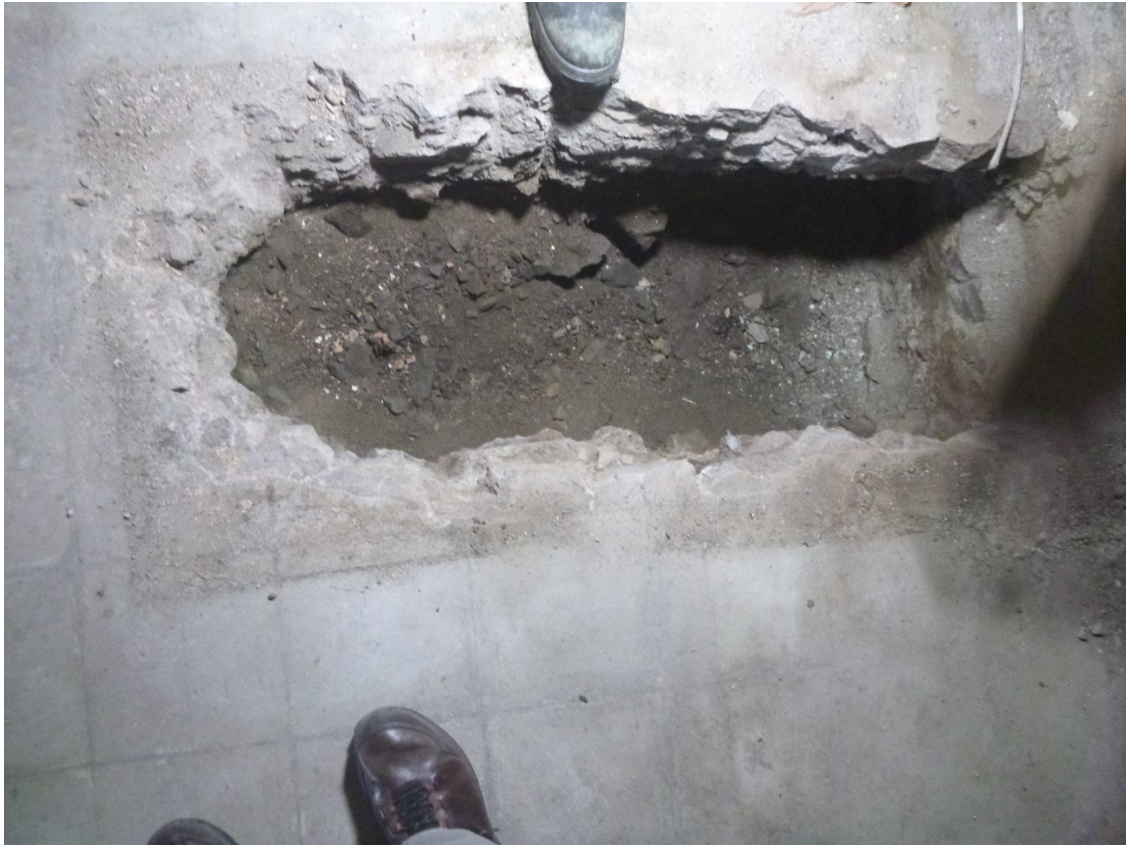
- The ground floor slab, while in a reasonable condition, doesn't have any insulation, damp proof membrane or radon barrier.
- The solid masonry walls, i.e. no cavity, are a mix of random stone, cut stone and brickwork. There is no insulation in the walls. Historic photographs show that the external face of the walls were originally clad in slate, but this is no longer present.

Photo 9: Trial hole in ground floor slab

The lack of a damp proof membrane in the ground floor slabs will need to be addressed. It will also need to be established whether a radon barrier is required.

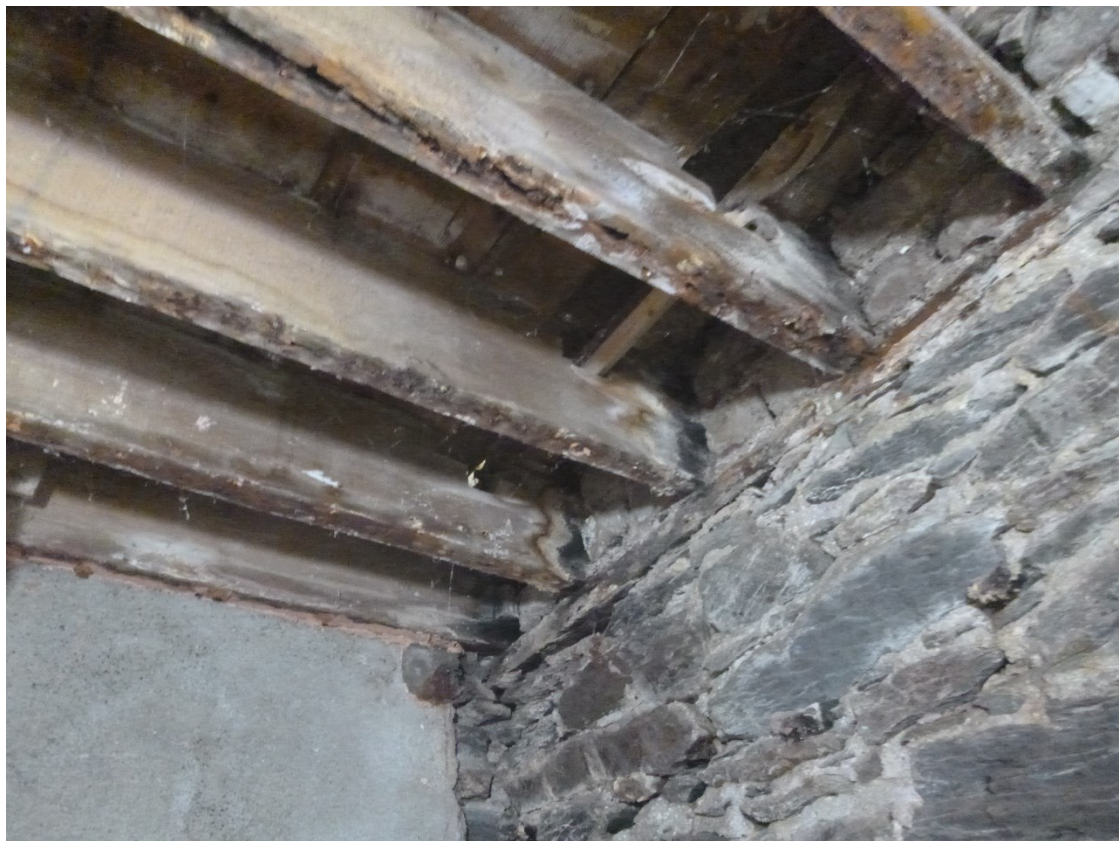
- The lintels over the window openings are a mix of cut granite, brickwork, timber and reinforced concrete.
- The first floor consists of timber joists supporting timber floor boards. The joists span front to back and are typically 190mm x 45mm @ 305mm centres. The joists are built into the front and back walls and the central spine wall, on the long axis of the building. Significant wet rot of the timber is present where the joists sit into the walls. This is particularly the case in the front wall.

Photo 10: First floor timber joists built into front wall

The sections of joists that have suffered from wet rot should be cut out and sound timbers spliced on to them. The undersized timber trimmers around the infilled stairwell, at the front of the building, will need to be strengthened.

It should be possible to retain these joists which have adequate load carrying capacity to take a domestic or light office loading. However, the extensive wet rot needs to be addressed by cutting off the affected lengths of joists and splicing on new sections of treated timbers. The undersized timber trimmers around the infilled stairwell at the front of the building will need to be strengthened.

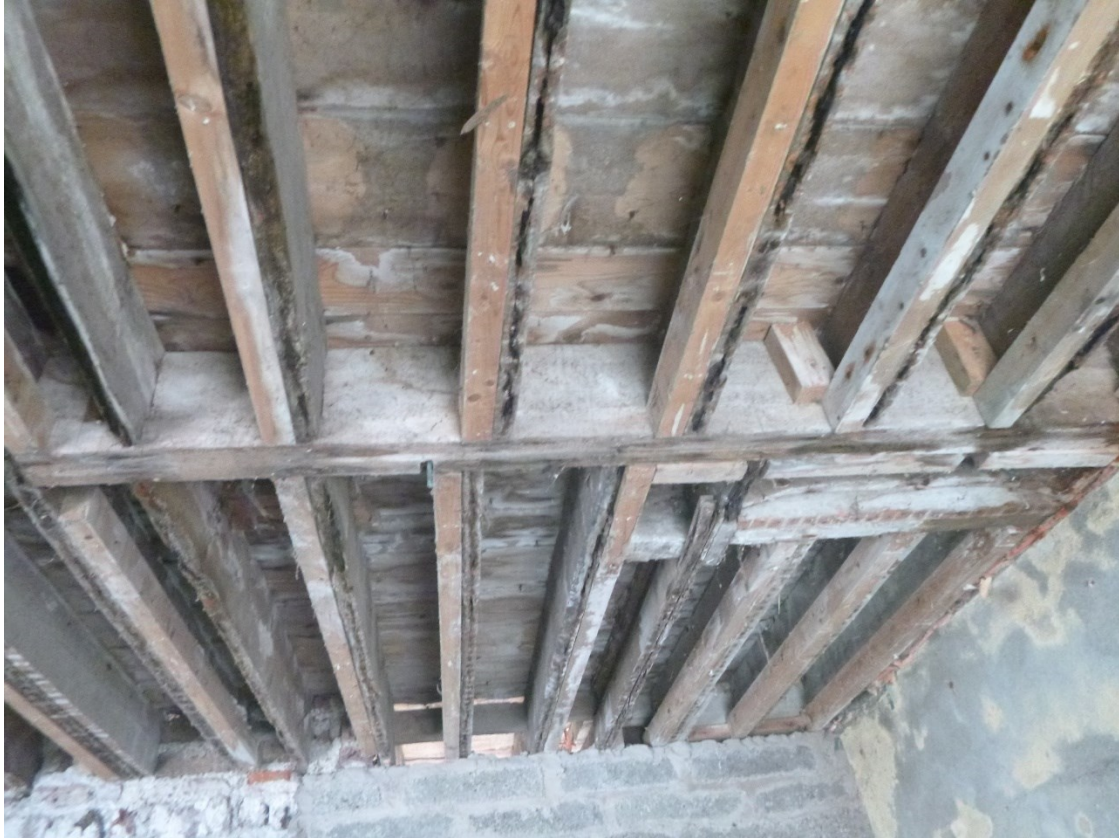
- Within the front room at the southern end of the block (right hand side when viewed from the front) there was a stairwell which has been removed and floored over. The trimming joists for this seem undersized.

Photo 13: First floor timber joists trimmed around old stairwell opening

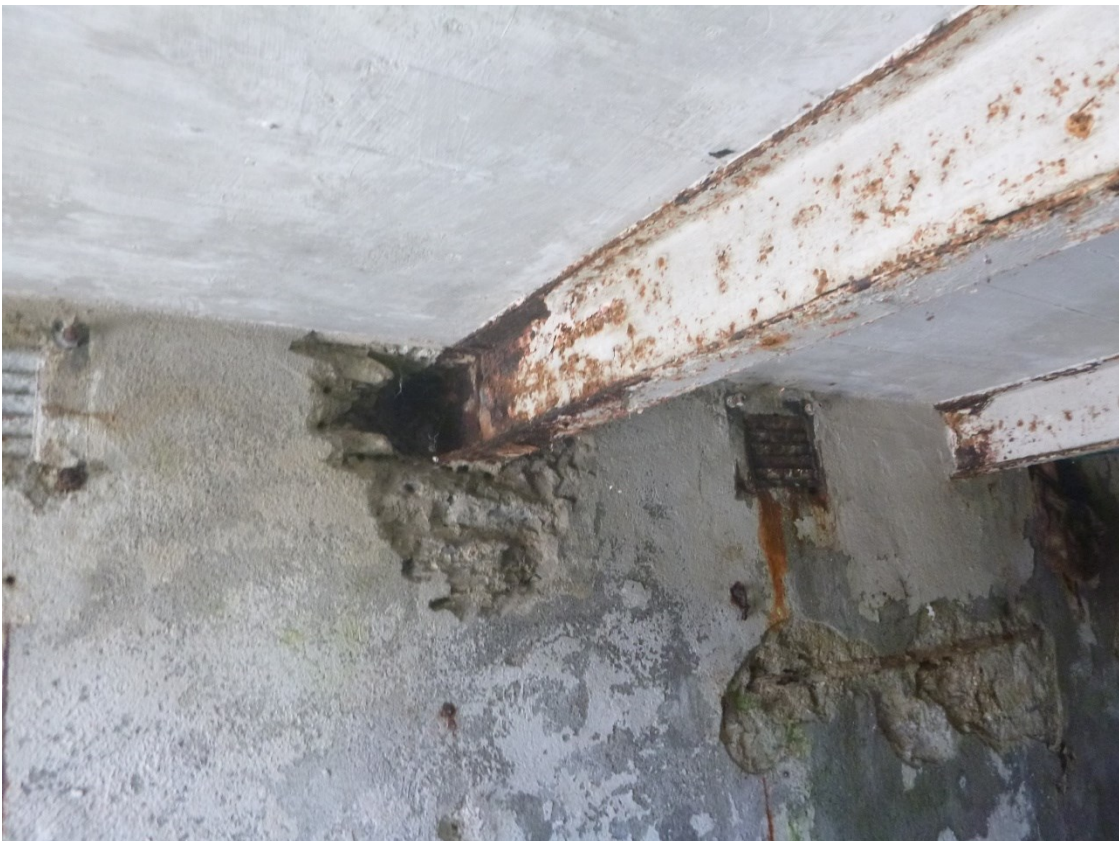
There is some corrosion of the RSJ's but there was no significant loss of section visible during the inspection. The ends of the RSJ's, embedded in the side walls, have the most significant corrosion and may need strengthening.

Photo 14: View of RSJ's supporting concrete roof slab of northern annex

Both the reinforced concrete roof slab and the steel joists (RSJ's) supporting it were found to have a live load capacity in excess of 20kN/m². There is some corrosion of the RSJ's but there was no significant loss of section visible during the inspection. The ends of the RSJ's, embedded in the side walls, need to be further investigated for corrosion and repaired if necessary.

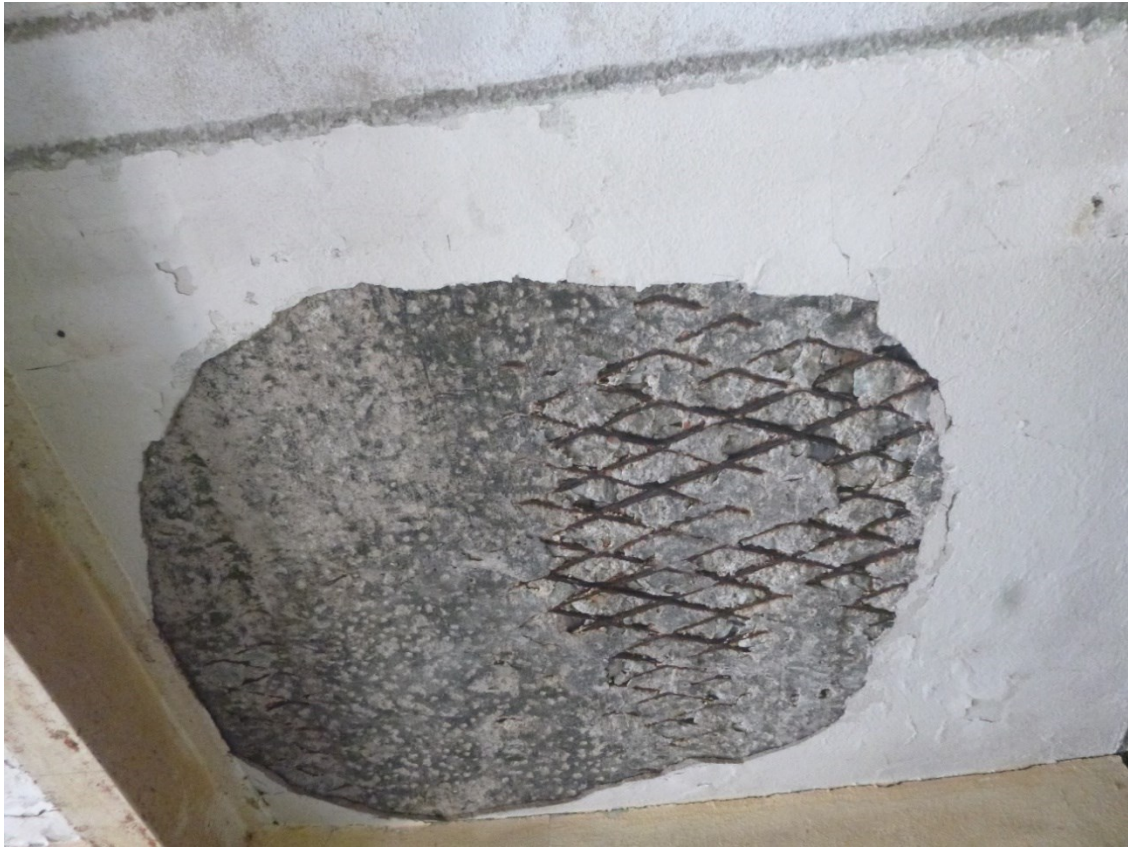
- The flat roof over the first floor is a 152mm (6") concrete slab with a 25mm (1") layer of asphalt on top. The underside of the slab is plastered.
- The slab is reinforced with an expanded metal. The details of the expanded metal are not available from the archive drawings. However, based on the site inspection, it has little or no cover to the underside of the slab and has suffered from extensive corrosion and loss of section in a number of areas. This corrosion and the resulting expansion of the metal has blown off the concrete cover and plaster in a number of locations.

Photo 15: View of expanded metal in first floor roof slab

Unfortunately the details of the expanded metal, that is reinforcing the concrete roof slab, were not on the archive drawings provided. While it is highly likely that the expanded metal did provide adequate reinforcing to the slab, and this can be confirmed by opening up a section of the slab, the mesh has suffered extensive corrosion and loss of section in a number of locations. Given this loss of section, the expanded metal can no longer be relied upon to provide adequate reinforcing to the concrete slab. The slab therefore has to be either replaced or repaired and strengthened. Given the difficulties that would arise from removing and replacing the roof slab, it is recommended that the repair and strengthen option be pursued.

- Remove all the plaster from the underside of the slab.
- Remove any loose or hollow concrete cover to the expanded metal.
- Mechanically clean the exposed expanded metal to remove and rust product.
- Apply a rust inhibitor to the exposed expanded metal.
- Fix additional mesh to the underside of the slab. A grid of shear bars (dowels) will likely need to be drilled and grouted into the slab to provide a shear key between the original slab and the additional mesh.
- Guniting (a sprayed structural render) the underside of the slab to encapsulate the additional mesh and the exposed expanded metal.

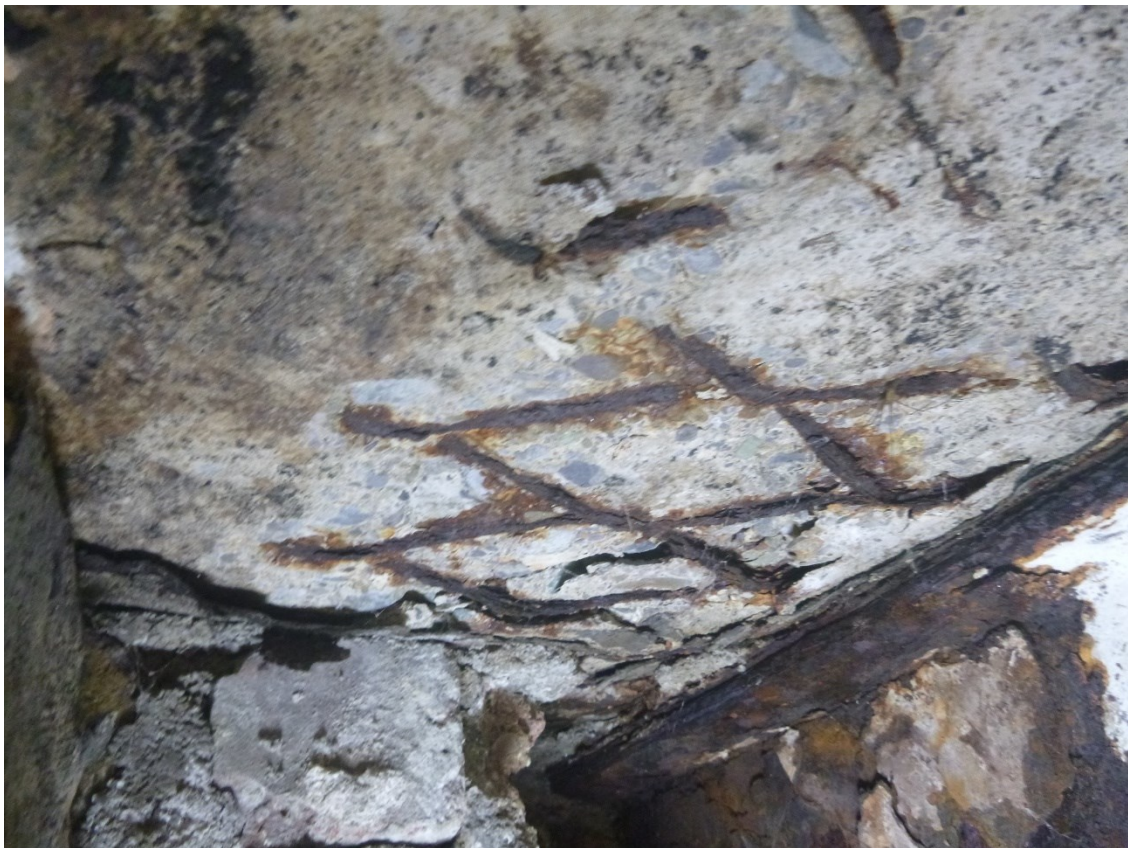
The analysis shows that an A142 mesh equivalent (6mm diameter bars at 200mm centres) would be adequate to support the slab and a normal flat roof loading (0.75kN/m²). Unfortunately the details of the expanded metal that is reinforcing the concrete roof slab were not on the archive drawings provided. While it is highly likely that the expanded metal did provide the equivalent or greater reinforcing that 6mm bars @ 200mm c.c., and this can be confirmed by opening up a section of the slab, the mesh has suffered extensive corrosion and loss of section in a number of locations. Given this loss of section, the expanded metal can no longer be relied upon to provide adequate reinforcing to the concrete slab.

Photo 16: Close up view of corrosion of expanded metal in first floor roof slab

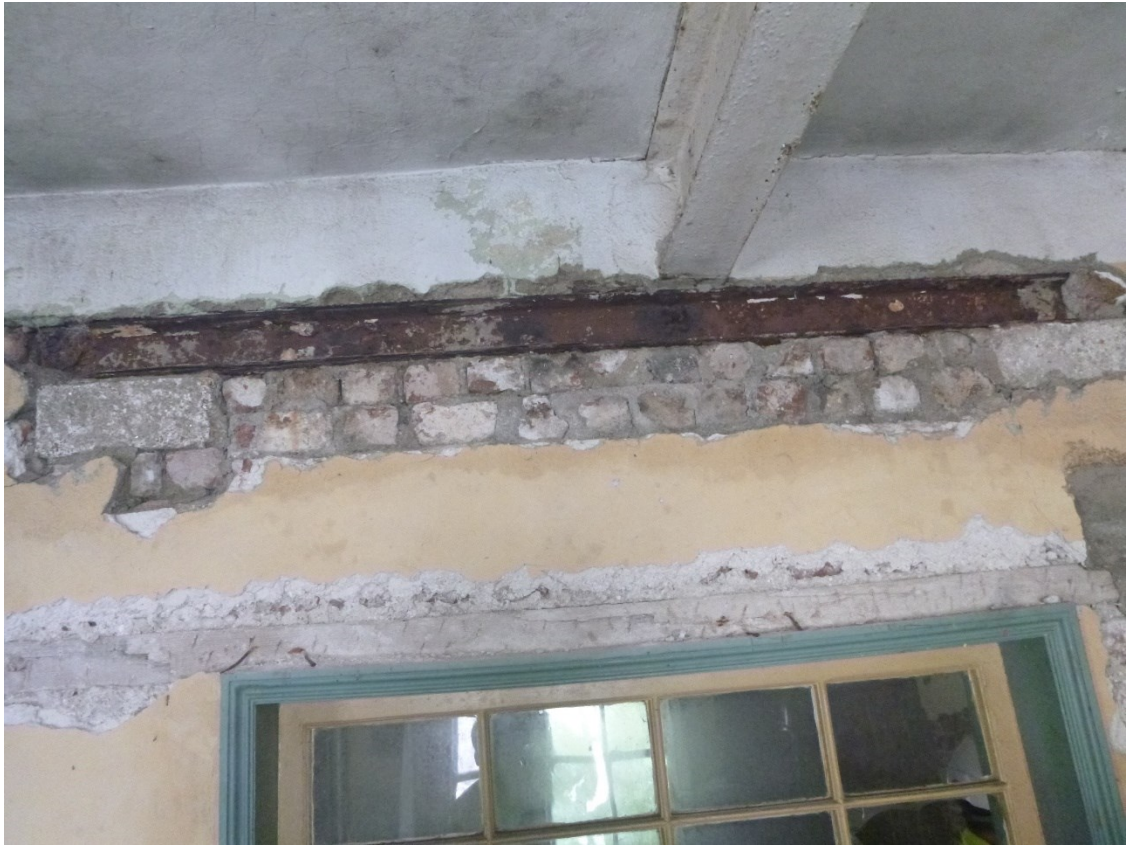
- Two of the beams at the front and two of the beams at the rear of the building are at over windows. In these four locations, steel spreader beams have been installed to span over the window opening. These spreader beams are very badly corroded.
- There are also steel spreader beams under a pair of the beams in the spine wall. It is assumed that this was to allow for an opening through the wall.
- The beams that are not on spreader beams sit onto granite pads within the wall.
- The ground floor to ceiling height is 2.64m (8' 8") and the first floor to underside of ceiling is 2.97m (9' 9"), although the downstand beams reduce the clear height to 2.72m.

The steel spreader beams set into the walls, immediately under the ends of the RSJ's in six locations, are badly corroded with full loss of section in some of the beams. These spreader beams should be replaced.

Photo 17: RSJ supporting roof slab bearing onto steel spreader in rear wall

The steel spreader beams, set into the walls immediately under the ends of the RSJ's, should be replaced.

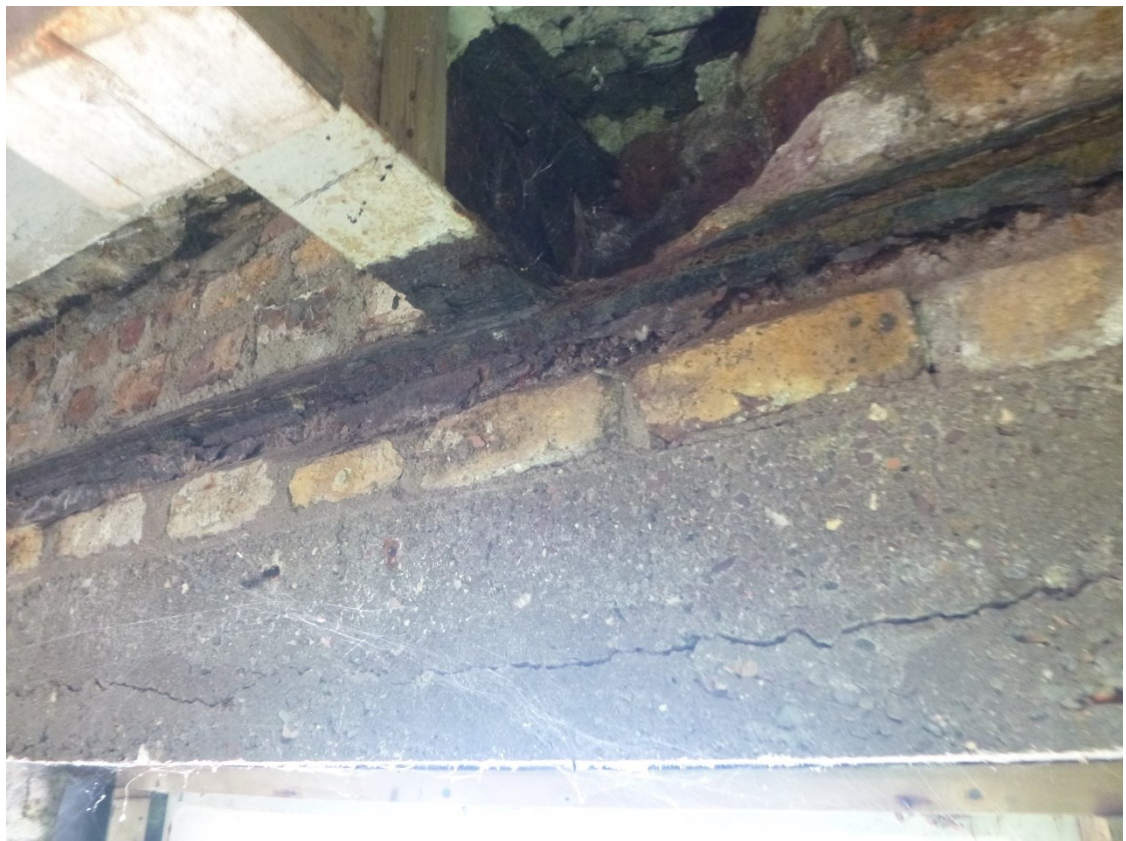
Photo 18: RSJ supporting roof slab bearing onto corroded steel spreader in front wall

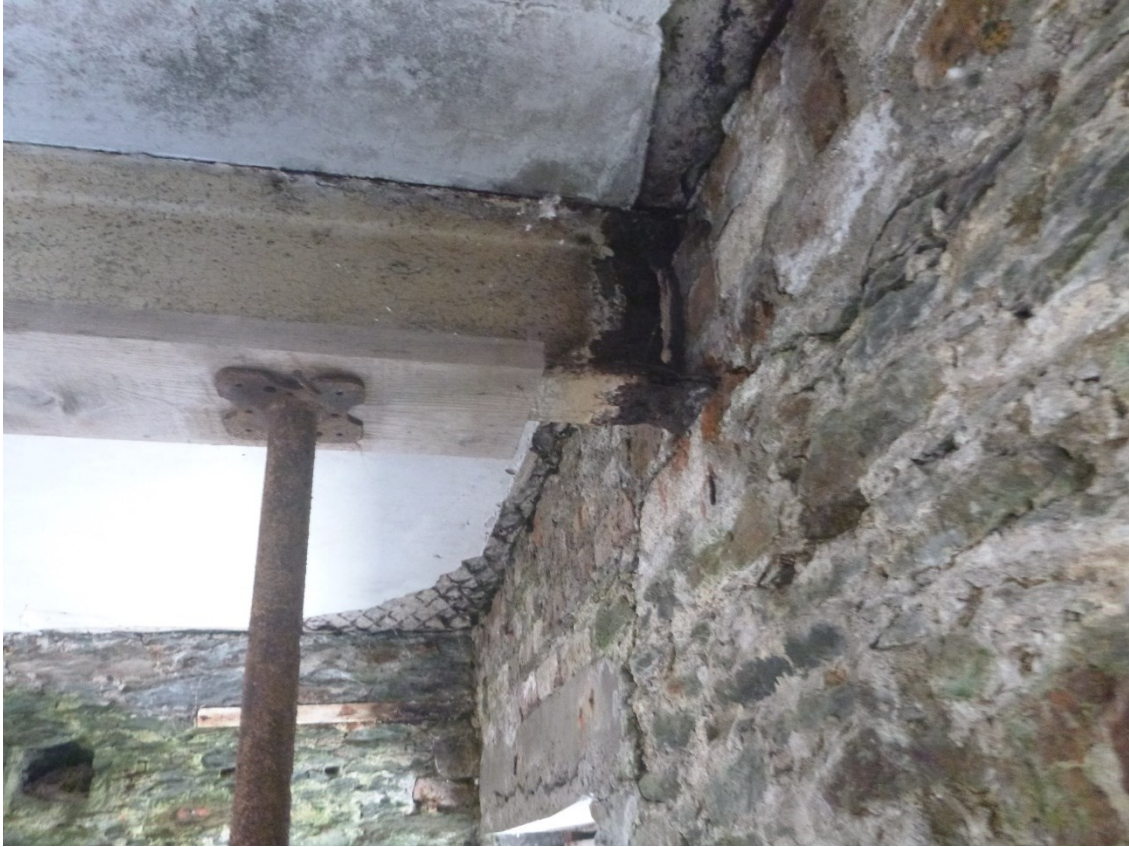
Photo 19: Propped roof RSJ bearing onto front wall

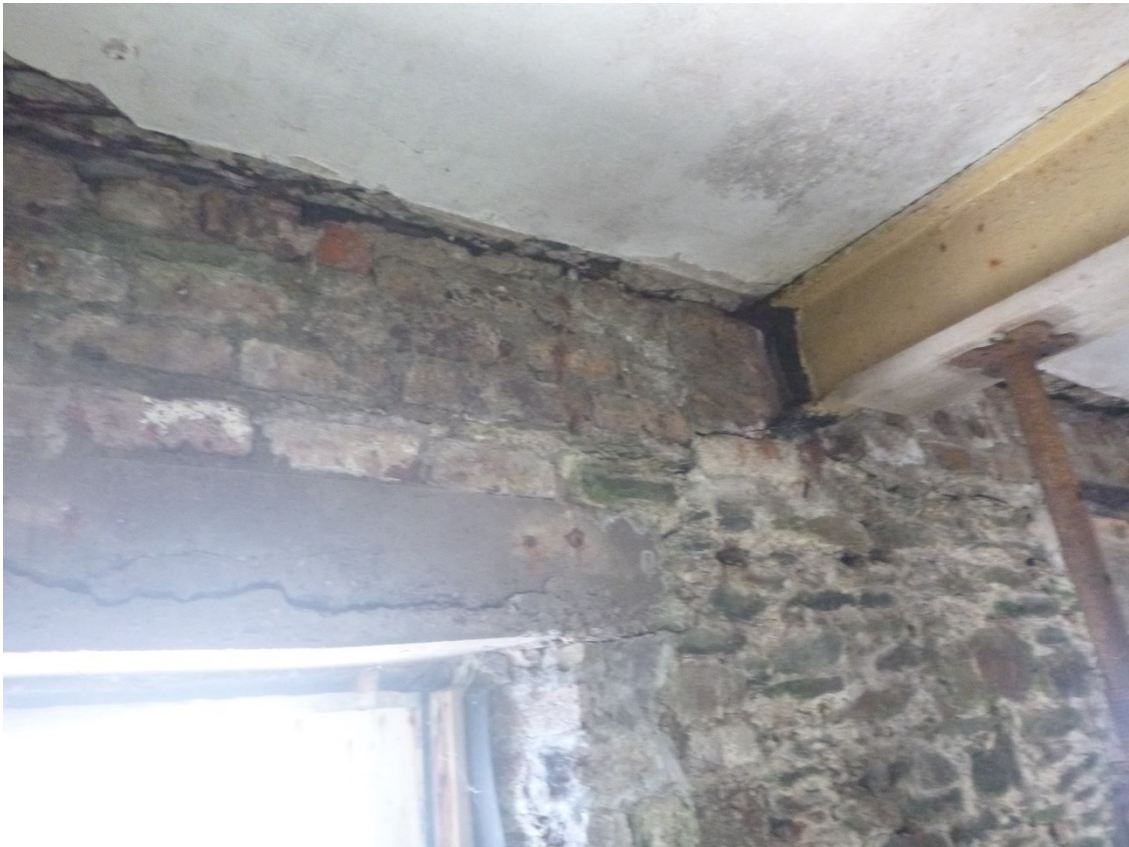
Photo 20: Propped roof RSJ bearing onto front wall

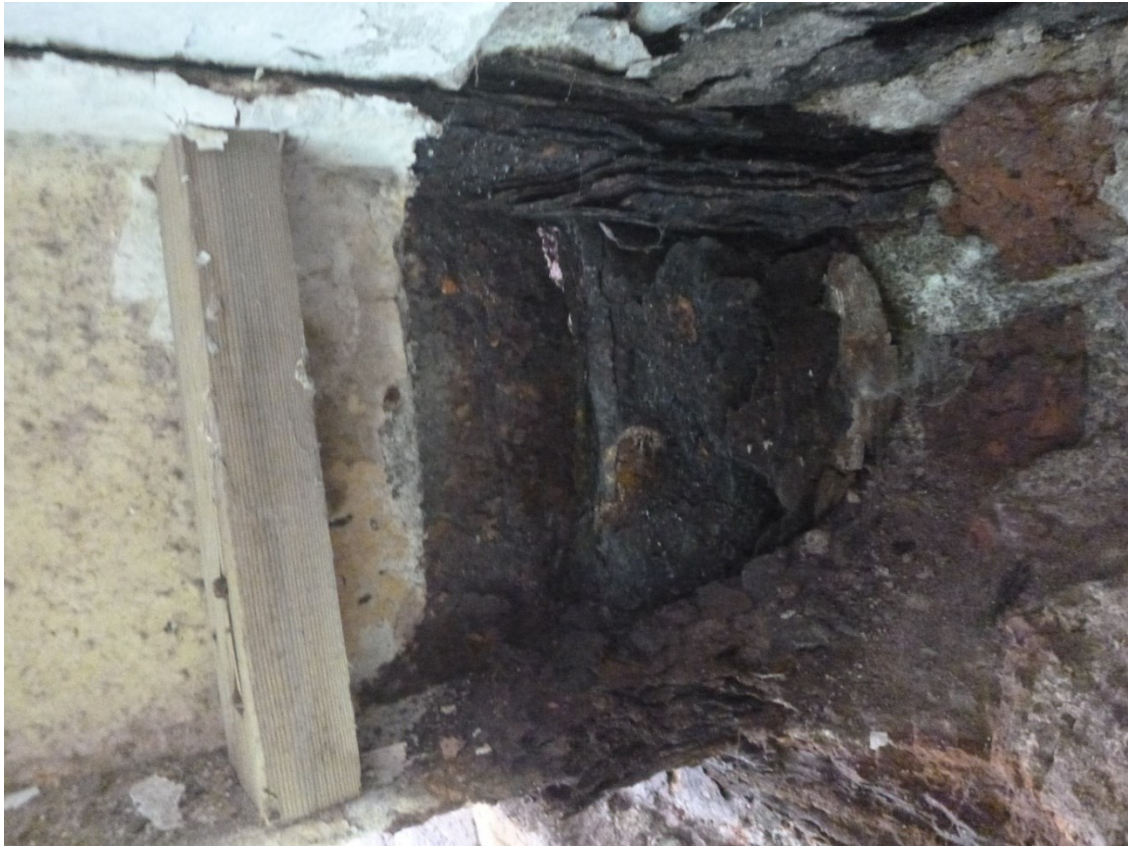
- The concrete slab is supported by a by four pairs of steel beams spanning between the front, central spine and rear walls of the building. The beams are 254mm x 125mm x 45kg/m (10" x 5" x30lbs/ft) Rolled Steel Joists (RSJ's). The ends of the four joists built into the front wall have suffered severe corrosion and loss of section. Two of these beams have been propped onto the timber first floor, but these are not back propped to the ground floor. While there is some corrosion to the ends of the beams embedded in the spine wall and the rear wall, the beams are still in a reasonable condition.

There is significant corrosion and loss of section from the RSJ's, particularly where they are embedded in the front wall of the building. This can be addressed by splicing pairs of steel channels to the ends of the RSJ's.

Photo 21: Corrosion of end of roof RSJ built into front wall

The RSJ's supporting the roof slab have adequate load carrying capacity. However, the significant corrosion and loss of section, particularly where the RSJ's are embedded in the front wall of the building, needs to be addressed by splicing pairs of steel channels to the ends of the RSJ's.

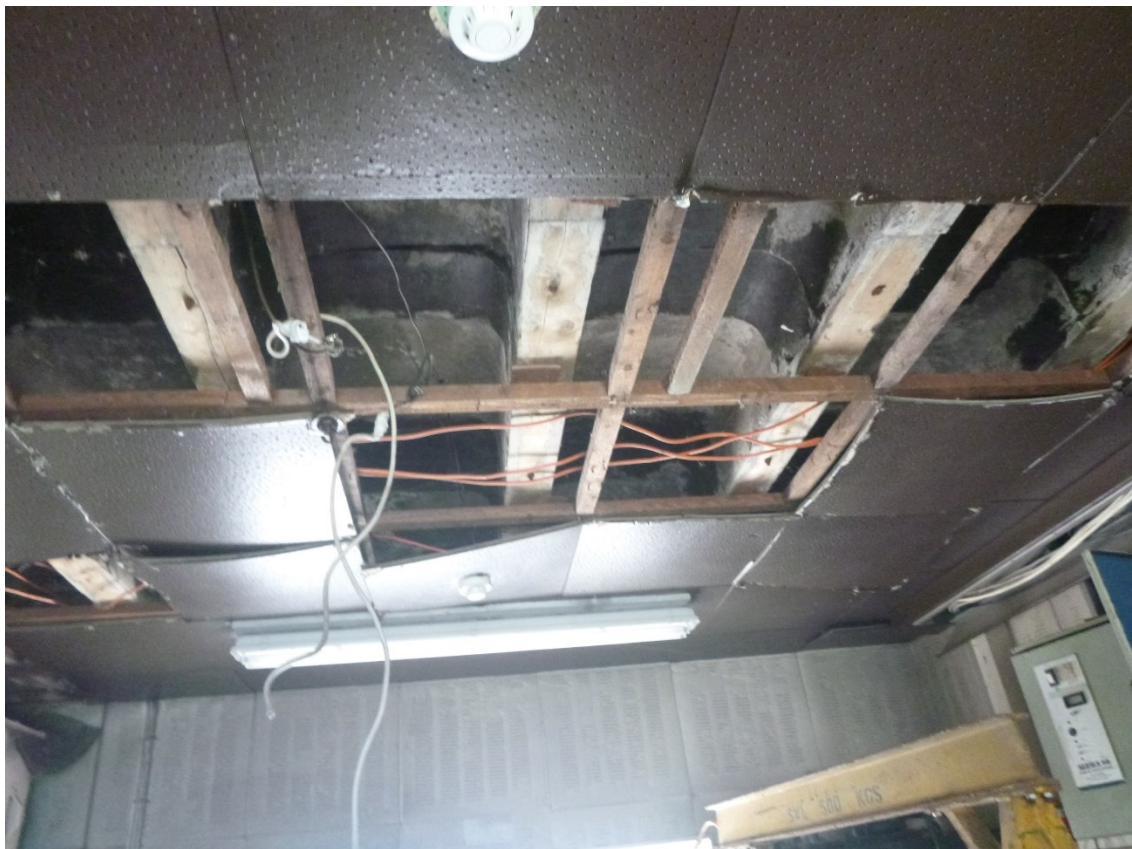
The roof slab of this building is a reinforced concrete ribbed slab with reinforced concrete ring beams around the edge of the building. This is a very robust type of construction and is in a good condition from a structural point of view.

While the archive drawings give the dimensions of the ribbed reinforced concrete roof slab to this building and also show that there are two mild steel bars in each rib, the size of those bars could not be read from the drawing. In the absence of this key piece of information a back analysis of the slab was carried out to establish the diameter of the two bars in the ribs that would be required to carry a range of live loads on the roof, after allowing for self-weight.

This back analysis showed that for a normal roof live load of 0.75kN/m² the two bars need to be 16mm diameter or greater. For a live load of 7.5kN/m² (this is equivalent to a typical plant room), the two bars need to be 20mm diameter or greater. While the diameter of the bars in the ribs needs to be established by opening up the bottom of one of the ribs, it is anticipated that the bars are likely to be 25mm diameter.

Photo 24: Underside of concrete rib slab roof of single storey machine room

Unfortunately, the size of the reinforcing bars in the ribs is not known at present. However, the back analysis showed that for a normal roof live load of 0.75kN/m² the two bars in the ribs need to be 16mm diameter or greater. For a live load of 7.5kN/m² (this is equivalent to a typical plant room), the two bars need to be 20mm diameter or greater. It is highly likely that the roof of this building will have the structural capacity to carry a plant room. The bottom of one of the ribs should be opened up to check the bar size and allow the capacity of the roof to be established.
