Sceilg Mhichíl
World Heritage Property
2021 Works Season
Report

OPW Oifig na
nOibreacha Poiblí
Office of Public Works

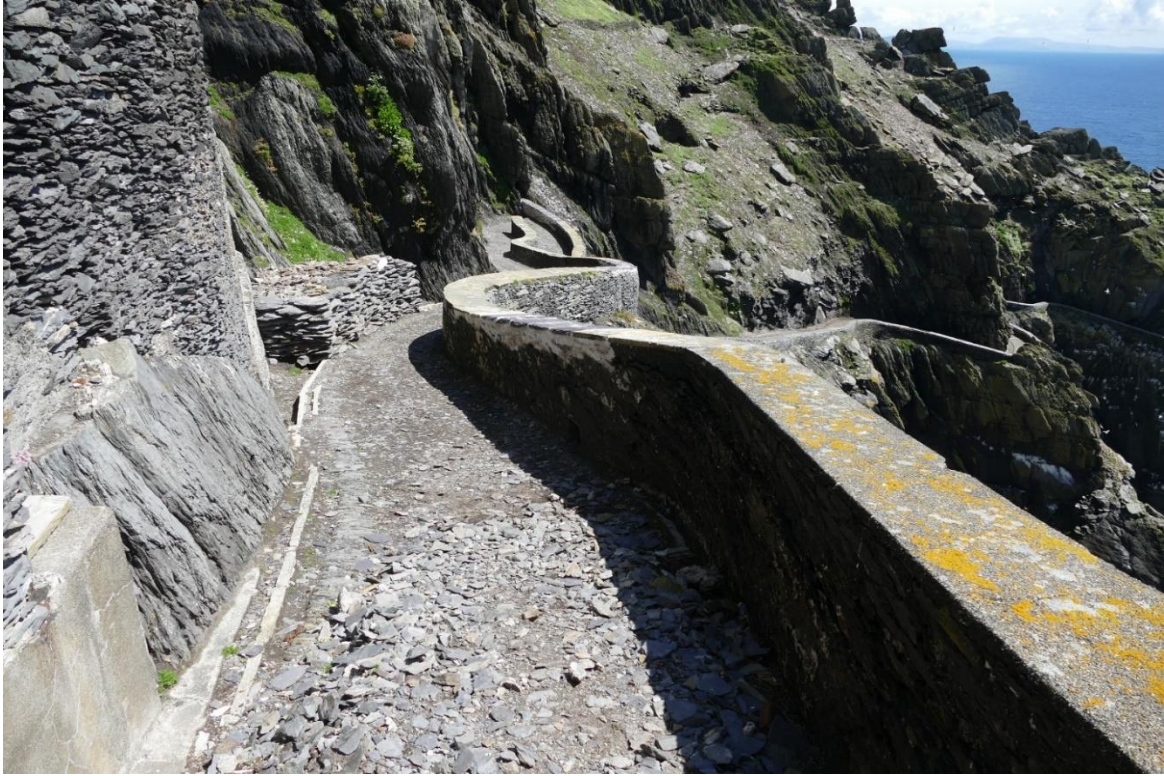
Fig. 7. – View of the Upper Lighthouse Road

Repair works to the Lighthouse Road continued through the 2021 season, having commenced in the 2017 season. The works were preceded by archaeological investigation that revealed the construction details of the Lighthouse Road and its associated features, thereby informing the repair works. It is envisaged that repair works will be completed to the Upper Lighthouse Road over the course of the next two seasons. The repair of the Upper Lighthouse Road will provide safe access for workers and visitors to the fog signalling platform and Upper Lighthouse complex.

Following an approved archaeological excavation strategy in 2021 at the Upper Lighthouse, clearance of organic buildup and debris, cleaning of the original drainage system, the replacement of missing wall capstones with locally sourced Valentia slate and the retention and repair of existing sand stone capstones was carried out. Repair works were undertaken using lime mortar and traditional construction techniques. MWP also issued a Natura Impact Statement report to the OPW for the proposed repairs to the sea wall along the Lighthouse Road (Appendix A).

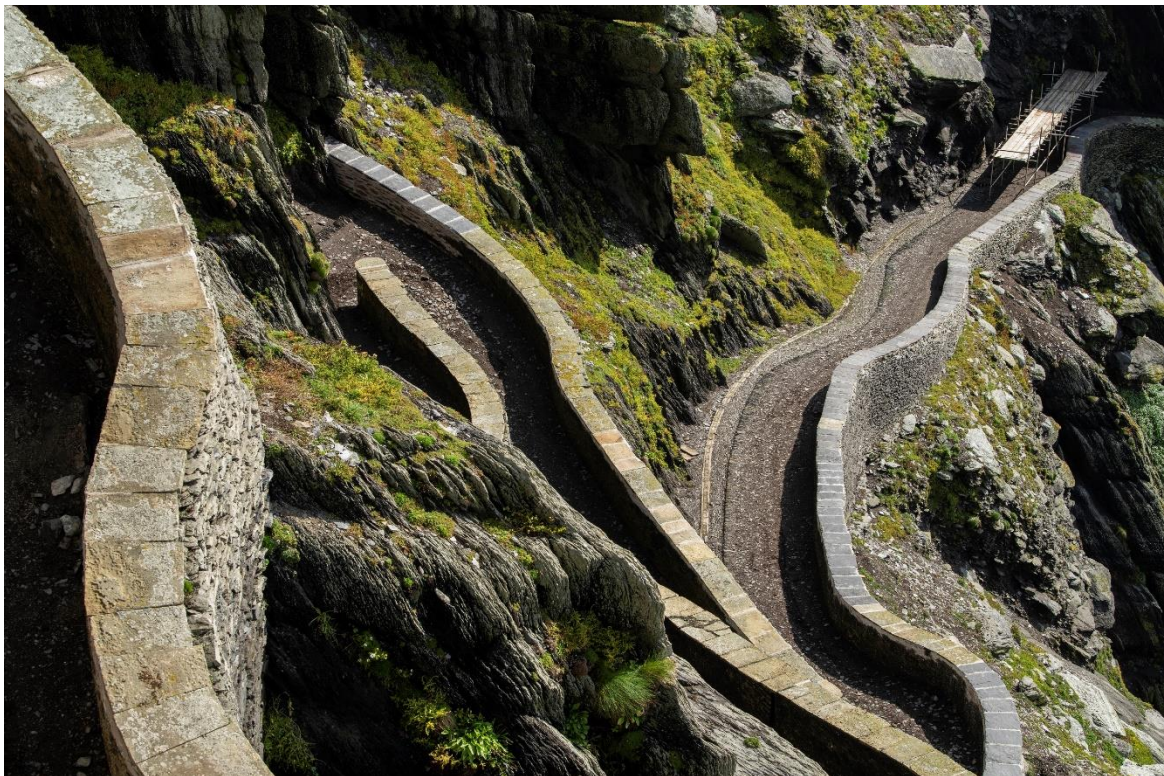
Fig. 9. – View of the Upper Lighthouse Road from the Upper Lighthouse gate

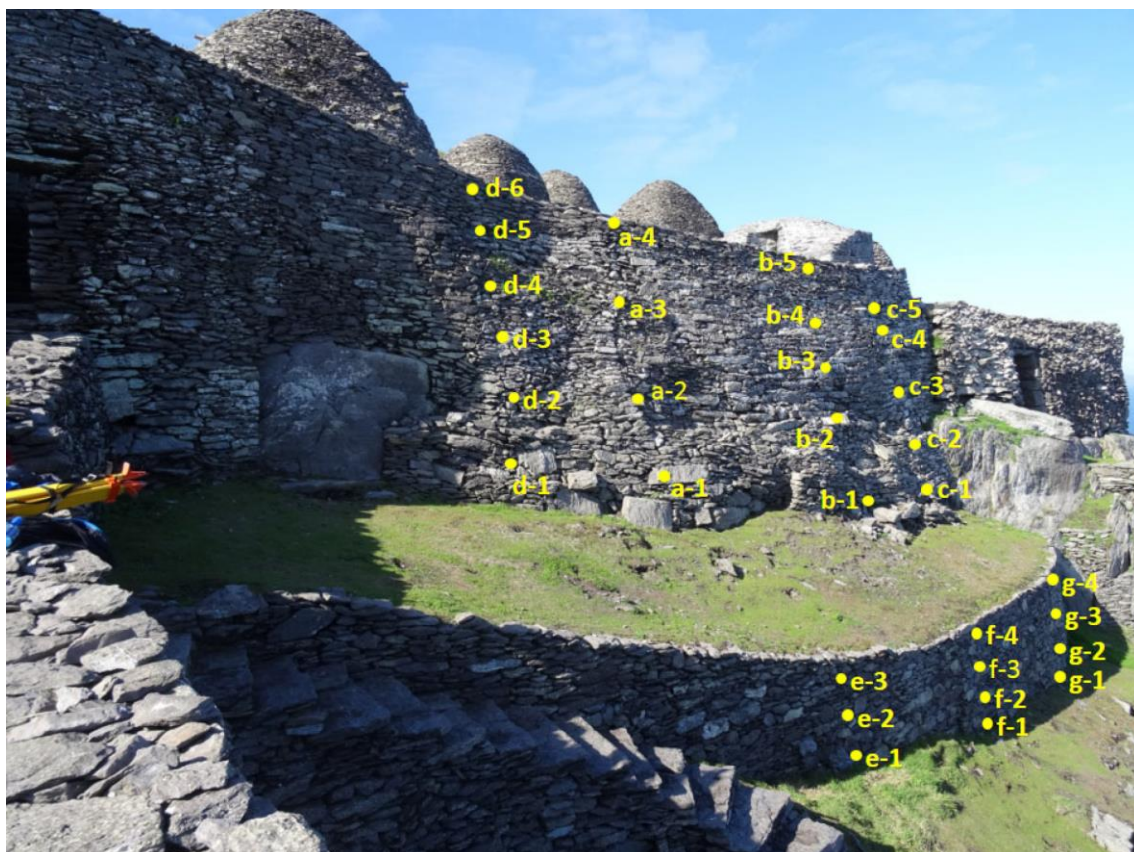
Fig. 11. - Discovery Programmed marker point locations at monastery retaining wall.

Since 2015, the Discovery Programme have been monitoring the movement of the main retaining wall of the monastic settlement. Markings were added in 2017 to the South Peak to determine the stability of the structures at that location. The Discovery Programme issue an annual report to the OPW with their findings and recommendations. In September 2021, the Discovery Programme undertook a survey of the monastic settlement and published their findings (See Appendix I). The 2021 report confirmed that a section of the retaining wall directly below St. Michael's chapel is currently undergoing slight movement beyond acceptable tolerances, but slightly at a reduced rate than observed in 2020. This section of the monastic wall has been historically susceptible to collapse, with major reconstruction having been undertaken during the 19th century.

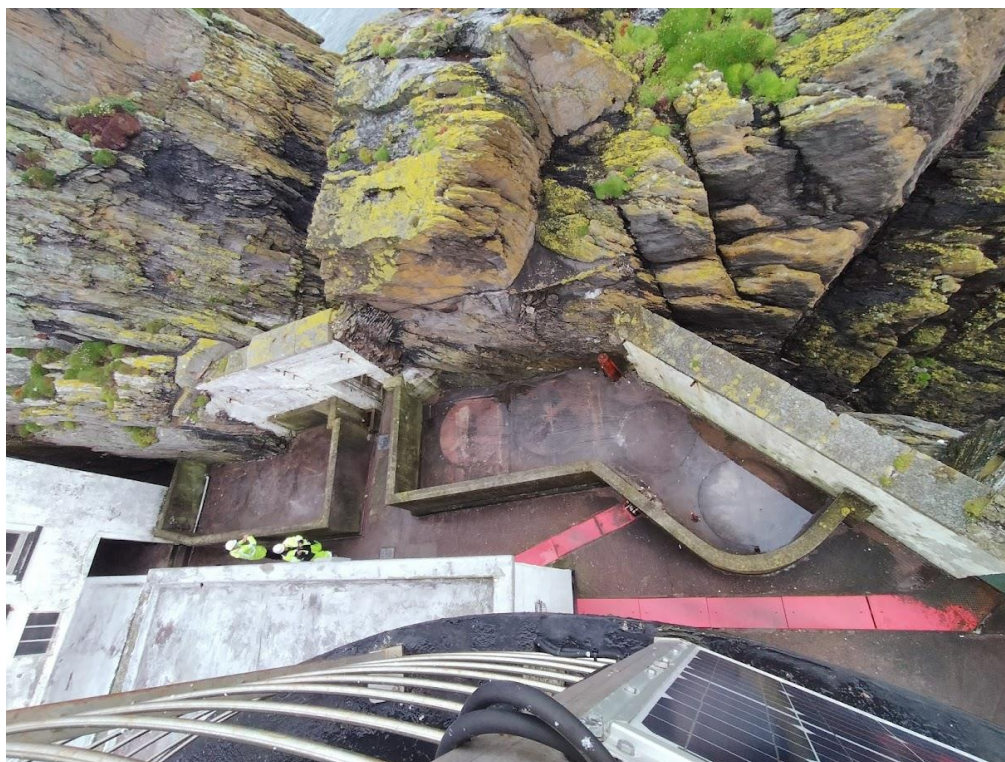
Fig. 13. – Area in the Lower Lighthouse Compound where former fuel tanks were removed

Works were completed on the dismantling of the former fuel storage tanks of the Lower Lighthouse complex. The tanks were fully removed in 2021 following the safe removal of oil by a specialist contractor in the 2020 season.

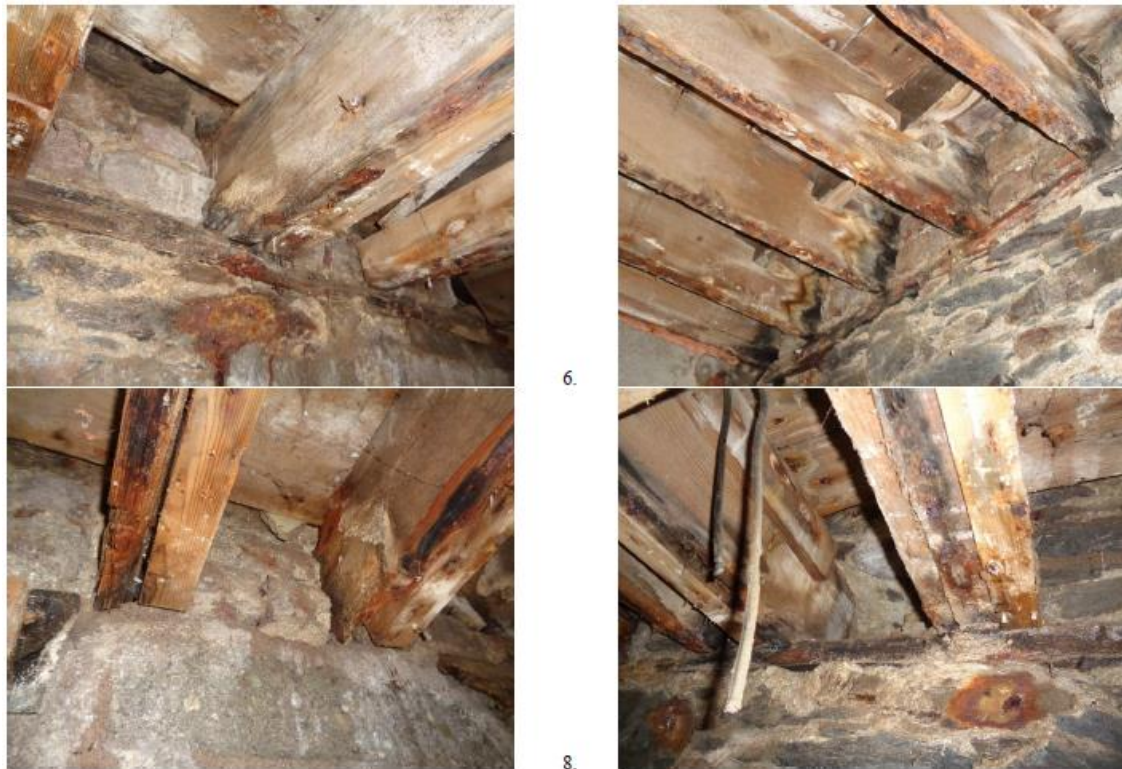
A timber survey was carried out by Glenwood Preservation Ltd. on 19th August 2021 at the Lower Lighthouse. The specialist report was issued to OPW on 20th August 2021 reporting significant deterioration to the remaining timbers due to wet rot (Appendix E & F). It was also recommended in the report that the timbers are to be meticulously removed and replaced. The building has suffered from significant damp ingress throughout the years which has resulted in the deterioration of the remaining timbers.

Fig. 15. – Existing timbers in poor condition at the Lower Lighthouse. Ref. Appendix F.

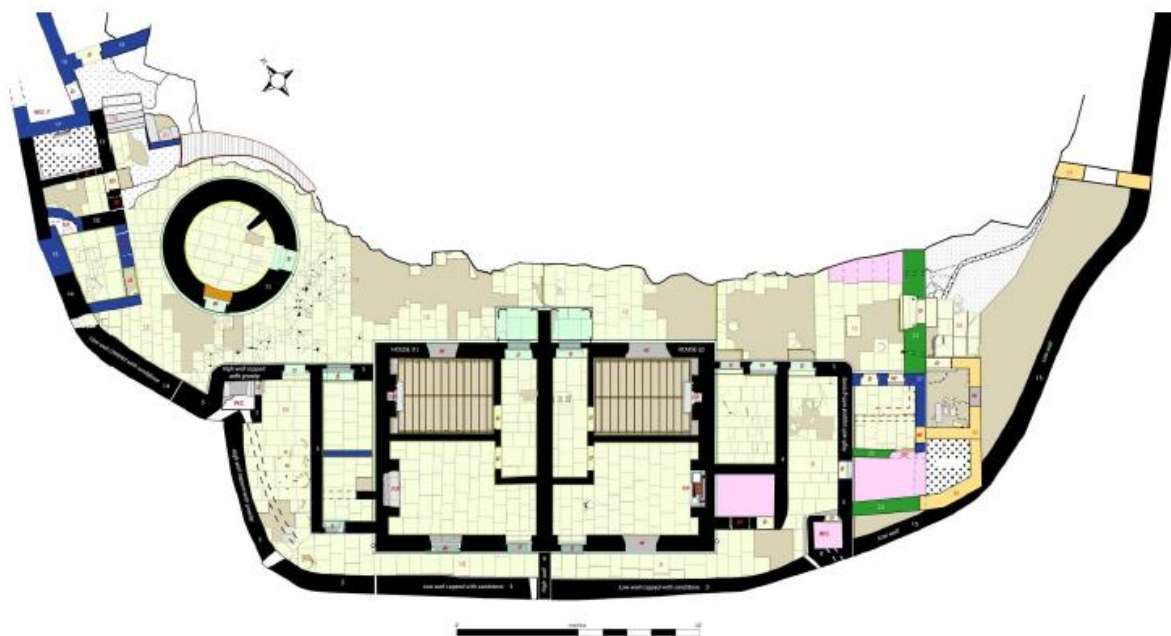
Fig. 18. – Post-excavation plan at the Upper Lighthouse

The archaeological excavations at the Upper Lighthouse exposed original sandstone flooring and paving that are in excellent condition. Artefacts were also discovered during the archaeological excavations and were stored at the Lower Lighthouse for possible re-use in the future. Artefacts of interest will be sent to the National Museum of Ireland. The archaeologist recorded, documented and catalogued the retrieved stones, materials and artefacts. When the archaeological works were completed, a protective covering was installed to protect the floor during the winter season.

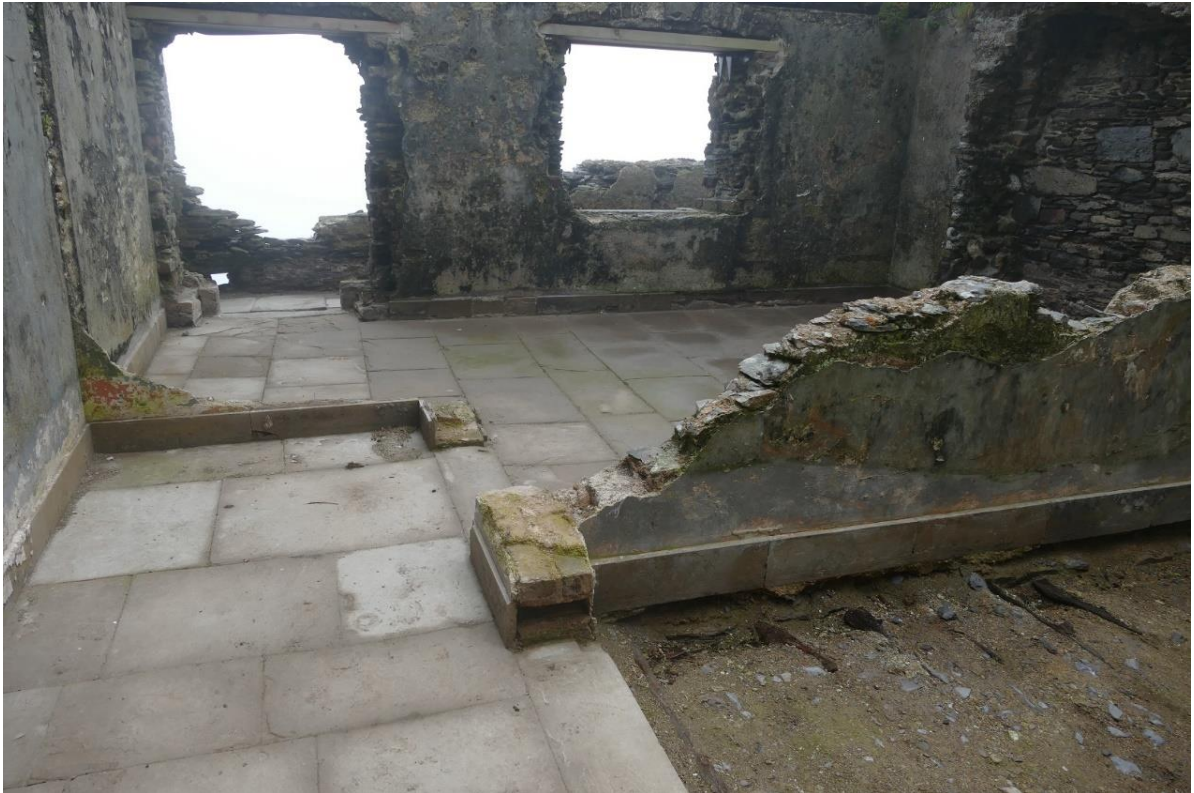
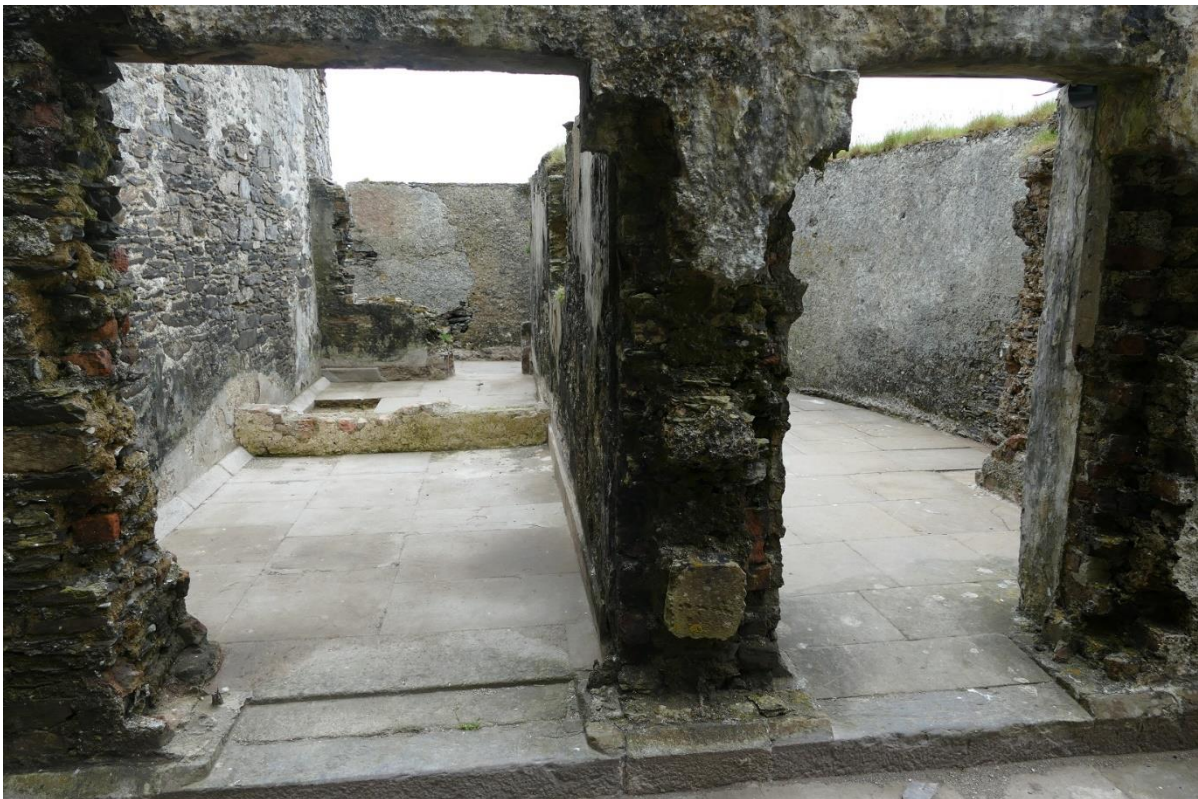
Fig. 19. – Exposed sandstone flooring at the Upper Lighthouse

Fig. 20. – Exposed sandstone flooring at the Upper Lighthouse

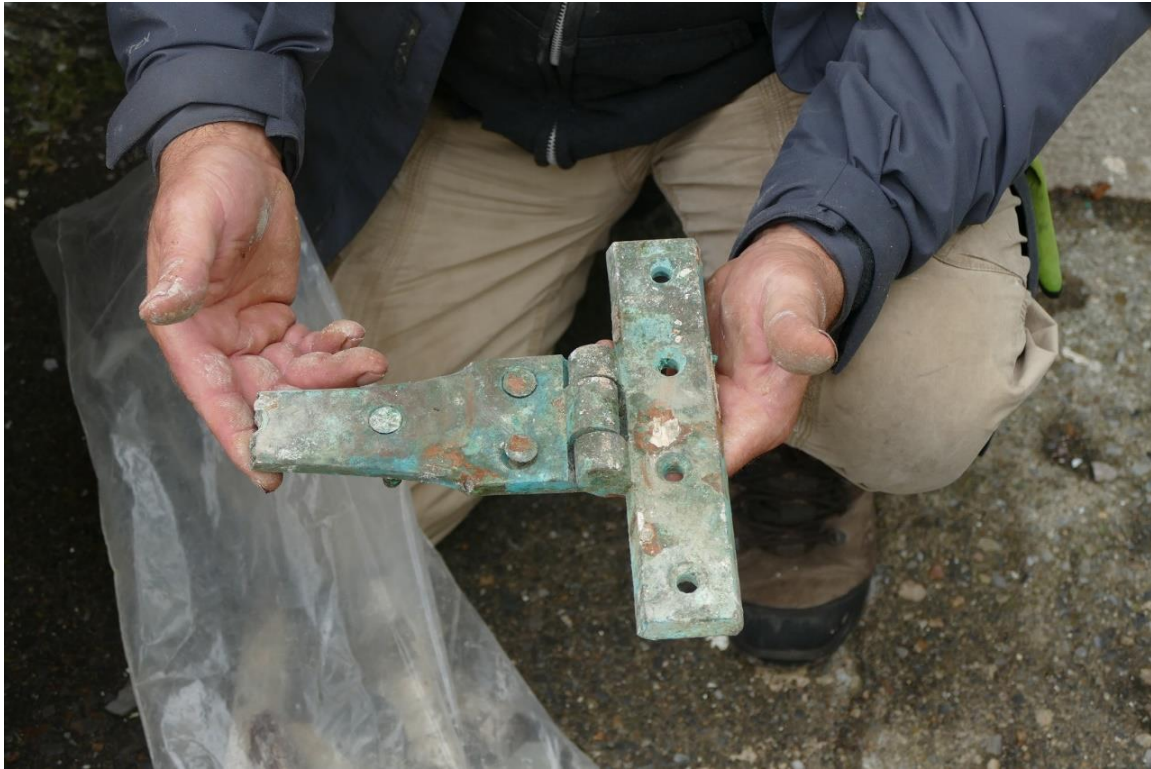
Fig. 21. – Original bronze hinge from Upper Lighthouse buildings

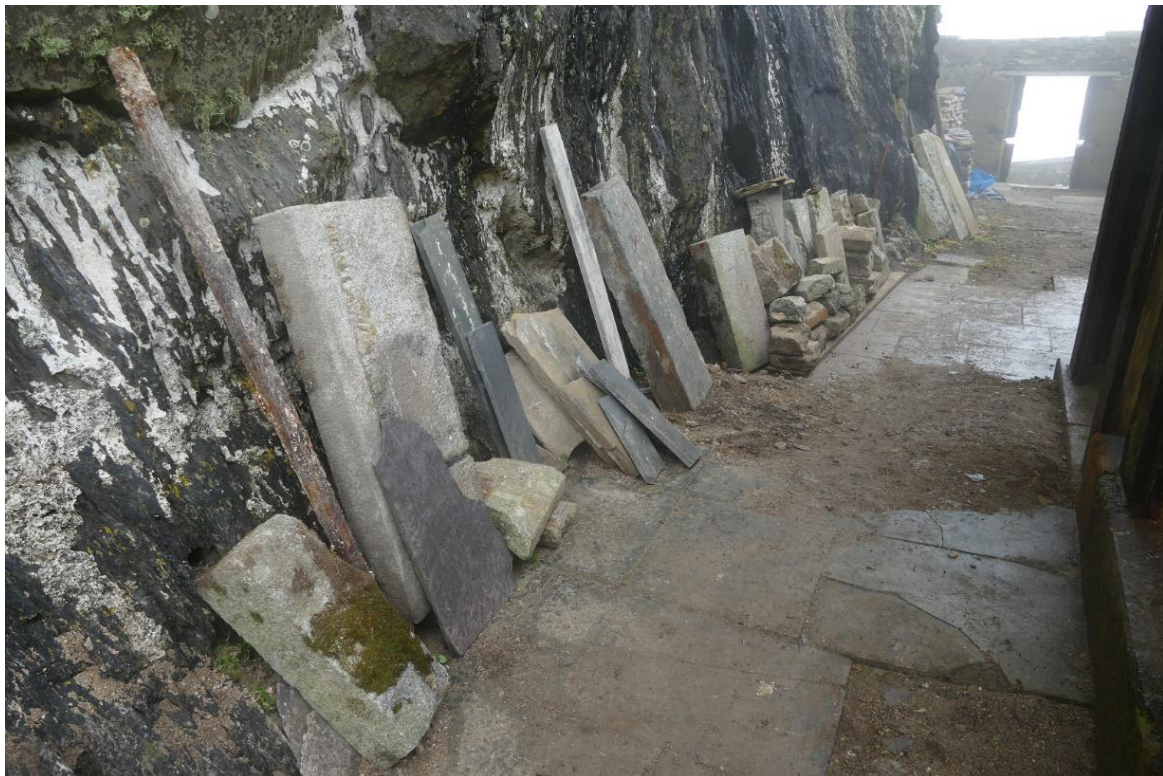
Fig. 22. –Retrieved stonework from the Upper Lighthouse

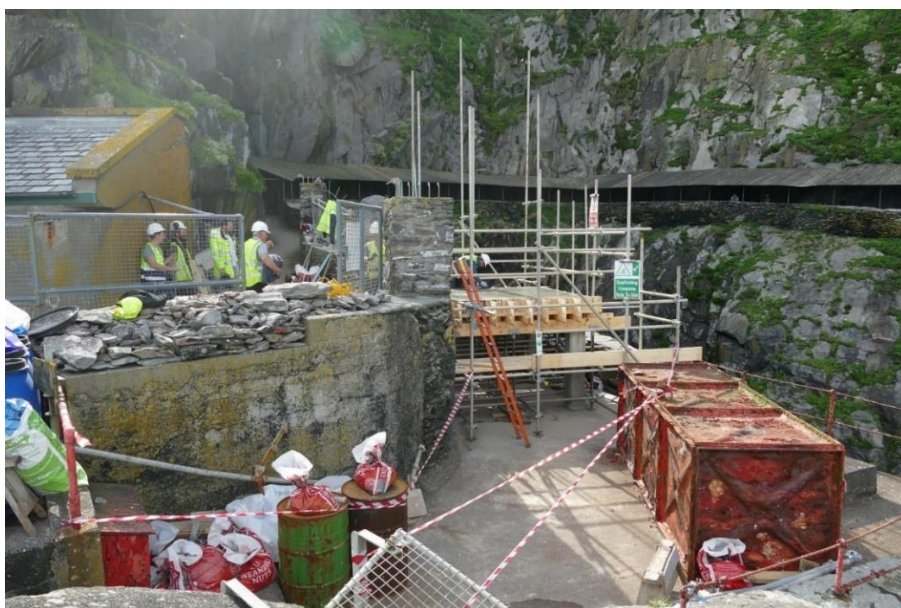
Fig. 23. – Construction of the concrete base prior to the installation of the visitor toilets

Ministerial Consent for the installation of the first visitor's toilets and associated works near the Helipad area was granted in May 2021. The OPW commissioned Malachy Walsh and Partners to produce a Natura Impact Statement report to accompany the Ministerial consent application (Appendix B). The visitor's toilets opened to the public on 24th August 2021 and are the first public toilets to be constructed on the island. They consist of 2 no. dry toilets and hand sanitation stations. The enabling works and making good of the ground were completed first on site. The toilet block was constructed in the Killarney Depot, dismantled and re-constructed on site. The timber toilet block includes a dry toilet system with a composting tank and a solar panel on the roof. It was vital to install these toilets on the island to meet the Covid-19 health and safety requirements.

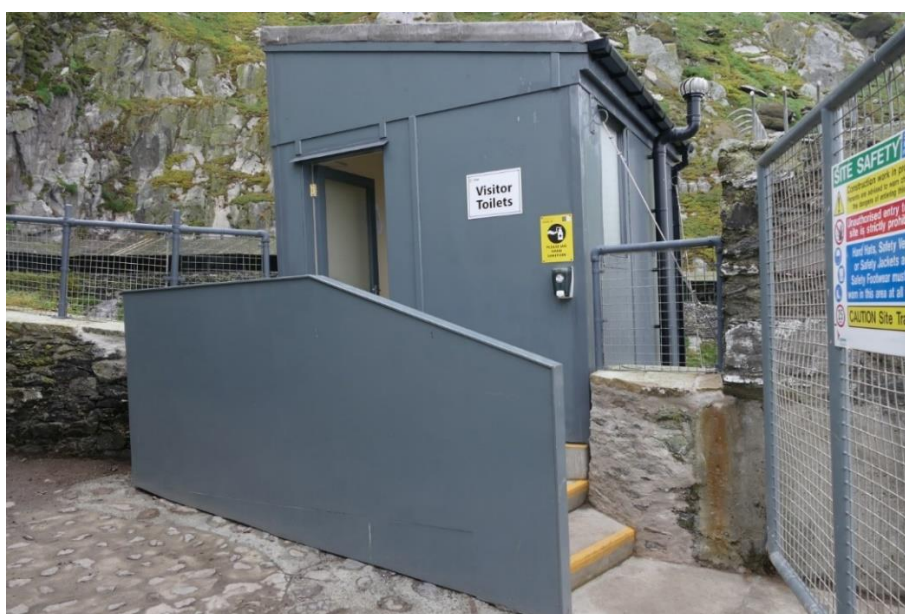
Fig. 24. – New visitors toilets completed in 2021 near the Helipad area

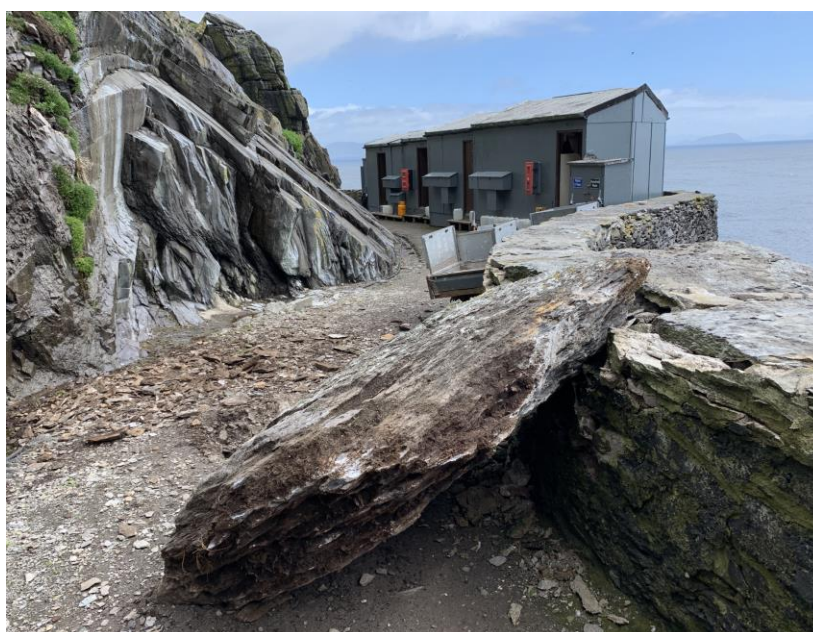
Rock-falls have increased in frequency in the past five years, due to the effects of climate change. The high levels of precipitation are leading to soil erosion and rock falls. The substantial rock fall which occurred in 2020 resulted in the installation of a temporary crash deck at this location and at another two high risk locations on the Upper Lighthouse Road to protect OPW operatives from falling debris.

Another minor rock fall was noted to crash deck on the Lighthouse Road in July 2021. The rock was deflected into the sea but three scaffolding planks were broken and required replacing. The OPW carried out regular inspections of all temporary crash decks throughout the season to mitigate the risk of rock falls.

Fig. 34. – Rock Fall on 27th July 2020

In response to the threat to the health and safety of the workers, the OPW appointed Downes Associates as consultant structural engineers in 2021 for the design of three permanent crash decks in critical locations on the Lighthouse Road. The OPW obtained DHLGH Ministerial Consent in August 2021 for the installation of the permanent crash decks. MWP also prepared and issued to the OPW a Natura Impact Statement report for the construction of the 3 no. permanent crash decks (Appendix D).

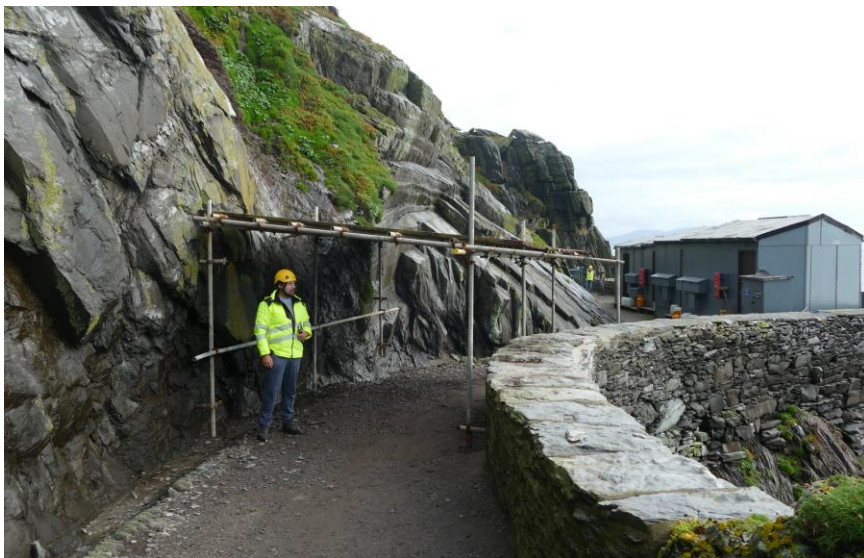
Fig. 35. – Temporary crash deck location A near site huts and installed following rock-fall.

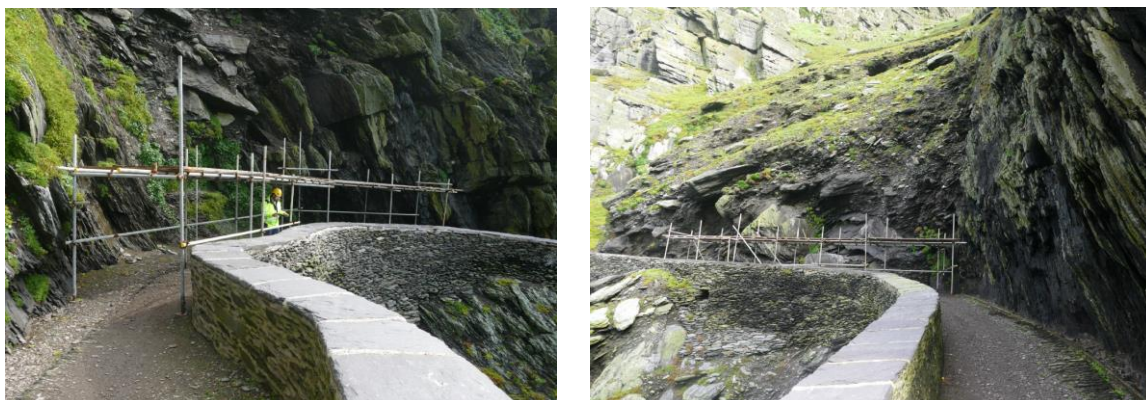
Fig. 36. – Temporary crash deck location B & C on the Upper Lighthouse Road.

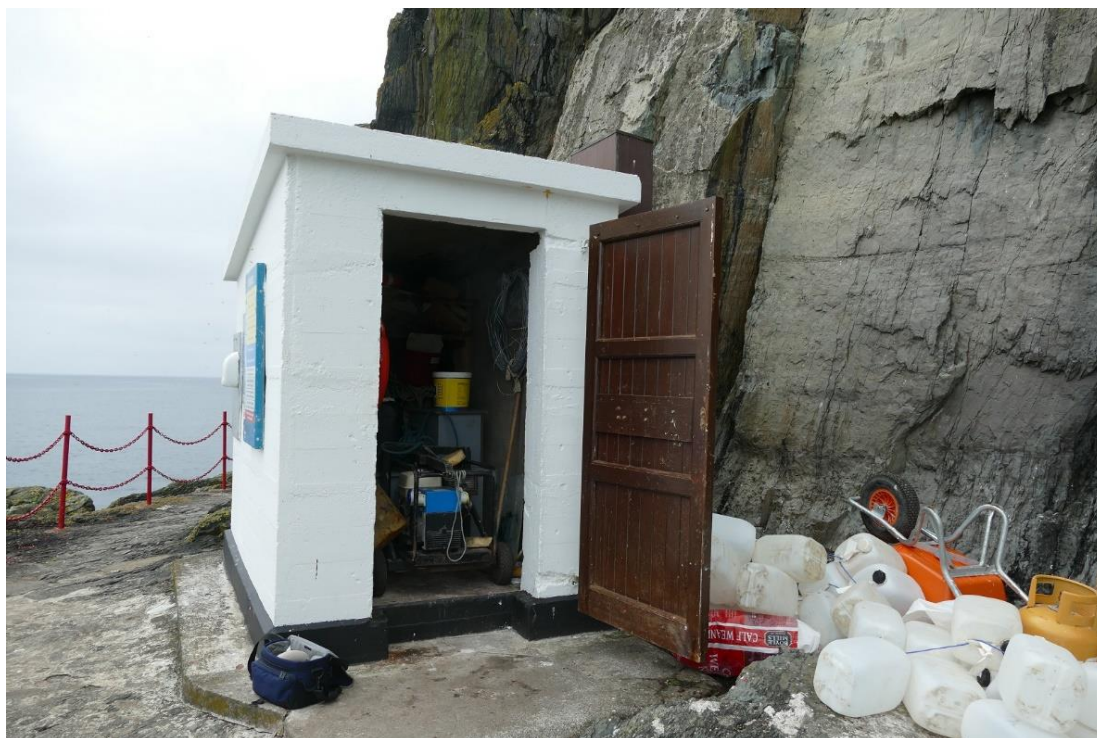
Fig. 37. – Proposed location of CCTV on the building at the pier

The OPW will endeavour to provide greater security to the site. The OPW are proposing to install CCTV and solar panels on the store building at the pier. An application for DHLGH Ministerial Consent will be submitted in 2022 for the proposed works. Technical information is being provided by OPW M&E Engineering section to accompany the Ministerial consent application. A Natura Impact Statement Document will be commissioned from a specialist environmental consultant to accompany the consent application.

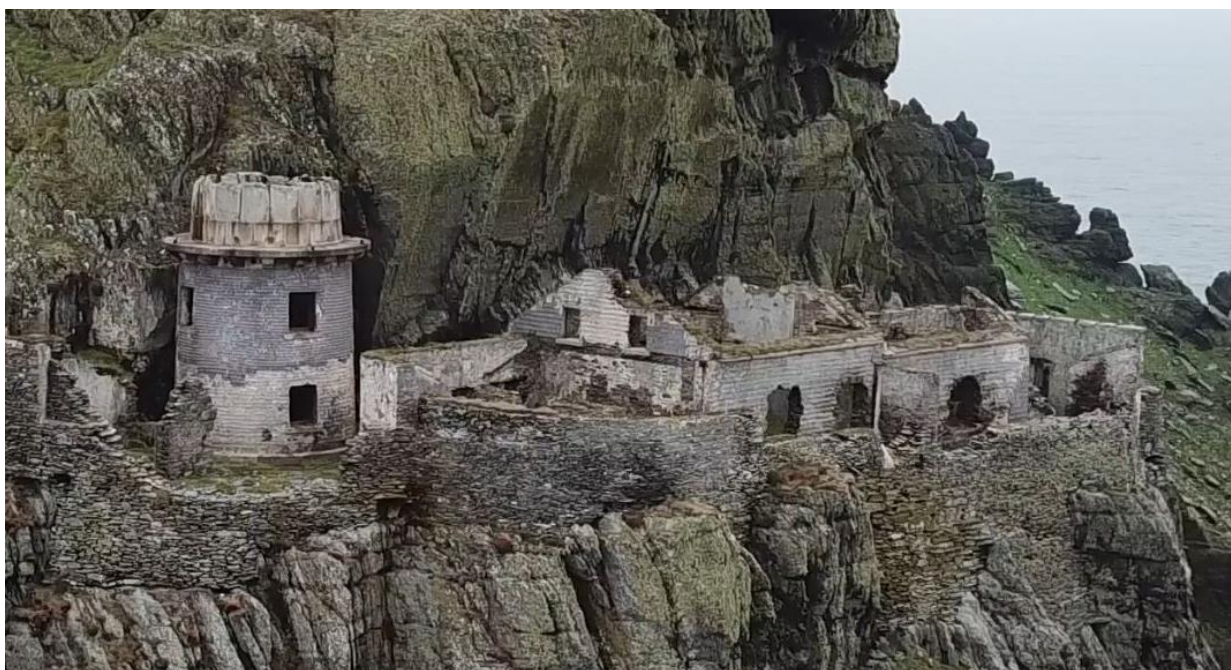
Fig. 38. – Proposed repairs to Upper Lighthouse sea wall in 2022 Season

- Repair works to the Upper Lighthouse buildings and entrance gate pier.
- Repair works to the Upper Lighthouse sea wall.
- PCA surveyors to re-survey the Upper lighthouse following archaeological excavations completed in 2021.
