Archaeological Impact Assessment
of the
Proposed Construction of a Barrier
on the South Steps,
Sceilg Mhichíl, Co. Kerry.

Alan R. Hayden
July 2024.

Archaeological Impact Assessment of the Proposed Constuction of a Barrier on the South Steps, *Sceilg Mhichíl*, Co. Kerry.

Alan R. Hayden
Archaeological Projects Ltd.,
July 2024.

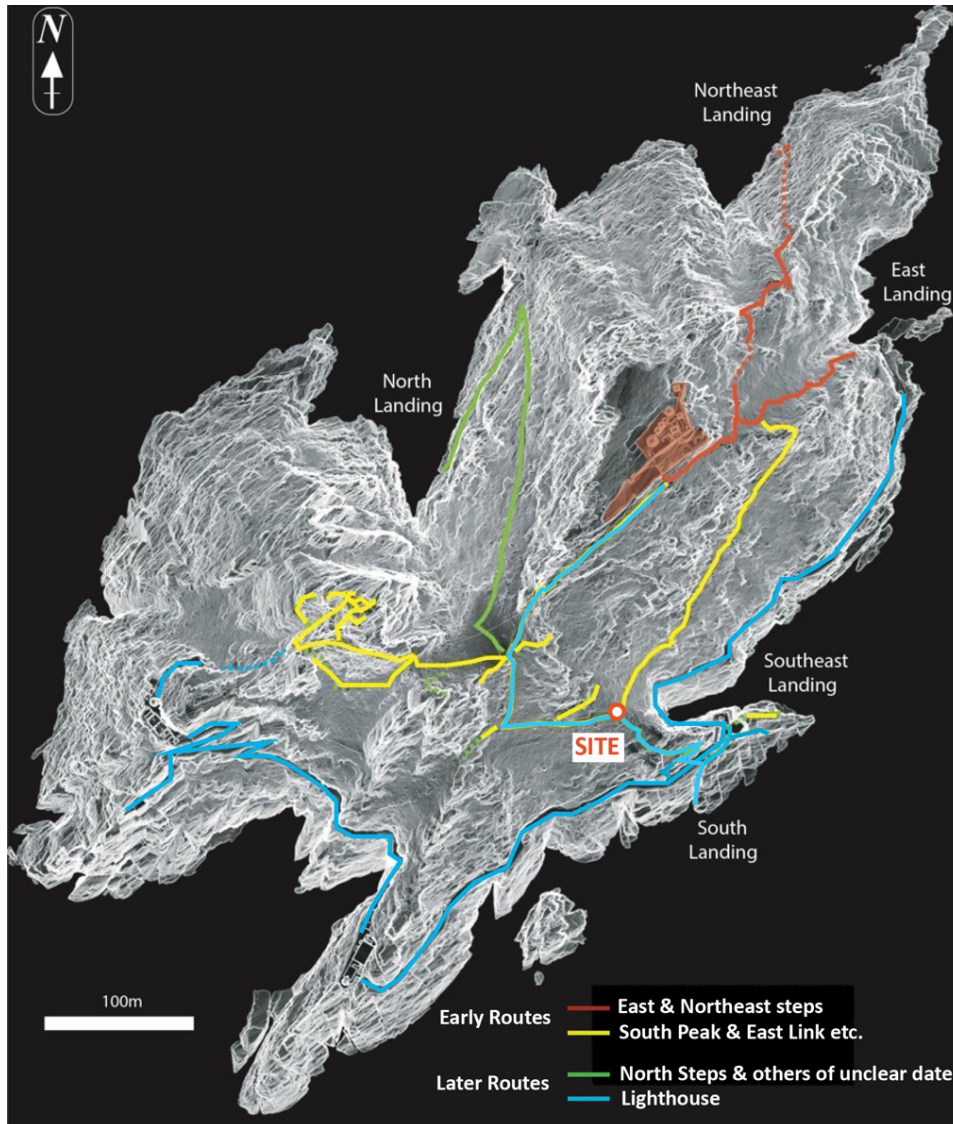
Fig. 1. Sketch plan of the known routeways on Sceilg Mhichíl, with suggested dates of surviving structures, showing the location of the site of the proposed barrier (base map LiDAR survey).

There are quite a number of routeways, which were known to have been used on Sceilg since it was first developed in the seventh century (fig. 1). They have not all been surveyed or explored and the date of many remain uncertain or unproved. However, the Northeast Steps are certainly the earliest known, with the East Steps (which superseded them), the routes on the South Peak, the East Link pilgrimage route, a run of five steps below the helipad close to the Southeast Landing and a route from the ‘Crocodile Rock’ area north-eastwards up to the monastery also being clearly of early-medieval date.

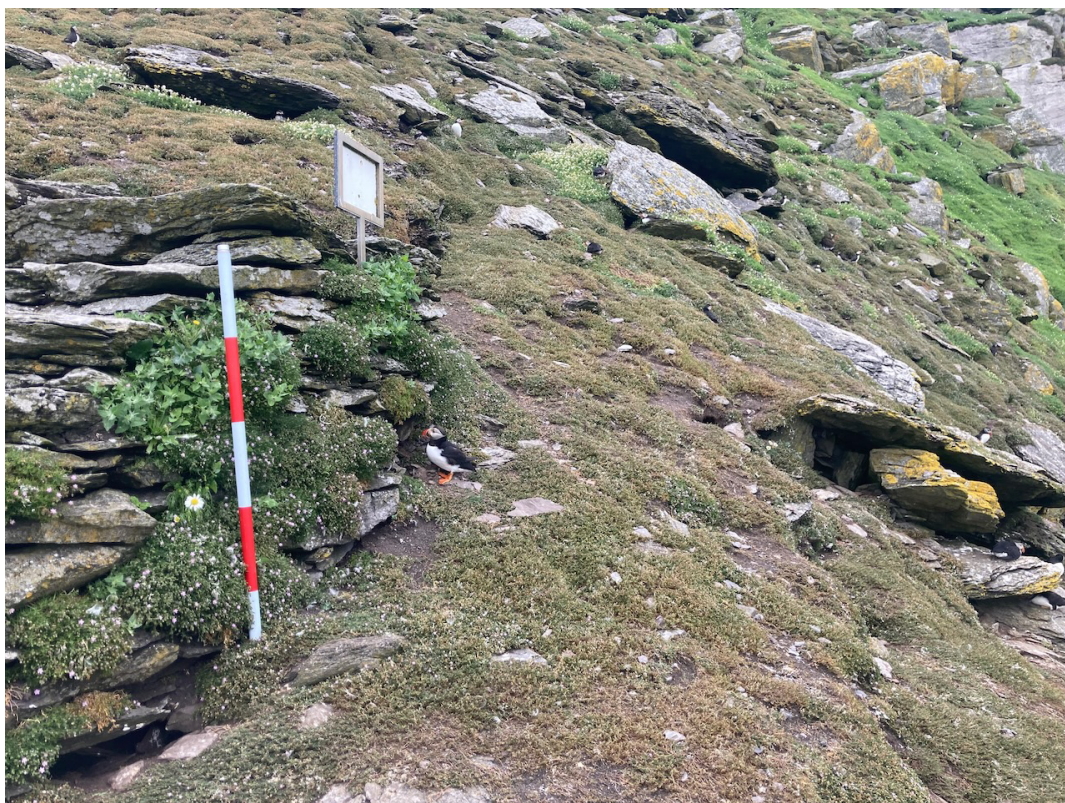
At the base of the east side of an abrupt 90-degree turn on the South Steps, where it is proposed to erect the barrier, there is a clear c. 1.5m wide flat area, which gently slopes upwards to the north. It does not look natural. While it might be no more than the result of material backing up behind a large rock on its south side, it conceivably could be the remains of a terrace, either built to facilitate the construction of the South Steps in the nineteenth century or made much earlier as part of a path linking the early East Link route to the early 'Crocodile Rock' building to the southwest.

Fig. 2. The unnaturally looking flat area to the east of the corner of the South Steps (left) where it is proposed to erect the barrier. Could this be an early terrace? The puffin in the picture was guarding his / her nest in the base of the walling supporting this corner of the South Steps.

It seems unlikely that the uprights could be anchored into the walling supporting the steps, as it is of loose and open drystone construction, and likely also provides nesting spots for storm petrels. There is also at least one active puffin nest in the base of the walling (fig. 2). It is therefore more likely that the uprights will have to be anchored into the bedrock below and east of the wall and braced by raking braces (also anchored into bedrock) on its outer side, to support it (fig. 4).

If the flat area east of the steps was a man-made terrace, excavation potentially could reveal walling supporting its east side. If such walling survives it is unlikely National Monuments Service (NMS) will allow it to be removed, which could limit the area in which the bases of any possible braces could be installed and hence influence their angle.

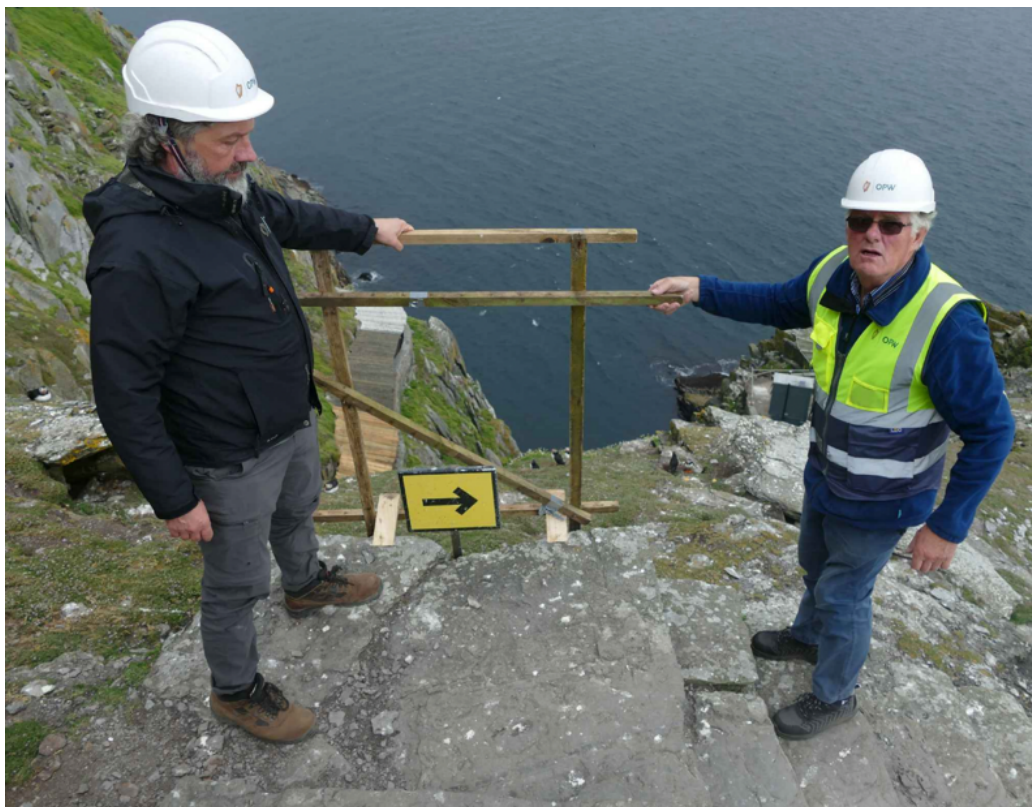
It is proposed to erect a barrier above the top of a right angled turn in the South Steps, which has heretofore been marked by a small arrowed sign (fig. 3). There have been to date no known accident nor fatalities at this point.

For the barrier to be effective it will need to stand approx. 1.25 metres or more above the level of the steps. A mock-up was constructed on site (figs. 3 and 4).

Fig . 3. Mock of the proposed barrier from the west illustrating the natural tendency for persons descending to lean on the proposed barrier (note tempting view down over Cross Cove) and also of persons ascending to hold onto it.

Given the natural tendency for persons descending to lean on the proposed barrier (note the tempting view down over Cross Cove) and also of persons ascending to hold onto it (fig. 3), the uprights will have either to be attached to the walling supporting the steps or anchored into bedrock and braced from the east.

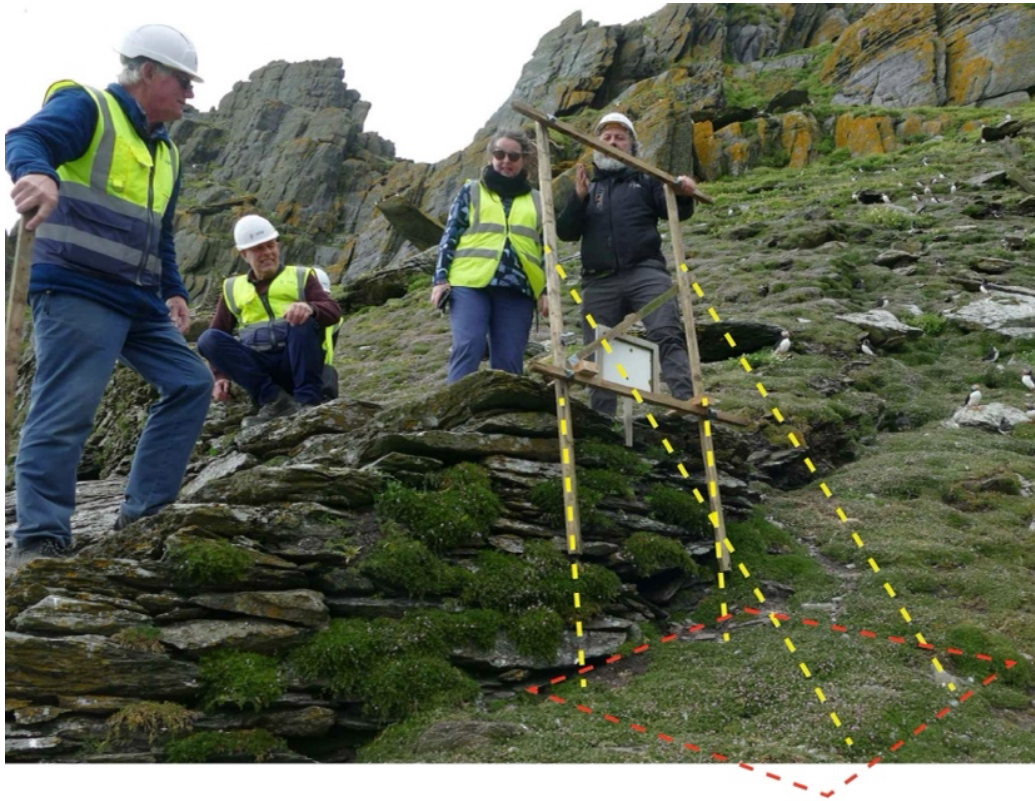
The pair of uprights supporting the barrier will have to descend down outside the east face of the walling beneath the corner and hence will have to be approx. 2.5m in height (fig. 4).

Fig. 4. Mock-up of the proposed barrier from the east with added yellow lines indicating base of uprights and possibly required raking braces and red lines showing likely area required to be excavated to accommodate anchoring of uprights and braces into bedrock.

The need to anchor the base of the uprights (and also the braces- if required) of the proposed barrier into bedrock will require an area measuring around 1 metre square or more (the east-west extent will depend on the depth at which bedrock lies) adjacent to the base of the east face of the masonry steps to be cleared to bedrock. It is not known at what depth bedrock lies in this area and so the depth of material to be excavated is unknown.
