Sceilg Mhichíl
2024 OPW Maintenance Plan
Date of Issue – 20th March 2024

OPW Oifig na
nOibreacha Poiblí
Office of Public Works

This report aims to outline the maintenance works to be carried out by OPW at the start of the 2024 season at Sceilg Mhichíl. The OPW carry out annual maintenance works on the island prior to the commencement of the tourist season. The purpose of the works is to make the island safe for the general public, OPW personnel, contractors, consultants, etc. The works include site set up, safety sweeps, removal of stones and debris, cleaning of vegetation, repair works, etc.

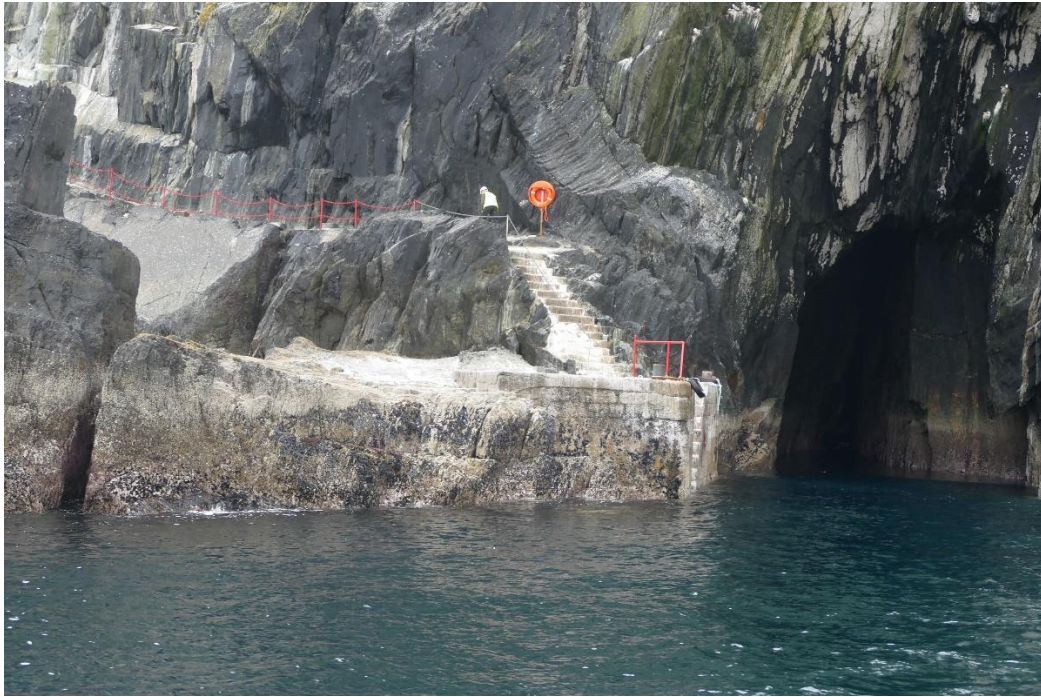
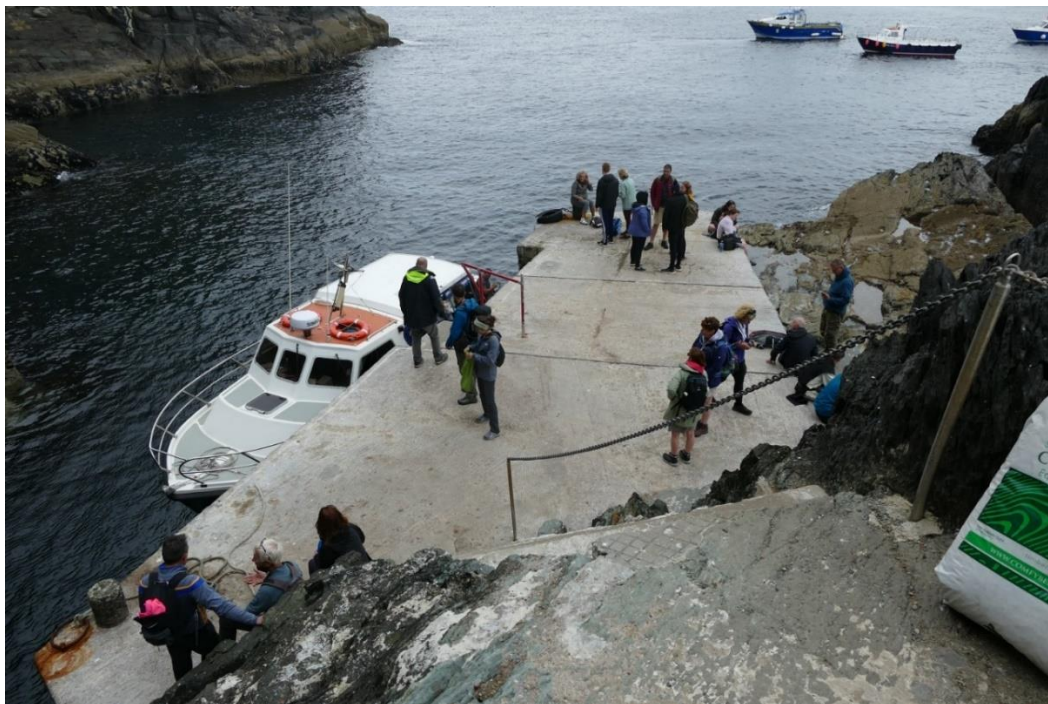
Figure 3 - View of the Landing Pier

The landing pier at Blind Man’s Cove is the only point of access to the Sceilg Mhichíl by boat. The landing pier is used by tourists, OPW personnel, consultants, etc. It is also used to transport materials to and from the island. The maintenance of the landing pier by the OPW is essential to ensure safe access to the island. The maintenance works to be carried out by the OPW include cleaning the landing pier of debris, ensuring that the access steps and handrails are secure, and securing any loose stones. The landing pier is cleaned with chlorus to remove the algae following the winter months. The removal of algae is essential to prevent serious slipping and tripping hazards. Debris is removed from the crane pit to ensure correct installation of crane.

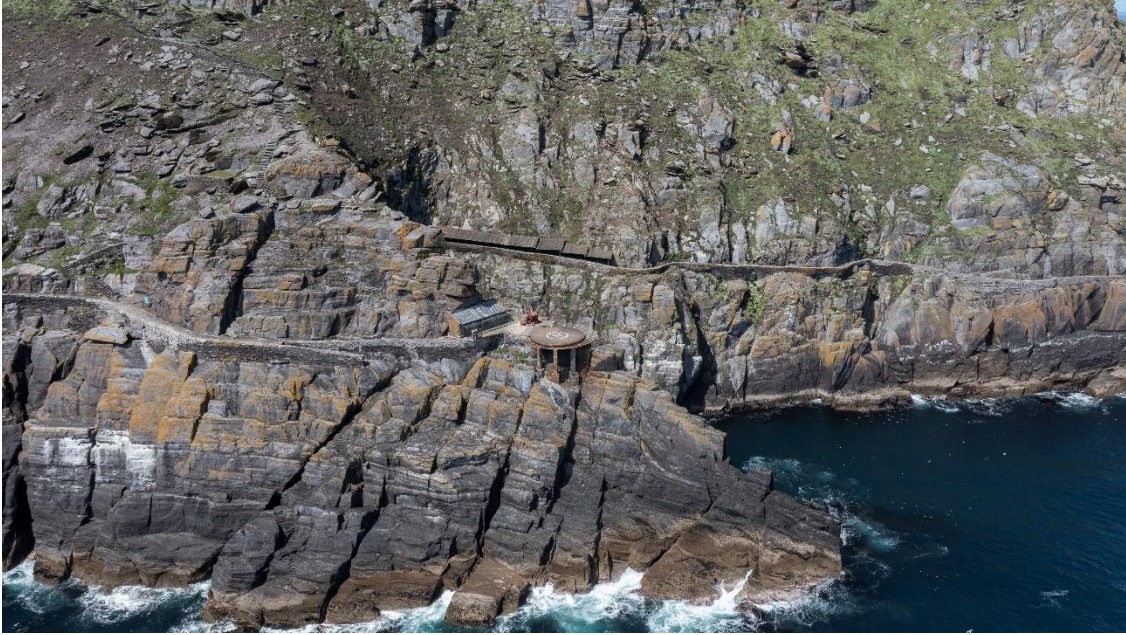
Figure 6 - View of the Lower Lighthouse Road

The lower lighthouse road is used by visitors to access the South steps towards the Monastery. It contains the visitors toilet which is located near the helipad. Tourists can only access the lower lighthouse road until they reach the South steps. The upper part of the lower lighthouse road contains the site huts, used by OPW guides, OPW staff, contractors and consultants. The lower lighthouse road is also used to access the lower lighthouse compound and the upper lighthouse road.

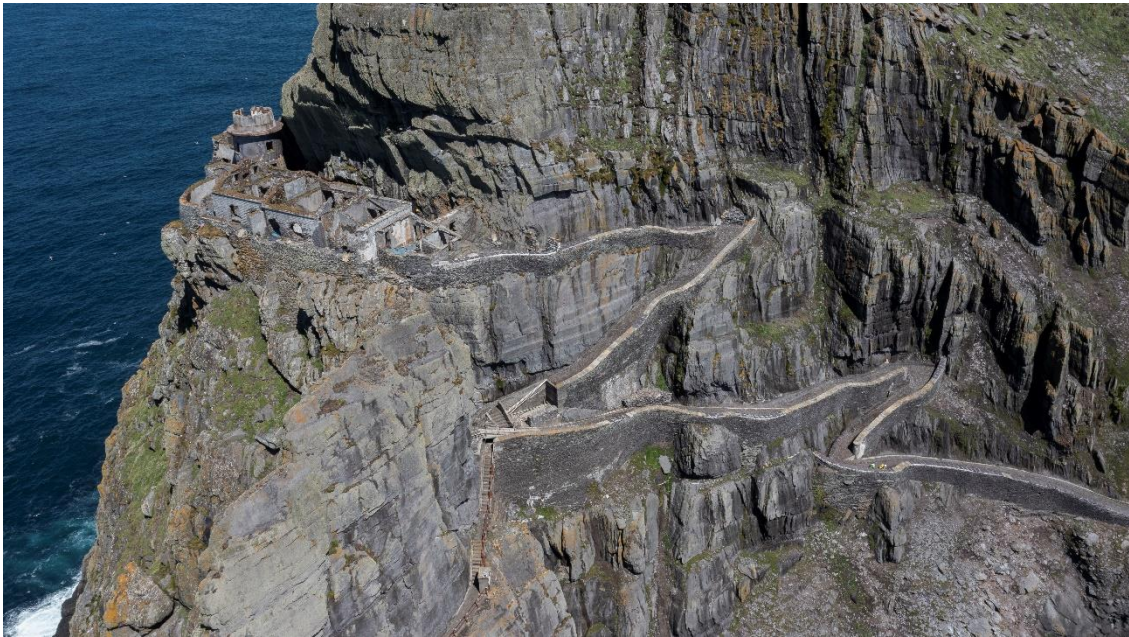
Figure 7 - View of the Upper Lighthouse Road

At the end of each season along the Upper Lighthouse Road, the OPW place sand bags along the drains to protect the road and ensure it is not washed away during a storm. As part of routine works, sand bags are brought to each drainage channel on the upper road and placed along the drain. These are placed parallel along the pathway to divert water into the existing drains in the stone walls. This action occurs to ensure that during winter months heavy rainfall will not wash away the surface of the pathway. At the start of season the sand bags are removed, drains cleaned and the pathway is restored.

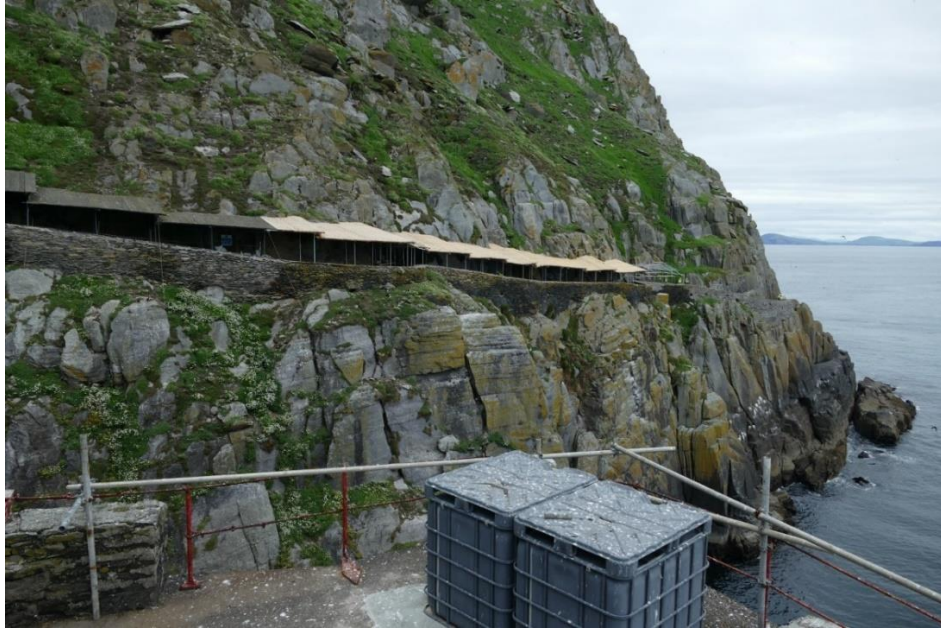
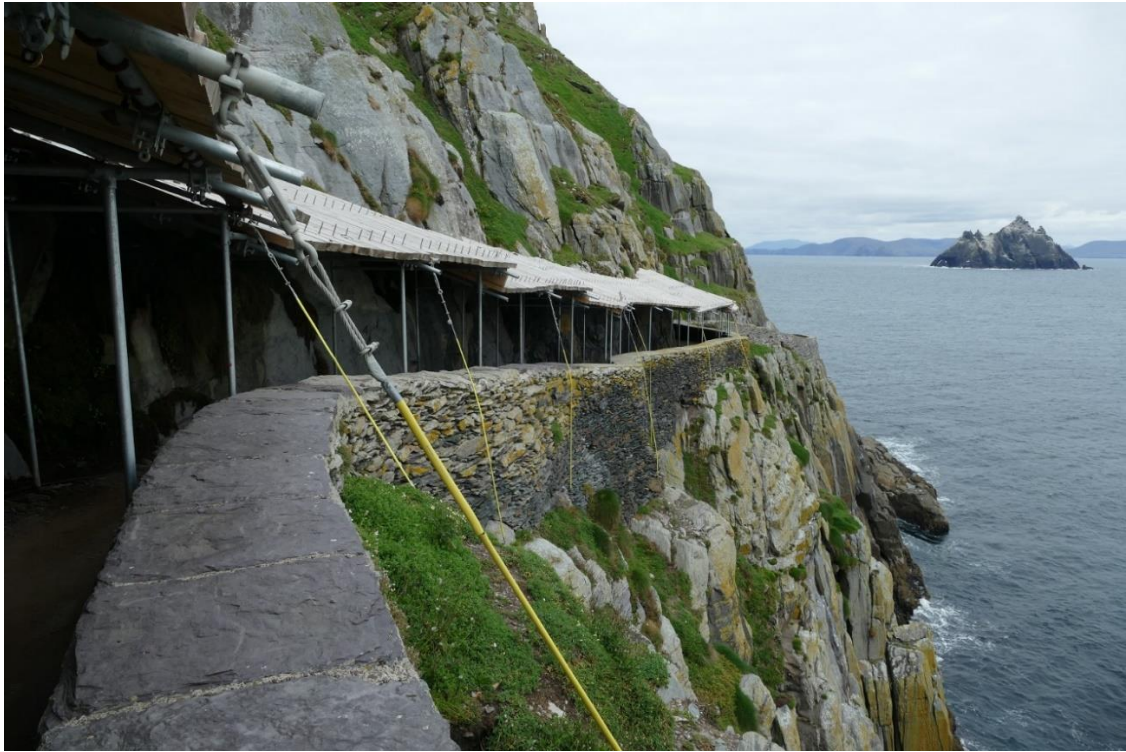
Figure 9 - View of the protective canopy on the Lower Lighthouse Road

Figure 10 - View of the protective canopy on the Lower Lighthouse Road

Additionally, the OPW carry out cleaning works to the protective canopy located on the Lower Lighthouse Road. The purpose of the canopy is to deflect stones and debris that fall down from the upper sloped areas. This is to provide safe access for all the visitors to Sceilg Mhichíl. The existing canopy on Sceilg Mhichíl was extended by approximately 100 linear meters in the 2022 season following a serious rock fall that occurred on the Lower Lighthouse Road on 13th June 2022.

The maintenance works to the canopy include the cleaning of stones, debris and potential rock falls. The works also include inspection and securing of the canopy. Following DHLGH’s Ministerial Consent condition the cable stays to this canopy are to be removed for the duration of the summer season and reinstated at the end. The canopy is built of a scaffolding system including scaffolding tubes and timber decking. Due to the larger size of debris that might fall on the lower lighthouse road during the winter months, some of the timber boards may sustain extensive damage and would require replacement. Therefore, timber boards on the protective canopy are inspected and replaced as required. The protective canopy may also require repair works and paintwork as required.

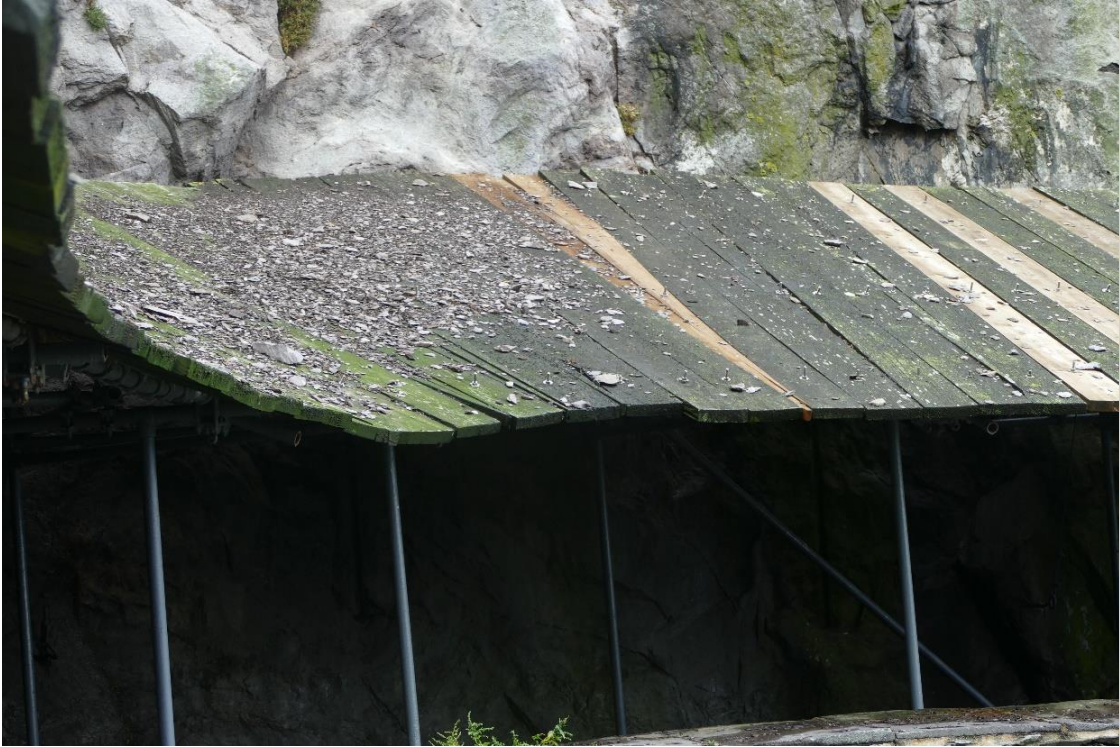
Figure 11 - View of fallen debris on the decking of the protective canopy on the Lower Lighthouse Road

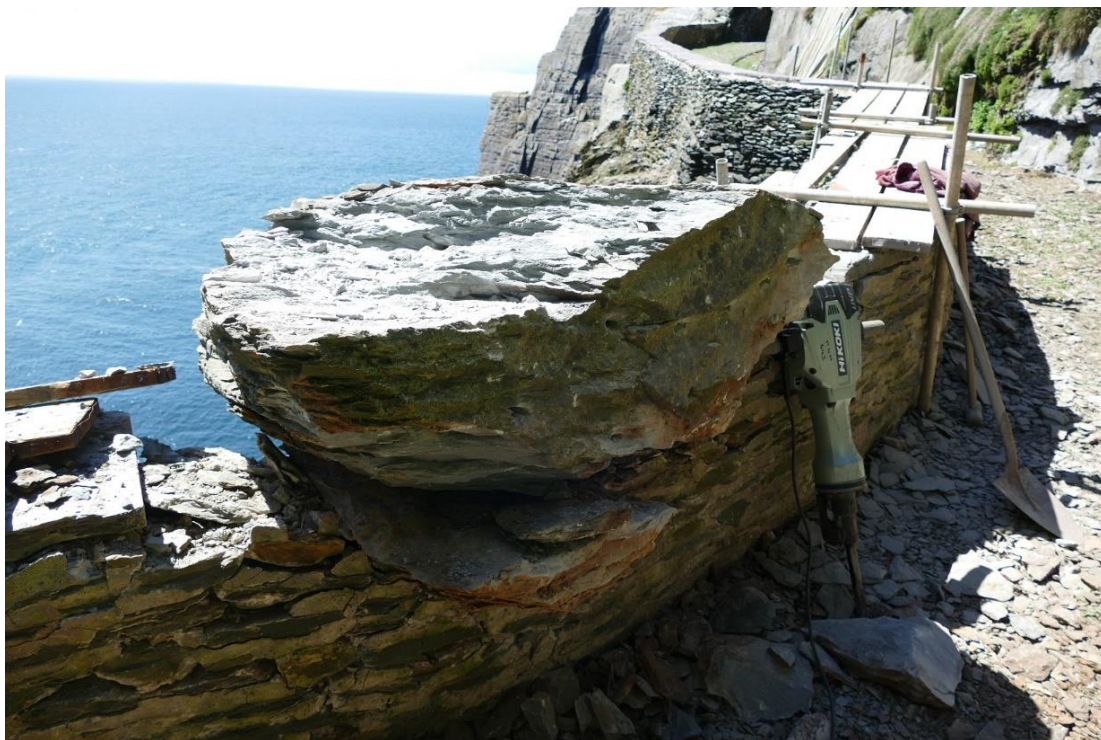
Figure 12 - Example of rock fall on the Upper Lighthouse Road in the 2022 season

Rock-falls have increased in frequency in the past five years, due to the effects of climate change. The high levels of precipitation are leading to soil erosion and rock falls. The OPW carry out a site inspection at the start of each season to identify any potential rock falls that might have occurred during the winter season. The OPW then proceed to clear any fallen rocks by breaking them and salvaging stones for future re-use. Additionally, the OPW endeavour to make the locations of rock falls safe for tourists, OPW staff, and any other visitors to the island.

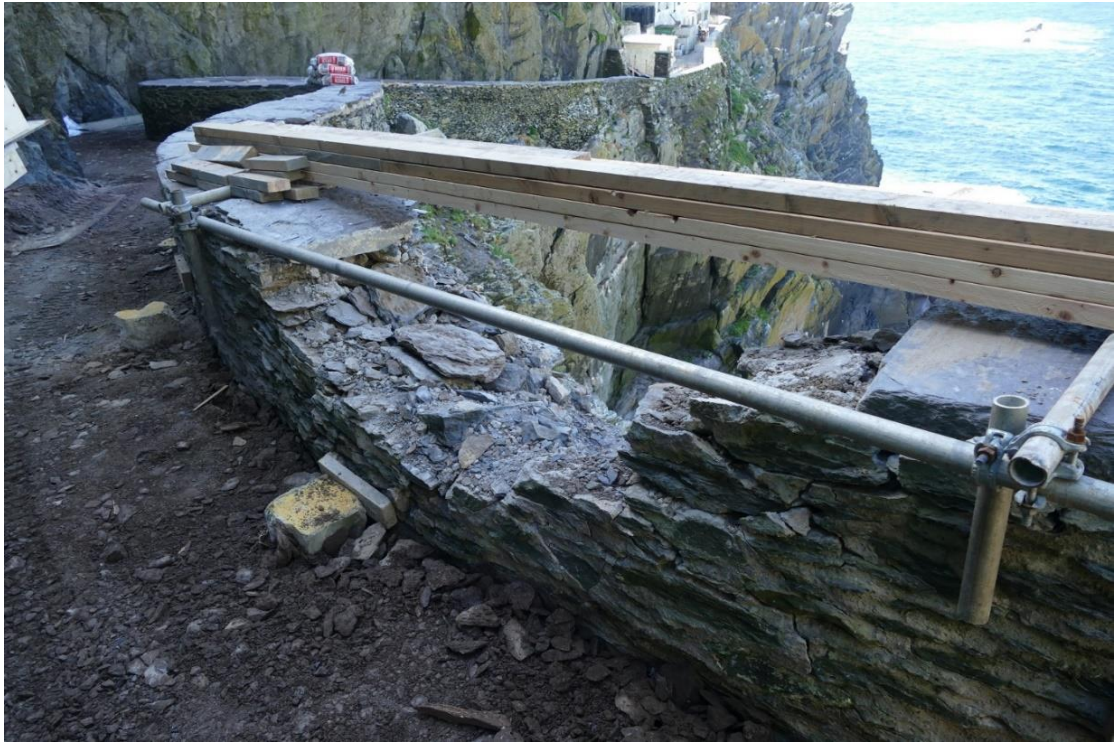
Figure 13 – Example of temporary safety railing installed at the Upper Lighthouse Road by OPW in the 2022 season

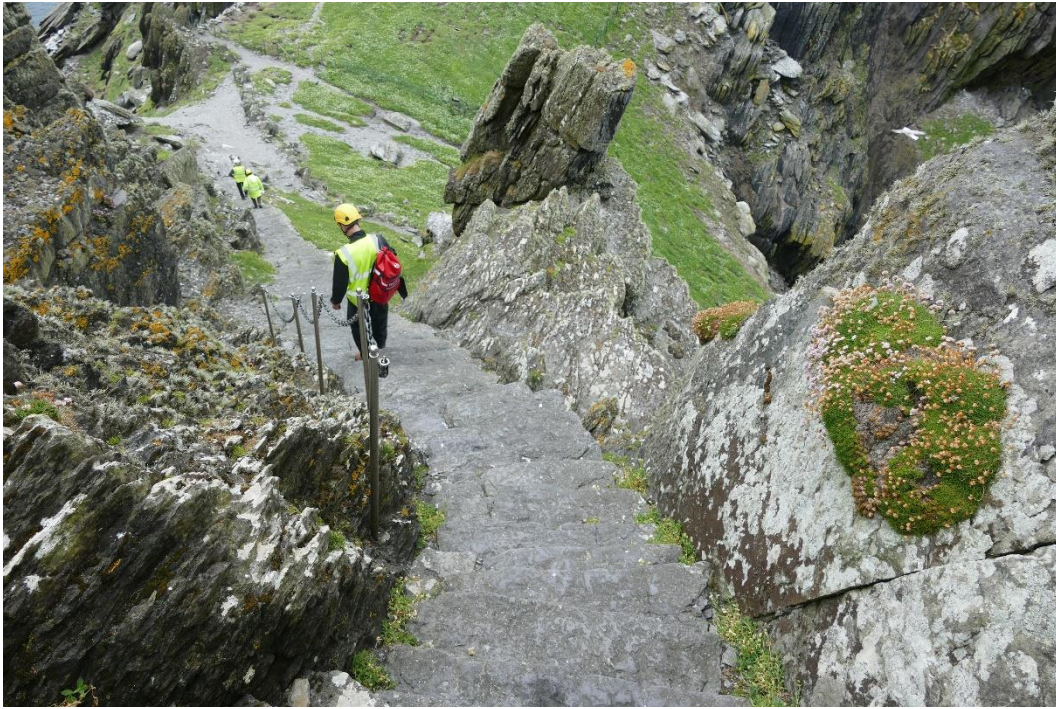
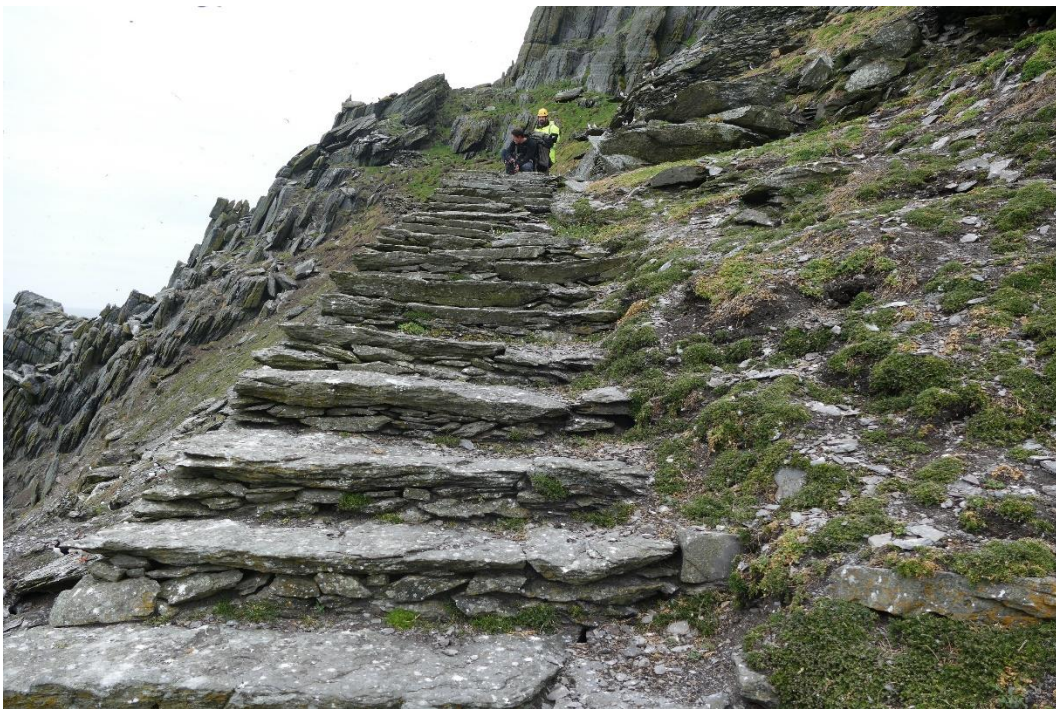
Figure 15 - View of the South Steps

The South Steps at Sceilg Mhichíl are the only access for tourists to the Monastery from the Lower Lighthouse Road. They consist of approximately 600 uneven steps. At the start of each season, and prior to the arrival of tourists, the OPW carry out essential maintenance works to the South Steps to ensure safe access for visitors. The maintenance works consist of careful checking and identifying of any repairs required. The OPW then carry out all the necessary repairs and cleaning of the steps from overgrown vegetation.

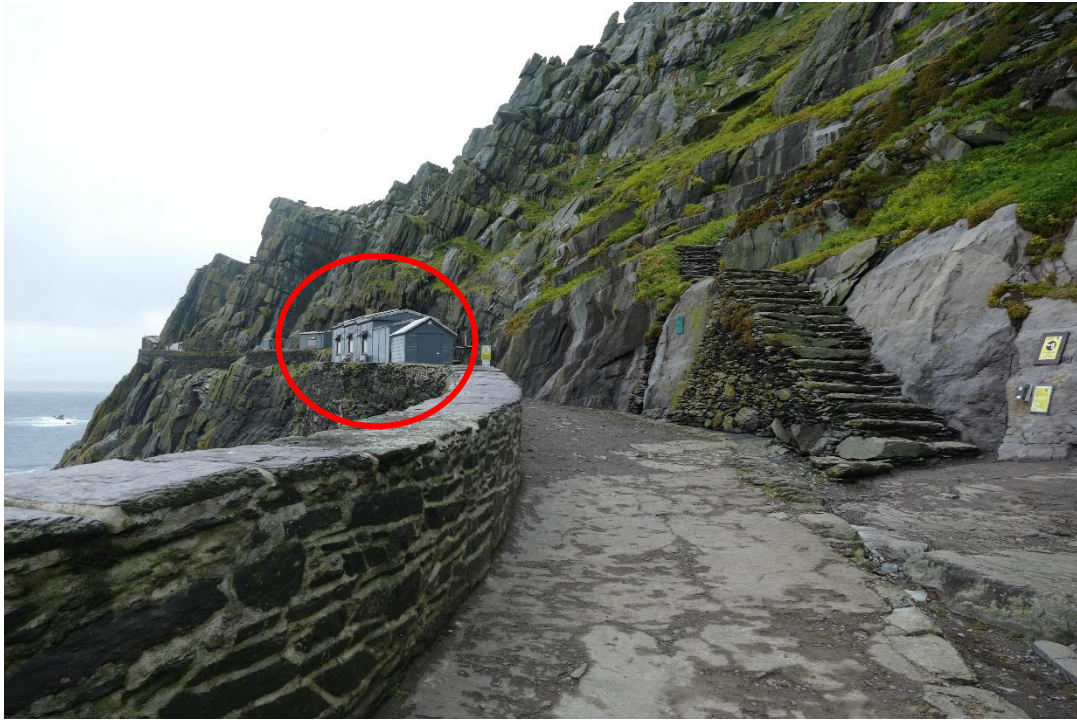
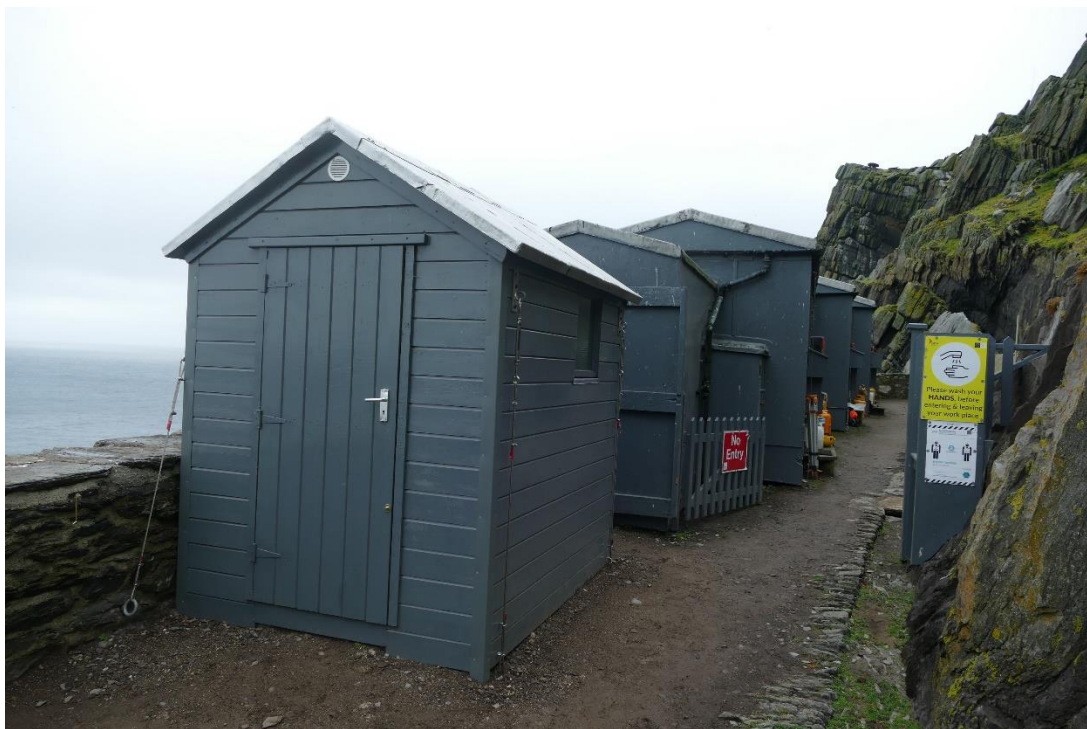
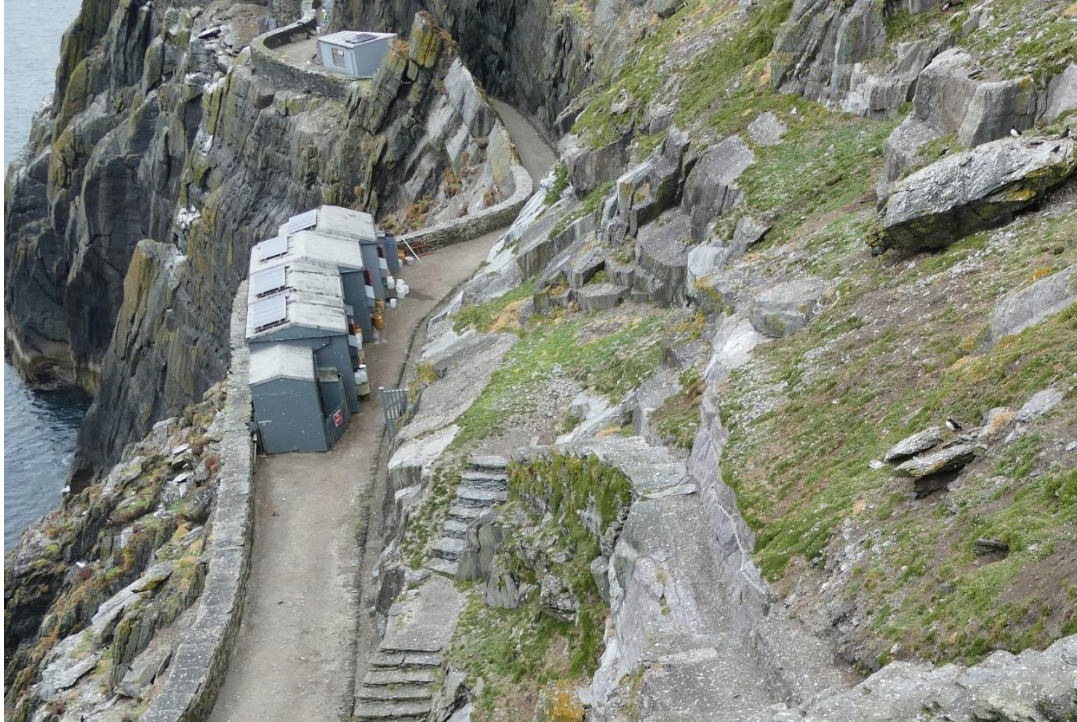
Figure 244 - View of the site huts on the Lower Lighthouse Road

The OPW undertake a site set up at the start of each season that involves cleaning and making good of the OPW workers and guides accommodations. This includes the checking of all appliances i.e. fridges, gas cookers, etc. The works also include any maintenance required externally to the huts and checking of the existing solar panels on the roofs of the huts. OPW carpenters carry out an inspection of the site huts and make a list of all the repairs required. In addition, the OPW carry out maintenance works to the OPW composting toilet located near the OPW guides huts.

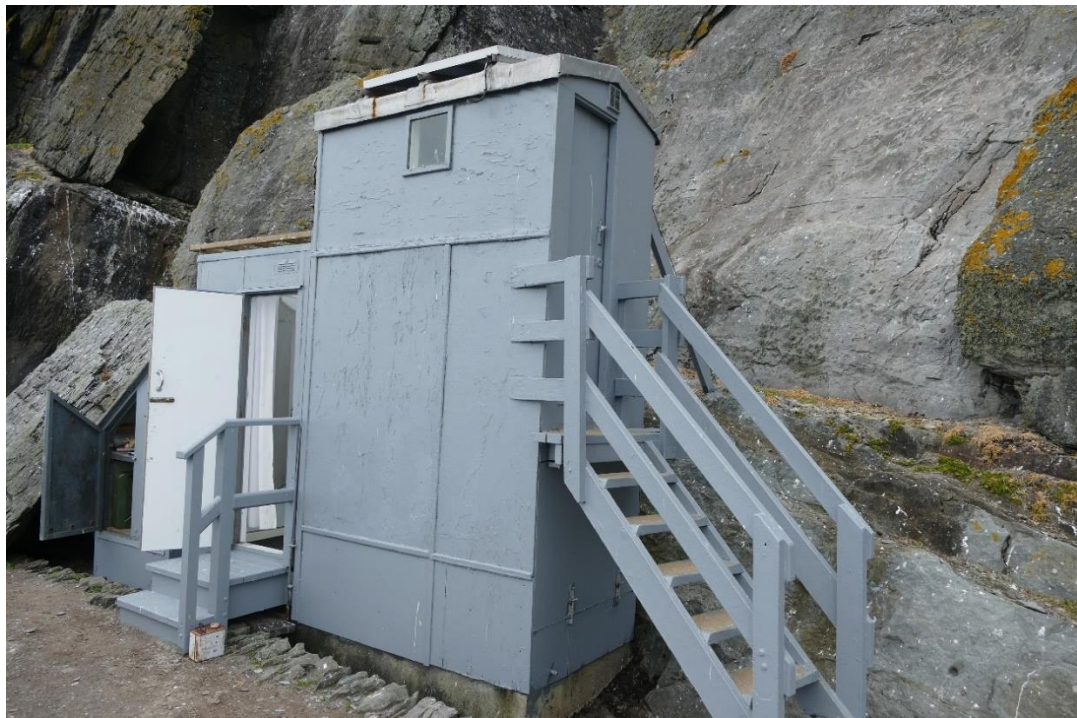
Figure 257 - View of the composting toilet used by OPW guides located on the Lower Lighthouse Road

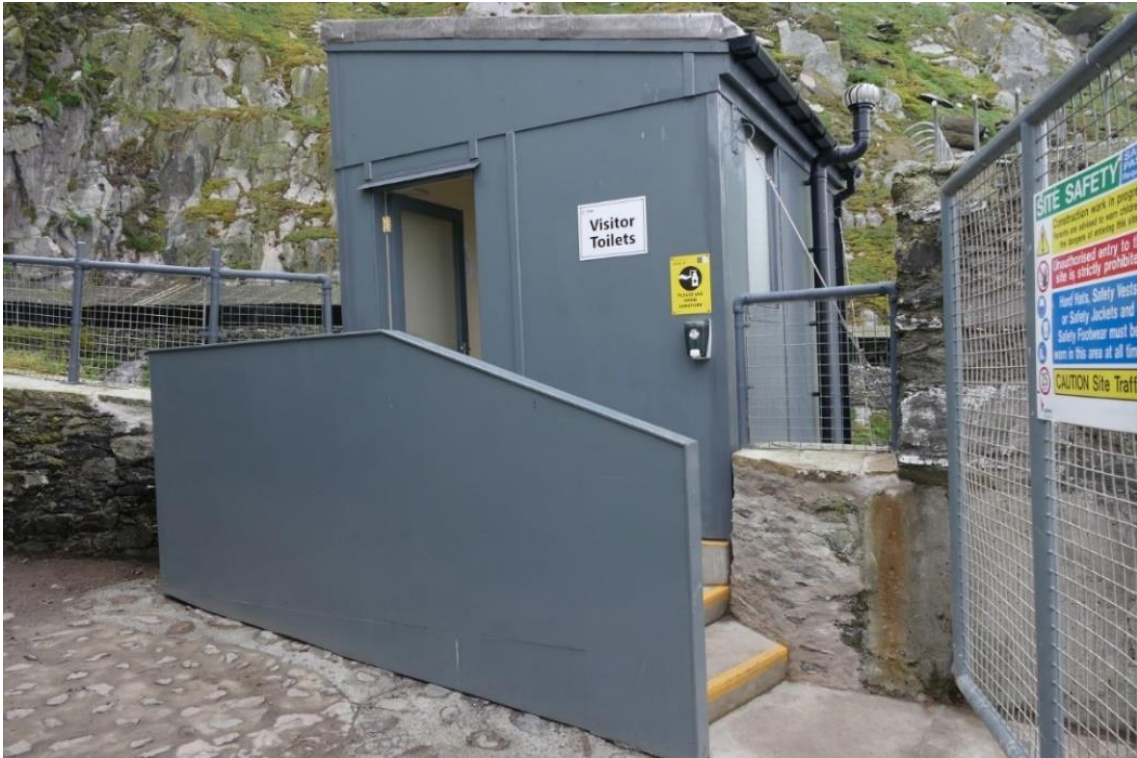
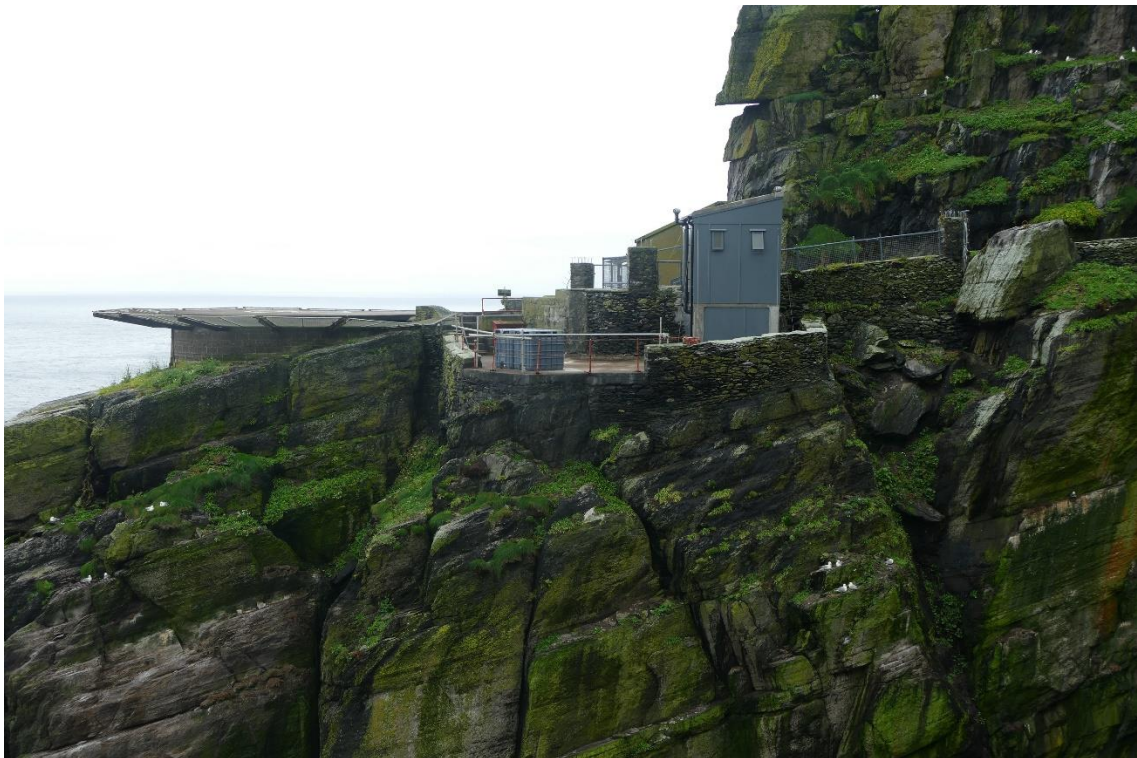
Figure 27 - View of the visitor toilets near the helipad

Figure 280 - View of the visitor toilets near the helipad

The OPW installed new visitor composting toilets in the 2021 season near the helipad on the lower lighthouse road. The visitor toilets opened to the public on 24th August 2021 and are the first public toilets to be constructed on the island. They consist of 2 no. dry toilets and hand sanitation stations. The OPW carry out necessary maintenance works to the visitors composting toilets prior to the visitors arriving to the island.

The composting toilets are cleaned annually from solids and the composting tanks are topped up with saw dust. The tanks are emptied at the start of the season after the remains are left to decompose over the winter months. All solids and waste are removed by OPW from Sceilg Mhichíl every season and brought ashore. Once ashore, a licensed contractor extracts the waste for disposal at a licensed waste facility.

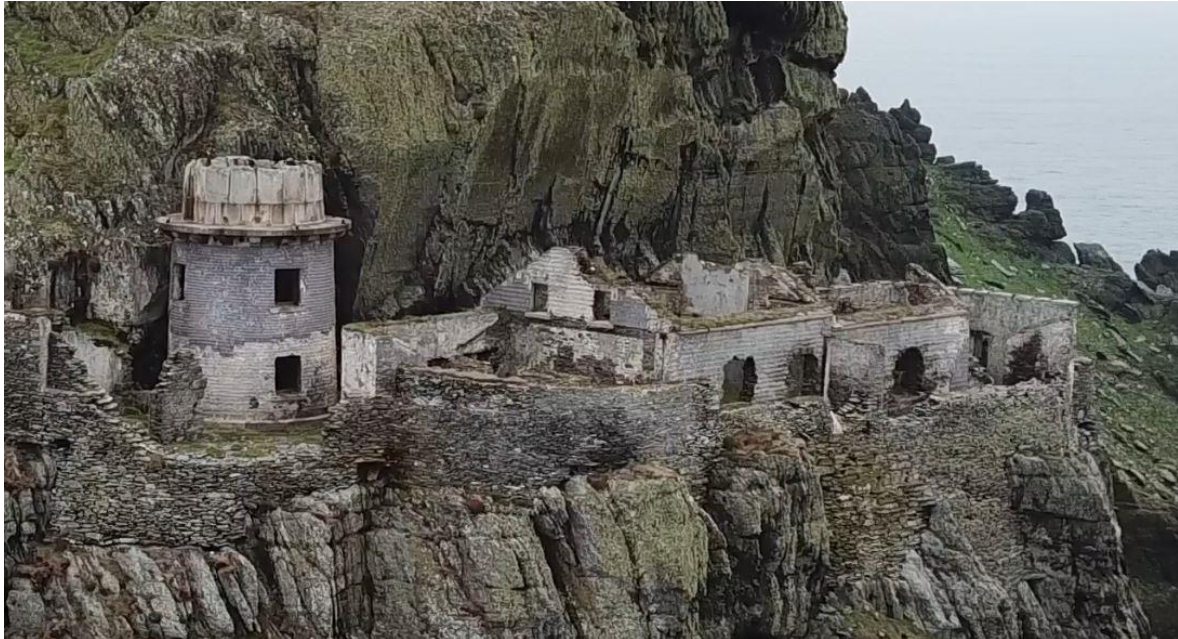
Figure 31 - View of the Upper Lighthouse Drone footage

In 2023 the floors slabs of the Upper Lighthouse were covered with plywood sheets and sand bags for protection. A site inspection will to be made to assess replacement requirements.

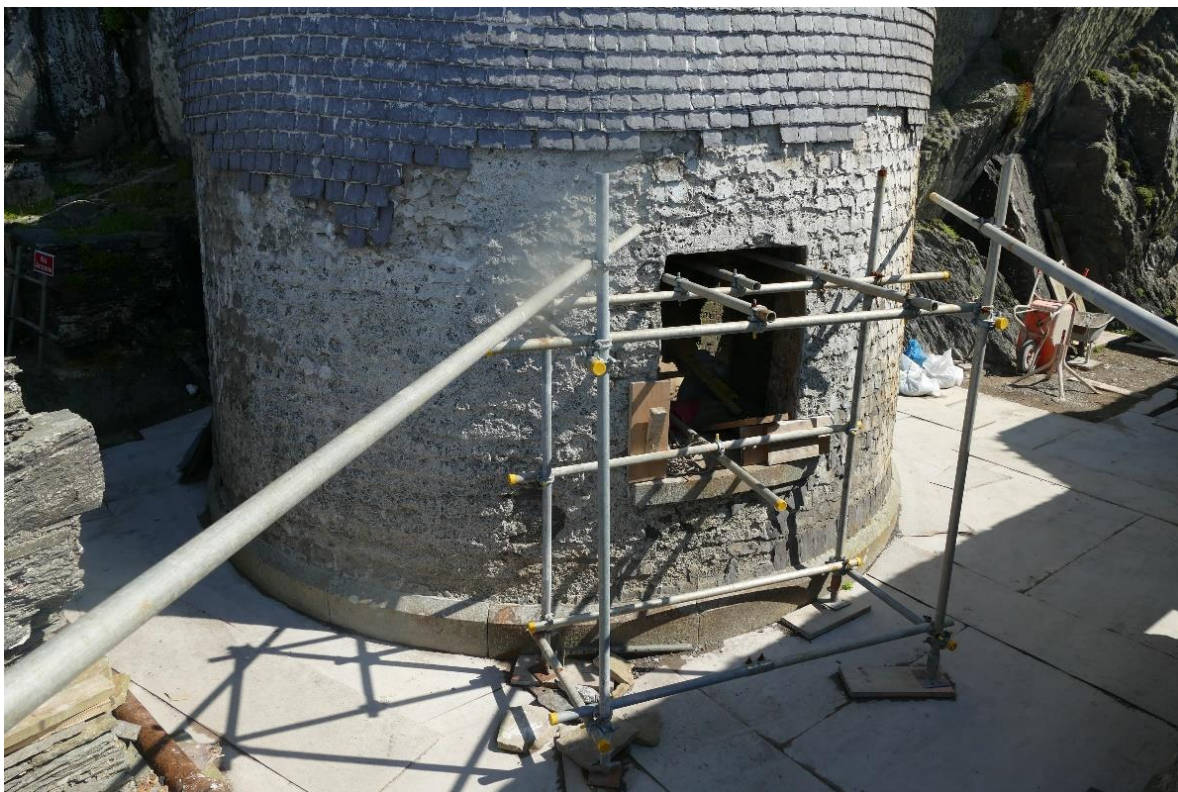
Figure 32 - View of the Upper Lighthouse Protection to floor slab.

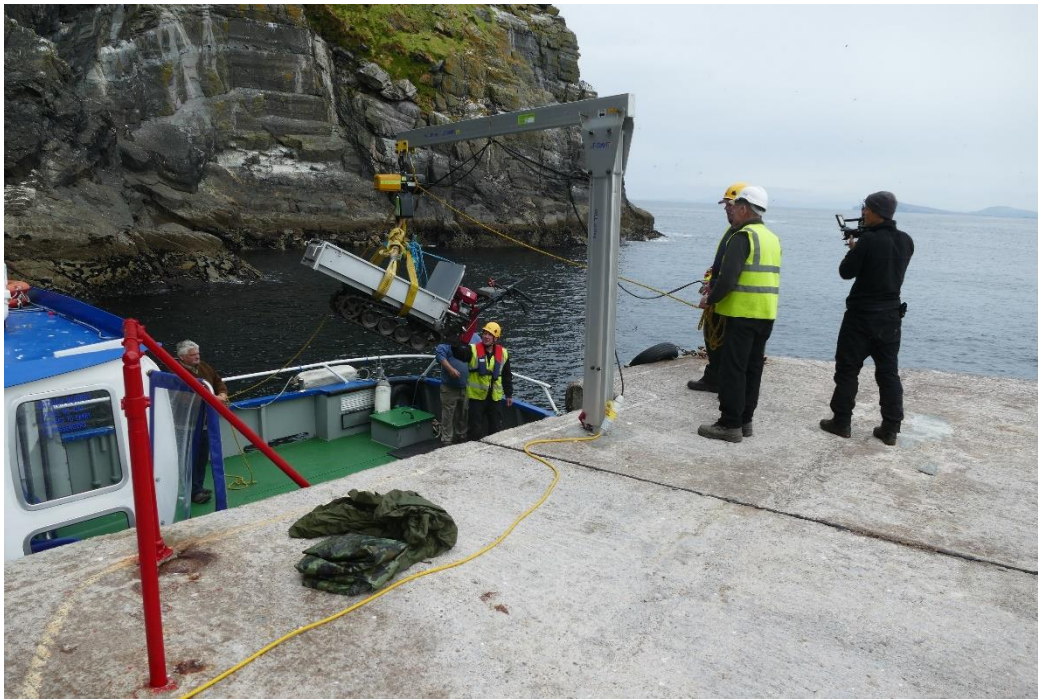
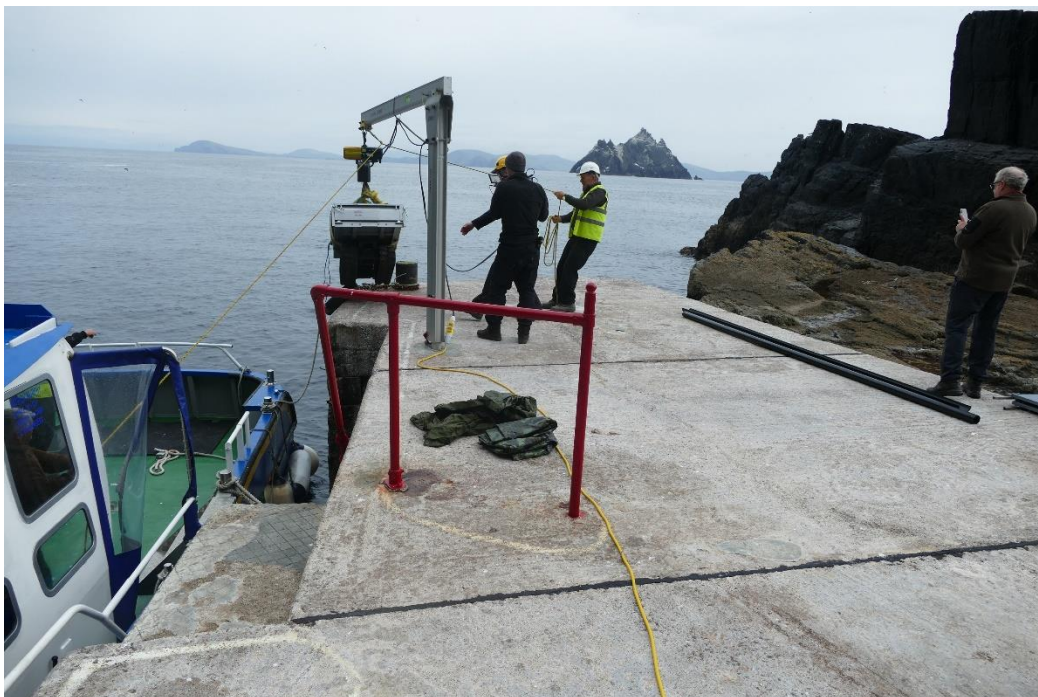
Figure 33 - View of the demountable hoist at the landing pier

Figure 34 - View of the demountable hoist at the landing pier

The OPW carry out an inspection of the mechanical machinery that will be used on the island throughout the season. These include a mechanical transporter, a small demountable hoist at the landing pier, cement mixers, muck trucks, and generators.

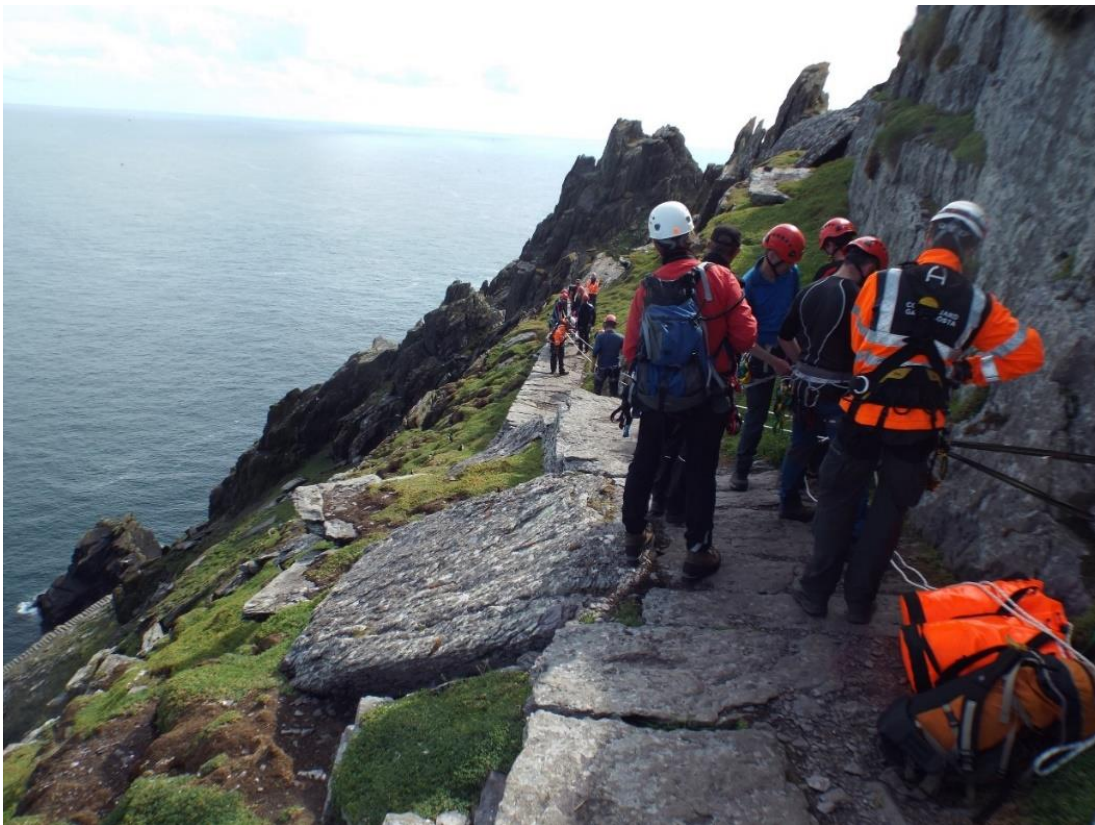
Figure 297 - Rescue exercise being carried out on site in 2019

The physical nature of the island and the uneven monastic steps are challenging to visitors and can cause serious accidents and injuries. The OPW has carried out two rescue exercises in 2019 that involved bringing a dummy casualty from the monastery to the pier on a stretcher. The Irish Coastguard Mountain Rescue team were involved in the rescue exercise and it is envisaged that a rescue exercise will take place during June of every year, weather permitting. The OPW will schedule a rescue exercise to take place in the 2024 season, to be agreed with the Irish Coastguard Mountain Rescue team.

During the rescue exercise, the OPW installed permanent safety anchors along the Monastery South Steps to be used in the event of an emergency. The OPW remove the safety anchors at the end of each season to prevent rusting and damage to the anchors during the winter months. The anchors are re-installed and tested by the OPW at the start of each season.
