Sceilg Mhichíl Annual Report

Archaeological Review

2024 Season

Prepared by the National Monuments Service
gov.ie

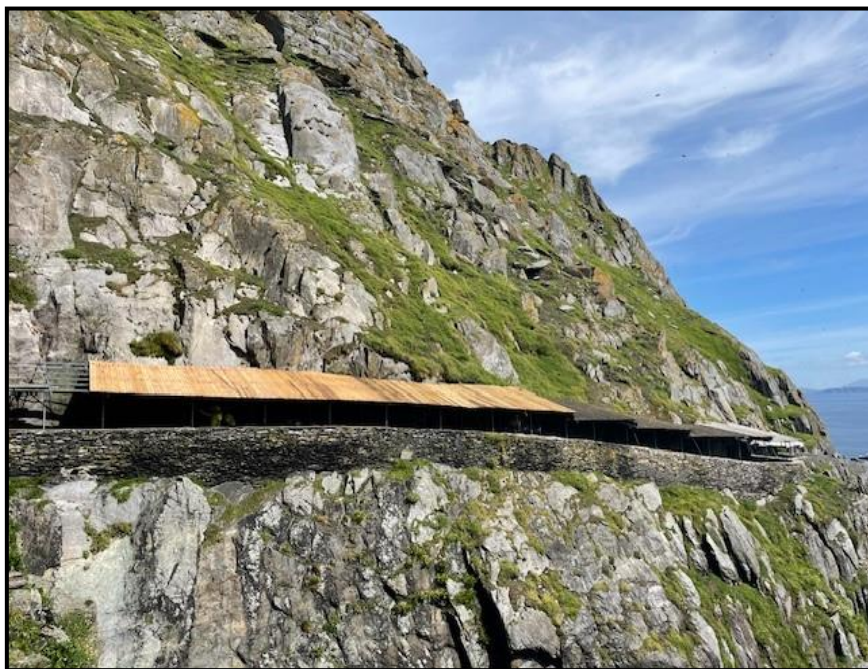
Figure 4 Crash deck at Cross Cove with replacement timbers on roof.

The June visit in partnership with our OPW colleagues enable inspection of the damage done by the rockfall at Cross Cove and the repair work to the crash deck there that was ongoing. A discussion also took place on the possibility of placing a larger sign at a certain location on the south steps, that turns acutely and which has been identified as potentially hazardous. We discussed a single handrail and OPW

The sweep was undertaken in May by OPW and a controlled removal of loose rocks formed part of the approved methodology, with the need to break up some larger rocks prior to removal from the slopes. The timbers that had been damaged in the crash deck at Cross Cove were also replaced. During the course of replacing these, which were about 20 years old, it was identified by the OPW that many were showing signs of rot and a more extensive replacement of timbers would be needed on safety grounds. More extensive replacement then took place of the remaining timbers, all of which has no impact on any cultural element and did not require archaeological monitoring.

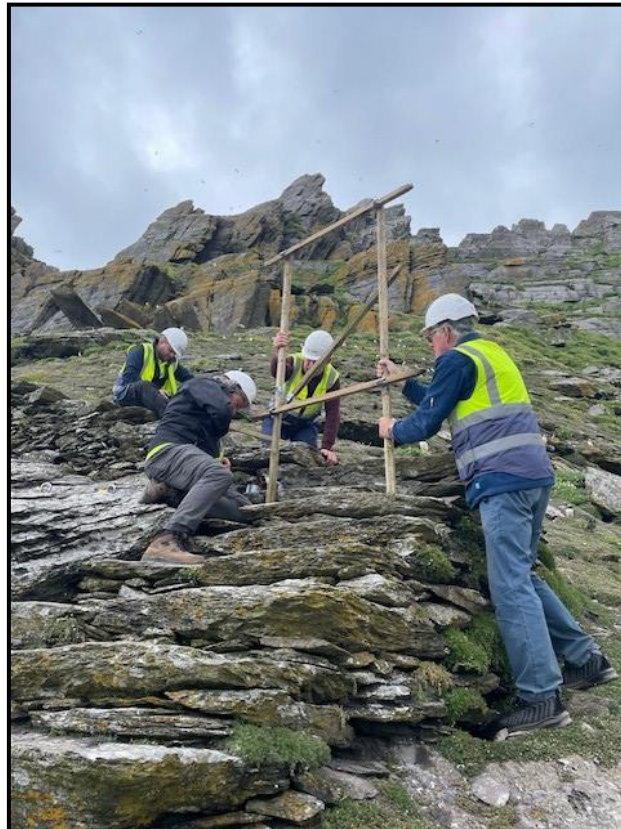
colleagues set up a template in timber. In principle it was agreed that such a structure would not be wholly visually impacting but it could only be erected prior to the nesting period. Subsequent engagement when looking at more detailed plans resulted in identifying that there would be a need to place much longer support legs on the structure and thus it would or could have, potentially, significant archaeological impact. It was therefore agreed to increase the existing signage at the location, rather than the erection of any additional steelwork.

Figure 5 OPW personnel using a timber template to assess potential for handrail at location on south steps.

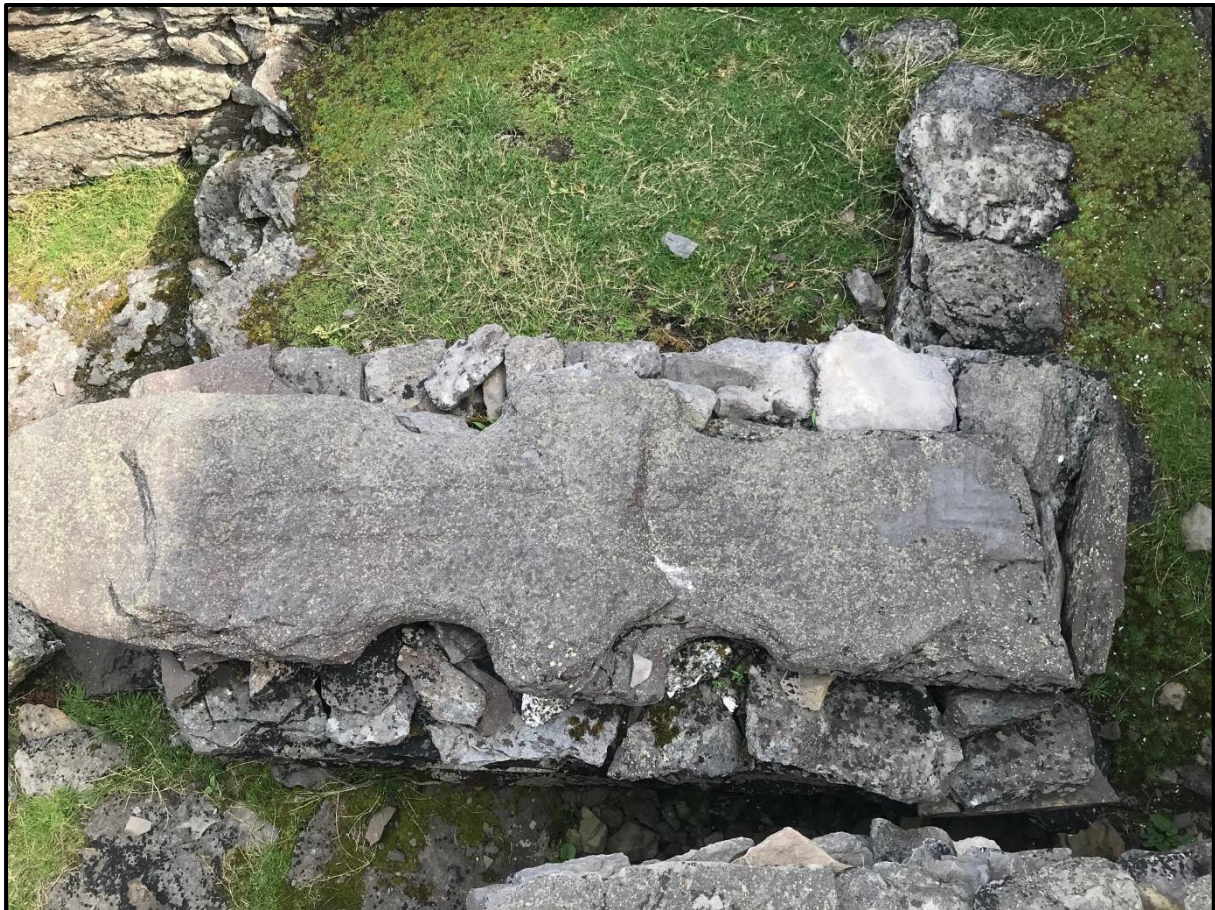
In July a dedicated inspection by Connie Kelleher looked at a stone engraved cross slab at the monastery. The slab is showing abrasion due to possible climate impact or it could denote tampering. Certainly, there is a specific area that has been cleaned. Subsequent discussion with OPW colleagues focused on whether there was a need to take the cross slab into care but the logistical reality of carrying it down the southern steps would be significant. It could be brought inside one of the huts but this would mean it was in darkness and not readily viewable, plus information as to its new location would have to be erected. It was concluded that a

Figure 6 Cross slab that lies horizontally beside St Michael's Church, with distinct wear evident at lower,

wider assessment of all the cross slabs at the monastery would be commissioned to determine the extent of impact and degradation, to view previous photographic and descriptive evidence as comparative analysis, with the results informing better the requirements for the cross slab and perhaps others also.

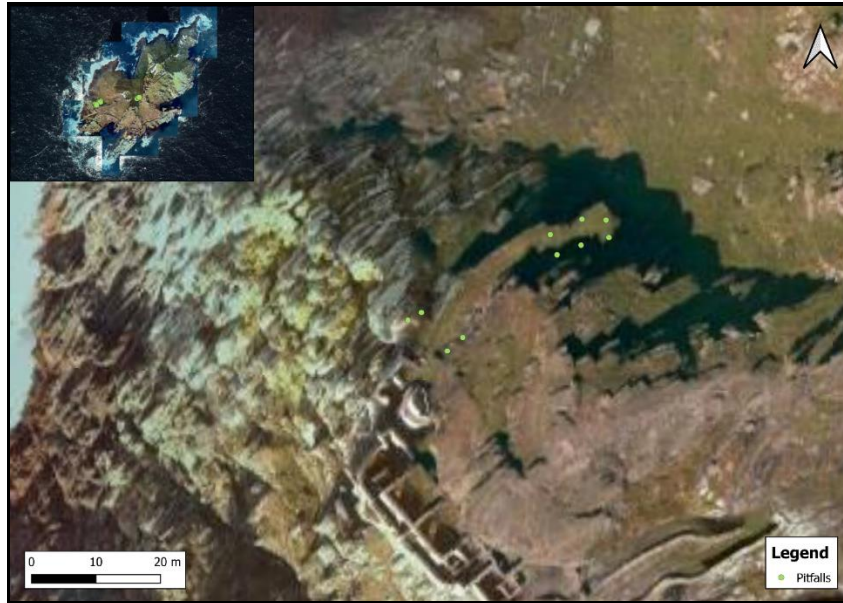
A separate report will be issued on the spider survey by NPWS as part of its annual reporting responsibilities. Archaeological monitoring did not identify any cultural material during the digging or back-filling of the trap holes.

Figure 7 Location of pitfall traps set as part of a spider survey of Sceilg Mhichíl behind the Upper Lighthouse.

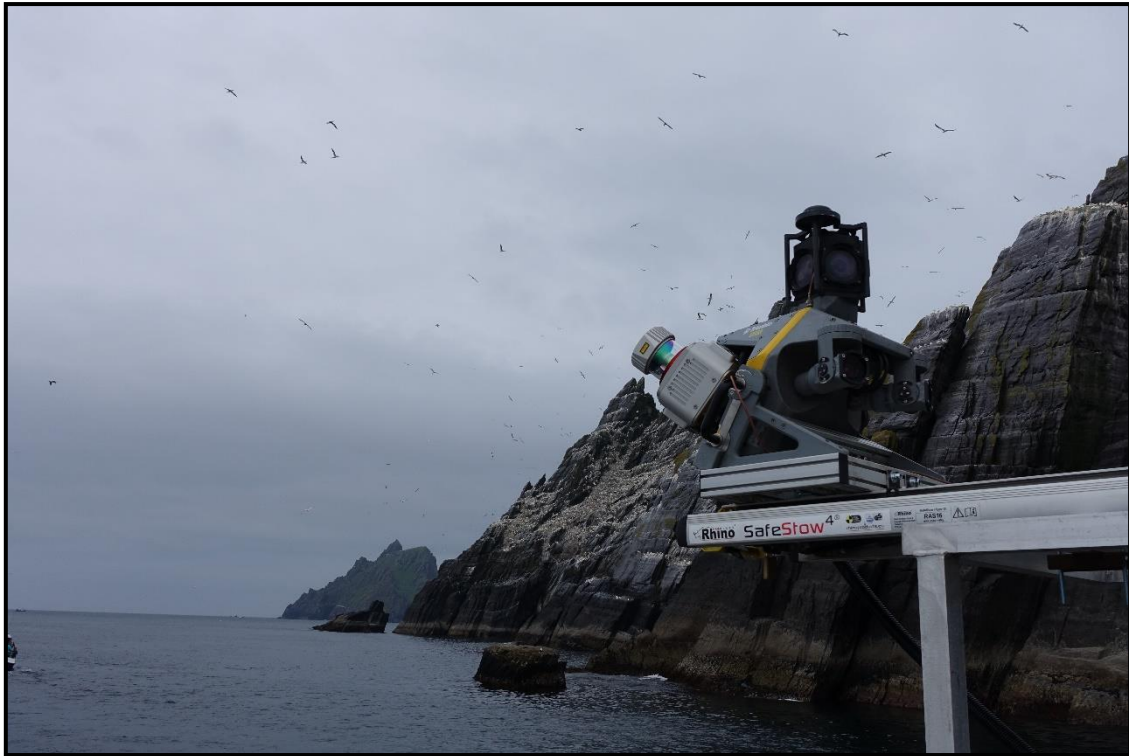
Figure 9 Hull mounted laser scanner on INFOMAR's survey vessel RV Keary undertaking a survey of both islands.

The INFOMAR mapping and laser survey was undertaken in July and the entire perimeter of both islands were mapped. The laser sought to map the area just above the waterline and thus to address the 'white ribbon' or area between land and sea that multibeam could miss.

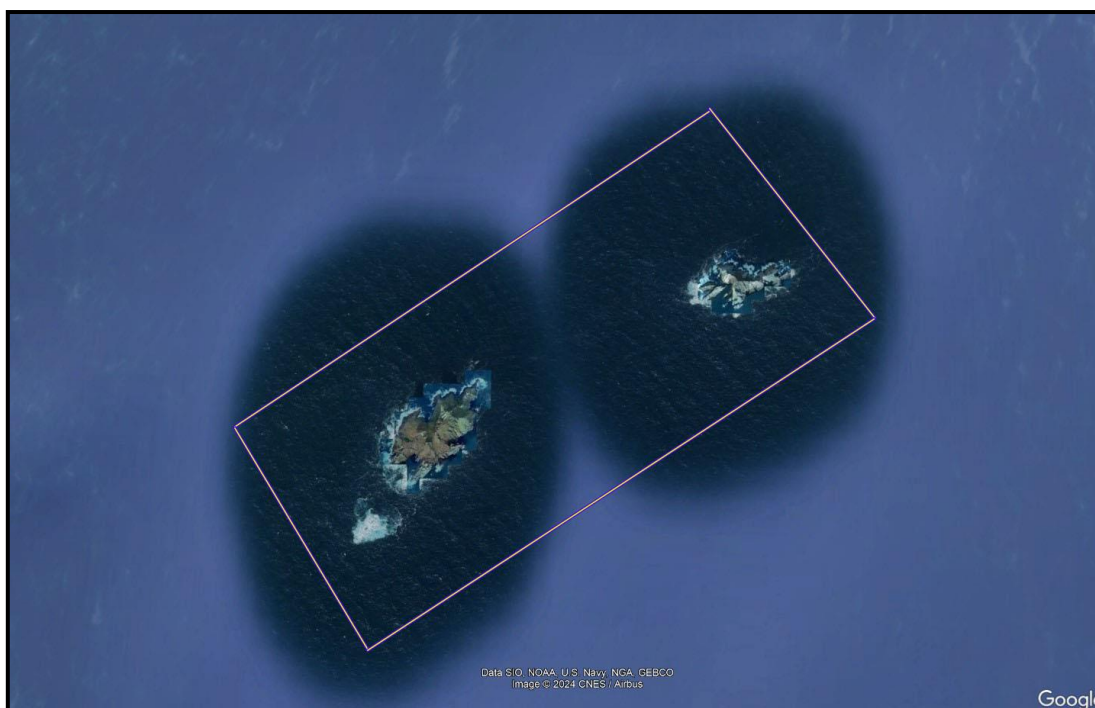
Figure 10 Marine mapping areas.

The data is being assessed currently, but it is hoped that some useful outputs from the survey could include information on sedimentation and the sedimentation transport processes at play which can indicate if scouring is occurring around the islands, and if increased storminess is impacting the steps on the WHP or the wreck at Sceilg Bheag. This information can indicate if sites are under threat from erosive processes or storm damage and can inform further archaeological intervention to protect them.
