# Sceilg Mhichíl World Heritage Property

OPW Works Season 2024 UNESCO Report Final Issue 11.12.2024

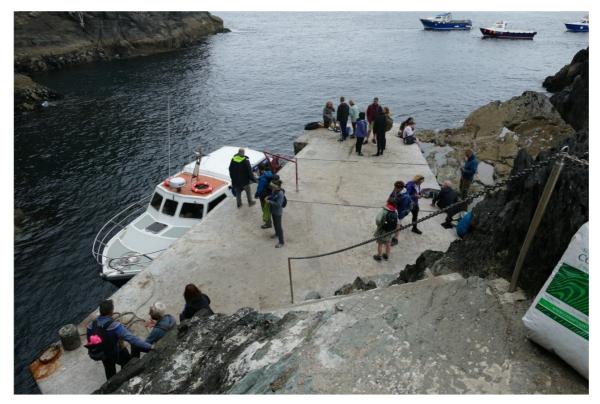
Figure 5 - Tourists arriving at the landing pier

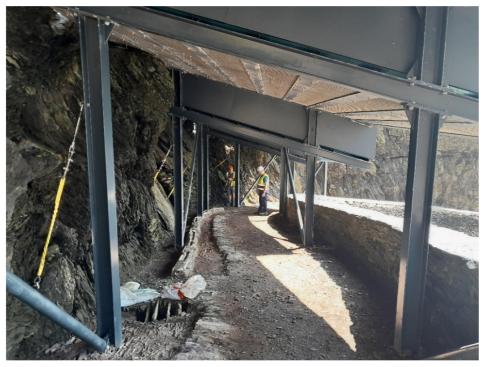
The OPW re-instated the historic drains in the locations of Crash Decks 1, 2 and 3 located on the Lower and Upper lighthouse roads in the 2024 season. The historic drains were removed in 2022 to facilitate the construction of the crash decks. The works were undertaken following the completion of the works to the 3 no. crash decks in the 2023 season. The OPW appointed Alan Hayden consultant archaeologist to carry out archaeological monitoring of the works. Alan Hayden issued an archaeological monitoring report to OPW in September 2024 following the completion of the works (see appendix D).

Figure 9 - View of the re-instated historic drains in the location of Crash Deck no .3

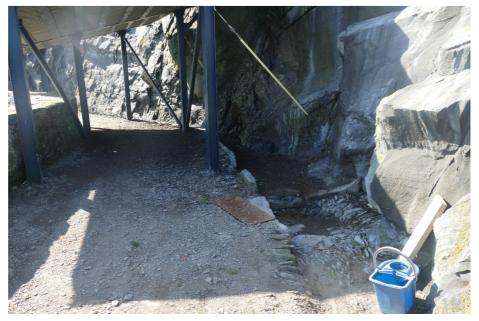
Figure 10 - View of the re-instated historic drains in the location of Crash Deck no .3

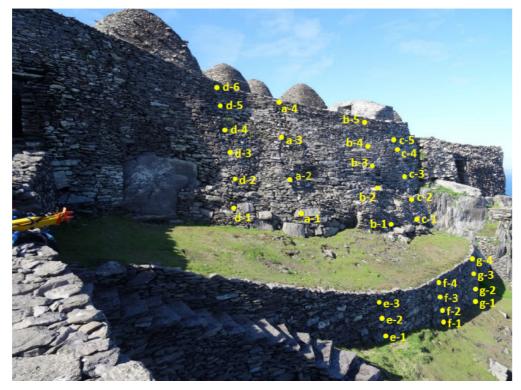
The Discovery Programme carried out their site visit and surveyed the monastic settlement during the 2024 season. The Discovery Programme issued their final report to OPW in June 2024. The largest movements in the retaining wall are occurring in lines A, B and C over the nine-year monitoring period. Lines E, F and G are generally stable within the tolerance of the survey instrument and methodology (see appendix H).

Figure 11 - Discovery Programme marker point locations at monastery retaining wall

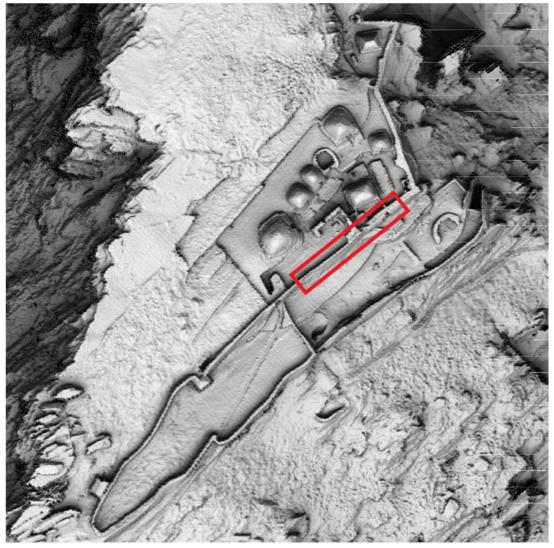
Due to increased rainfall and pressure from runoff rainwater, the OPW will be undertaking repairs to this section of the retaining wall over the coming years. The OPW commissioned a digital survey of the Monastery in 2021 to facilitate the future repair works. All works will be subject to DHLGH Ministerial Consent and best conservation practices will be implemented. All proposed repair works will be subject to an agreed archaeological mitigation strategy with DHLGH.

Figure 12 - Location of movement to retaining wall below St. Michael's Chapel

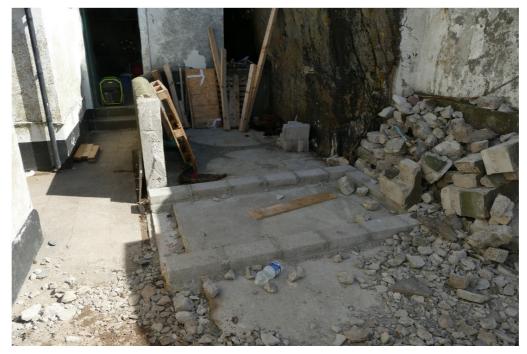
existing bund wall at the Lower Lighthouse complex. The section of the bund wall was removed in the 2022 season and the foundation for the proposed composting toilet was installed on site. The OPW will install the new composting toilet in the lower lighthouse compound in the 2025 season.

Figure 13 - Foundation for the proposed composting toilet installed at the Lower Lighthouse compound

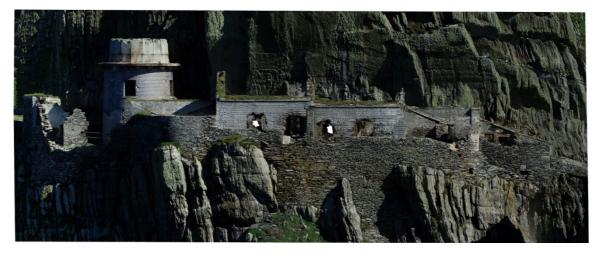
Figure 14 - Aerial view of the Upper Lighthouse and sea wall © Photographic Archive, National Monuments Service, Government of Ireland

The plywood protection to the floors at the Upper Lighthouse was damaged over the winter period in 2024. The OPW removed the damaged plywood protection and installed new ones during the 2024 season.

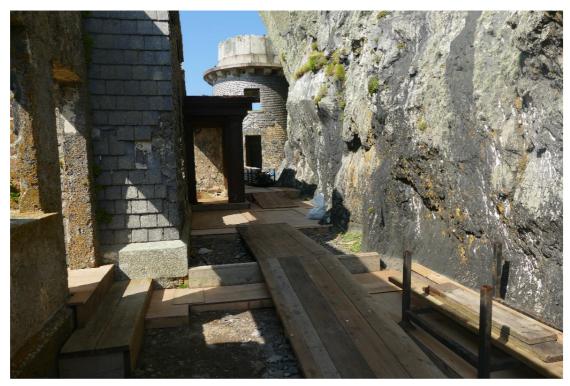
Figure 16 - View of the new installed plywood protection to the existing floor at the upper lighthouse

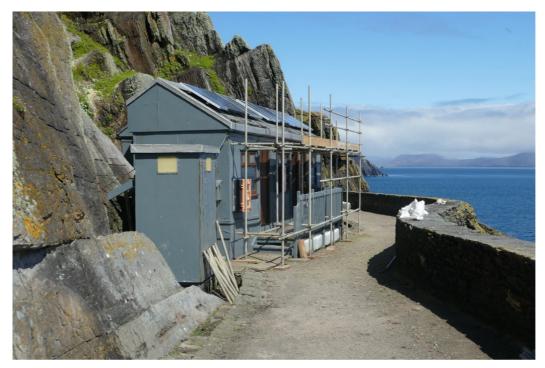
The OPW inspected the existing solar panels on the site huts in the 2024 season as part of their yearly maintenance. The existing solar panels required replacement. The OPW replaced the existing solar panels on the guides huts on the lower lighthouse road with new solar panels in the 2024 season.

Figure 19 - New solar panels installed to guides huts on site

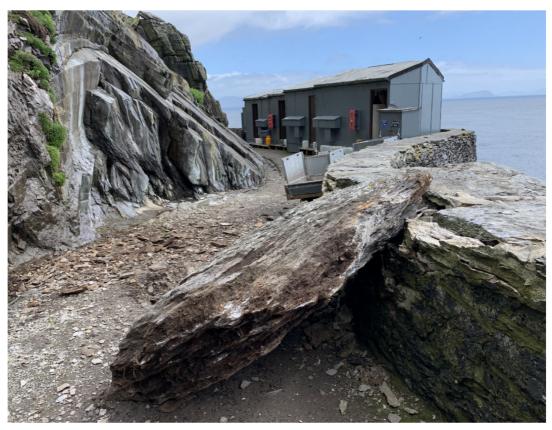
Rock falls have increased in frequency in recent years, due to the effects of climate change. The high levels of precipitation are leading to soil erosion and rock falls. The substantial rock fall which occurred in 2020 on the lighthouse road near the site huts resulted in the installation of a temporary timber crash deck at this location and at another two high risk locations on the Upper Lighthouse Road to protect OPW operatives from falling debris.

Figure 27 - Rock Fall on 27<sup>th</sup> July 2020

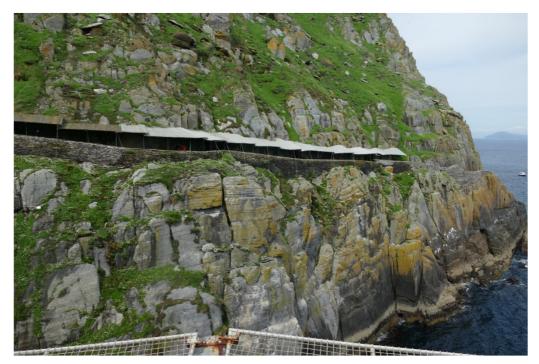
A serious rock fall occurred on the lower lighthouse road on 13<sup>th</sup> June 2022. The island was closed to the public with immediate effect for 3 weeks from 13<sup>th</sup> June 2022 and re-opened on 4<sup>th</sup> July 2022. To mitigate the effects of rock falls, the OPW installed a new canopy on the lower lighthouse road of approximately 100 linear meters in length following a grant of Ministerial Consent by DHLGH.

Figure 28 - View of the canopy installed at the Lower Lighthouse road following the rock fall that occurred on 13<sup>th</sup> June 2022

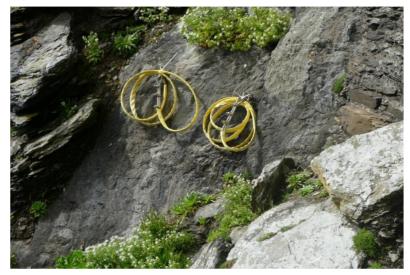
The Ministerial Consent conditions outlined the requirement for the temporary removal of the stainless steel stays on the seawall side of the crash decks during the summer season to avoid injury to the birds during the nesting season. The stainless steel stays are to be re-installed at the end of the summer season before the island closure. The OPW removed the stainless steel stays during the 2024 summer season to the 3 no. crash decks on the lighthouse road. The stainless steel stays were coiled up and attached to the rock face below the sea walls. The OPW later re-instated the stainless steel stays in September 2024 before the work crew evacuated the island.

Figure 29 – View of the stainless steel stays coiled up and attached to the rock face below the sea walls

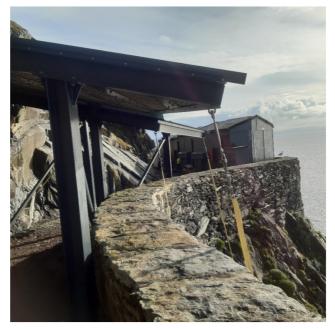
Figure 30 - View of the re-instated stainless steel stays of Crash Deck no. 1 at the end of the season

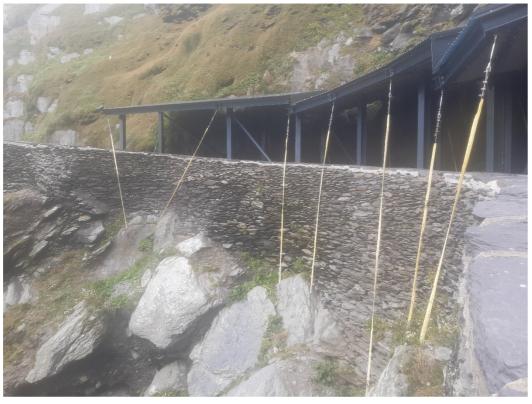
Figure 31 - View of the re-instated stainless steel stays of Crash Deck no. 2 at the end of the season

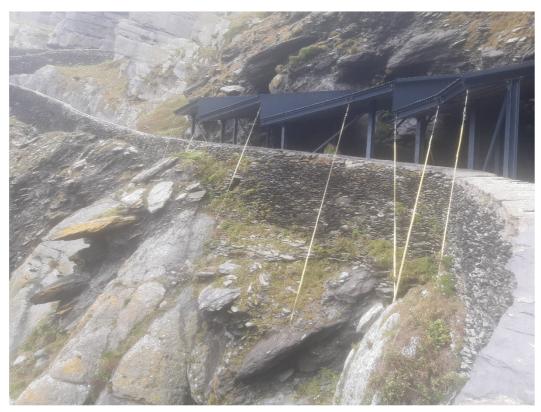
Figure 32 - View of the re-instated stainless steel stays of Crash Deck no. 3 at the end of the season

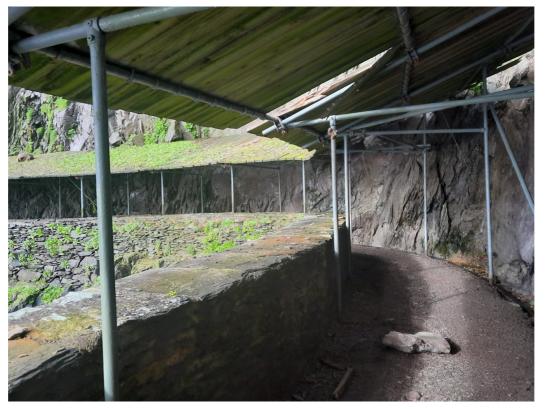
A rock fall occurred on the lower lighthouse road at Cross Cove early in the 2024 season that damaged the timber boarding of the existing timber crash deck. OPW architects carried out a site visit on 24<sup>th</sup> April 2024 to inspect the rock fall and the damaged timber boarding. The OPW appointed Gordon Knaggs consultant timber specialist to inspect the timber boarding. Gordon Knaggs issued a condition report of the damaged timber to OPW on 5<sup>th</sup> May 2024 (see appendix E). Gordon Knaggs also issued a report of the phases of repairs required to the timber canopy at Cross Cove to OPW on 24<sup>th</sup> May 2024 (see appendix F).

Figure 33 - View of the rock fall at Cross Cove and the damage to the timber decking

DHLGH confirmed to OPW that a Ministerial Consent is not required for the removal and replacement of the section of timber decking to the crash deck at Cross Cove. The OPW completed the installation of the new timber decking in June 2024.

The OPW will be including the repair and maintenance to the crash decks at Cross Cove as part of their yearly maintenance programme. The OPW are proposing to replace the existing timber boarding with new timber boarding to the 2016 section of the crash deck at Cross Cove in the 2025 season.

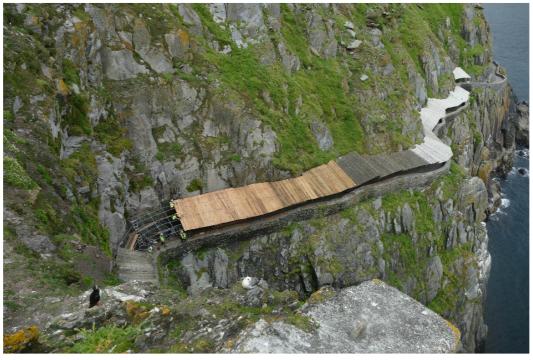
Figure 34 - Timber repairs in progress to Crash Deck at Cross Cove

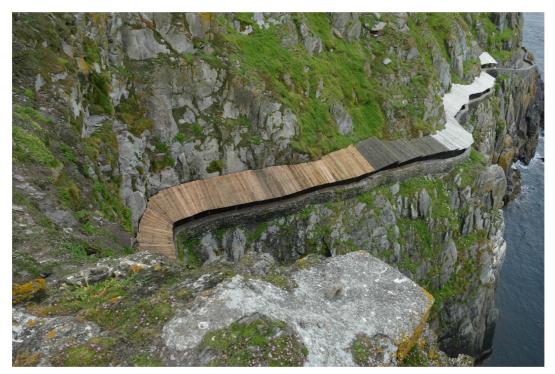
Figure 35 - New Timber decking installed on Crash Decks at Cross Cove
