**Reinstatement of the roadway features
removed to facilitate construction of the
three all-metal crash decks on the
Lower and Upper Lighthouse Roadways,
Sceilg Mhichíl, Co. Kerry.**

**Reinstatement of the roadway features removed to facilitate construction of the three all-metal crash decks on the Lower and Upper Lighthouse Roadways,
Sceilg Mhichíl, Co. Kerry.**

*Alan Hayden
Archaeological Projects Ltd,
September 2024*

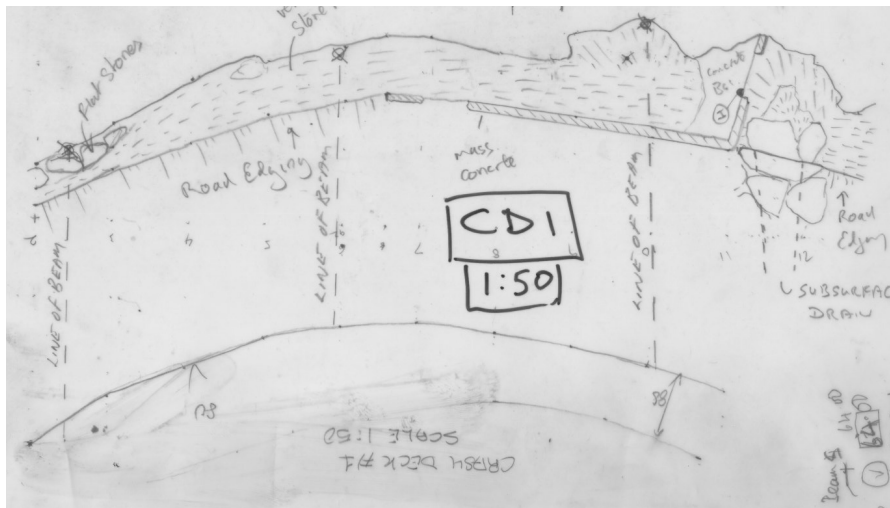
Fig. 2. Scan of field plan of the roadway features at Crash Deck 1.

The features in the area of Crash Deck 1 were fully visible before works were undertaken and were planned and recorded by the writer in advance of construction in 2022 (fig. 2). The areas beneath Crash Decks 2 and 3 were fully excavated, planned and recorded as part of the works on the Upper Lighthouse Roadway in 2017 and 2018 (figs. 3 & 4) (Hayden 2017 & 2018).
